# UNIT 400 DUNSBURY PARK, HAVANT

## Walking, Cycling and Horse-Riding Assessment

**WALKING, CYCLING AND HORSE-RIDING ASSESSMENT**

| <i>Document No:</i> | 273.0001/WCHAR/2<br>DP-PB-400-XX-RP-TP-WCHAR-2 | |

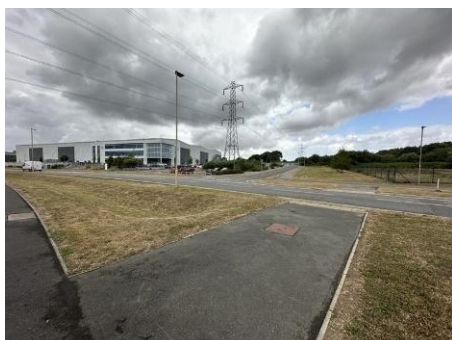
**Photograph 13:** Crossing point across the Fitzwygram Way to the south of unnamed road

- 3.5 Where crossing facilities are provided within Dunsbury Park these have been constructed to a high standard in the form of uncontrolled crossing points, accompanied by tactile paving and dropped kerbs shown in **Photographs 13** and **14**.

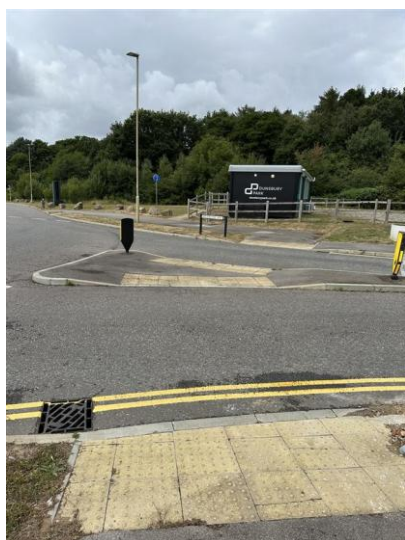
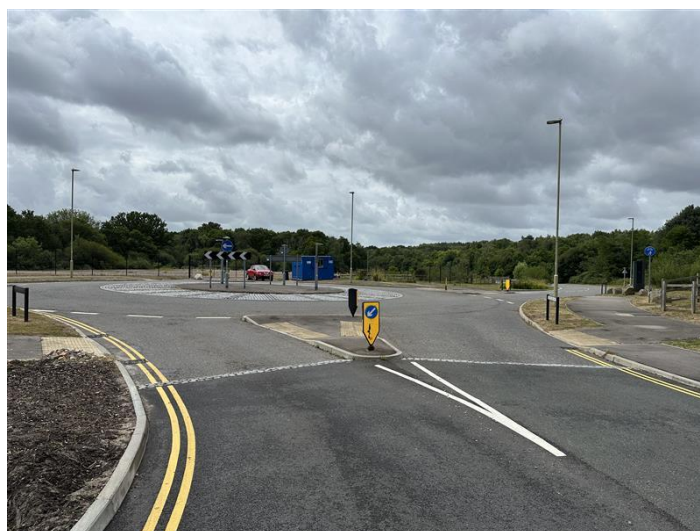
**Photograph 15-16:** Existing conditions (during site visit) in Dunsbury Park where the shared footway/cycleway terminates to the west

- 3.6 As noted above Fitzwygram Way travels east/west through Dunsbury Park. To the west of the access for Unit 400 the shared use footway/cycleway continues along the northern side of the carriageway, whilst the footway continues along the southern side, up to the roundabout junction with Brooklime Way, at which point the off-road provision around the roundabout is 3m wide and supports shared footway/cycleway provision across all arms (**Photographs 15** and **16**).

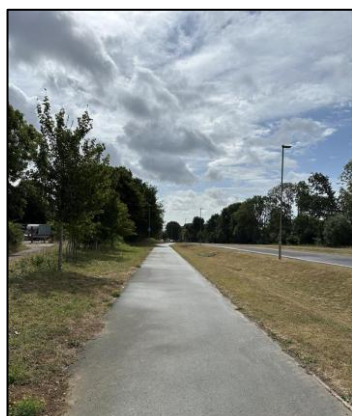
**Photograph 17:** Footway connection on the northern side of the carriageway towards Woolston Road (Heading East from Dunsbury Park)

3.9 Heading to the east from the unnamed road, along Fitzwygram Way, the shared footway/cycleway provision on the northside continues, as does the footway provision on the southern side. Existing conditions of these footways are shown in **Photographs 17** and **18**.

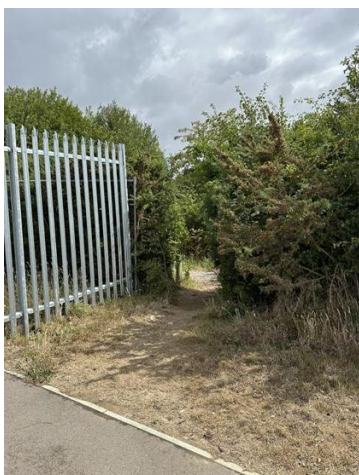
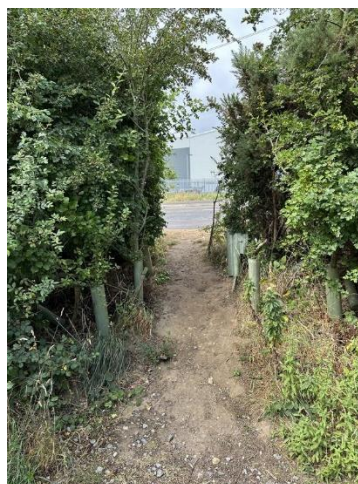
**Photographs 23-24:** Informal access link onto Park Lane off the unnamed Road to the north of Fitzwygram Way

- 4.2 For those travelling north from Unit 400 this review will consider the formal route to access Park Lane, however there are multiple informal access points onto Park Lane from Dunsbury Park, which were noted to be utilised during the site visit.
- 4.3 One is located adjacent to the current gated access to Unit 400 which is shown in **Photographs 23** and **24**, providing access from the unnamed road to Park Lane.

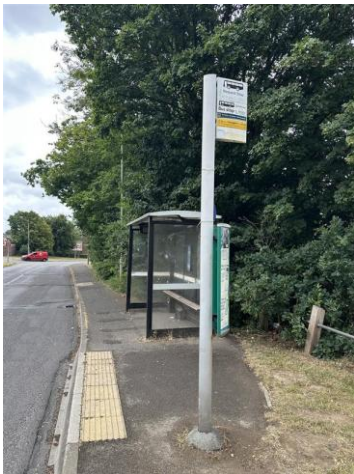
**Photograph 26:** Footway and bus stop condition on Calshot Road (Southern edge of carriageway)

- 4.6 Approximately 75m from the roundabout the footway on the southwestern side of Calshot Road provides access to the Larkwhistle Way Bus Stop (**Photograph 26**) before the footway on that side of the road terminates and becomes grass verge. Pedestrians wishing to continue north can use an uncontrolled crossing supported with dropped kerbs and tactile paving, approximately 20m south of the bus stop (shown in **Photograph 27**). This crossing provides access to the northeastern footway, which aids pedestrian movement travelling north on Calshot Road.

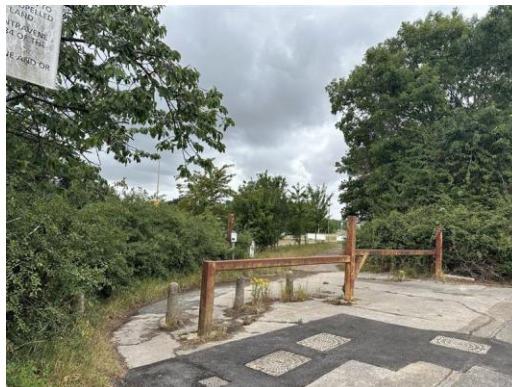
**Photograph 28:** Park Lane access from Calshot Road.

- 4.8 Approximately 100m north of the pedestrian crossing point is the access to Park Lane, which is on the western side of Calshot Road. There is no pedestrian crossing provision in the vicinity of the Park Lane access although Park Lane is on the same level as the carriageway and was noted to be utilised by pedestrians during the site visit. The access is opposite an area of dedicated car parking therefore a pedestrian crossing in this location would be challenging to deliver, without impacting on the current parking area.

- 4.9 An alternative could be to extend the footway from the Larkwhistle Way bus stop, north to the Park Lane access.
- 4.10 Cyclist using Calshot Road will do so on-carriageway. This is considered acceptable as the road measures over 6m wide and therefore is sufficient to accommodate the 1.5m minimum overtaking clearance stated with LTN 1/20 for a 30mph road. Cyclists are also able to cycle onto Park Lane, which is surfaced at its entrance. Although the entrance is gated to prevent motor vehicle access, and both cyclists and pedestrians must manoeuvre past this feature (**Photograph 28**) It is also noted within the HBC LCWIP that Calshot Road (section 362.2.4) should be upgraded to include appropriate traffic calming and allow for mixed traffic within a 20mph speed limit.

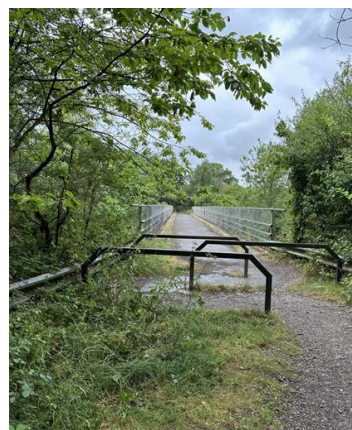
**Photographs 33-34:** Park Lane existing conditions heading onto bridge across A3(M) (Heading West)

- 4.13 Park Lane continues to the northwest with a wide route provided across the A3(M) bridge, barriers are in place to encourage cyclists to demount and slow down while crossing the bridge. The existing conditions of this section of the route are shown in **Photograph 33-35**.

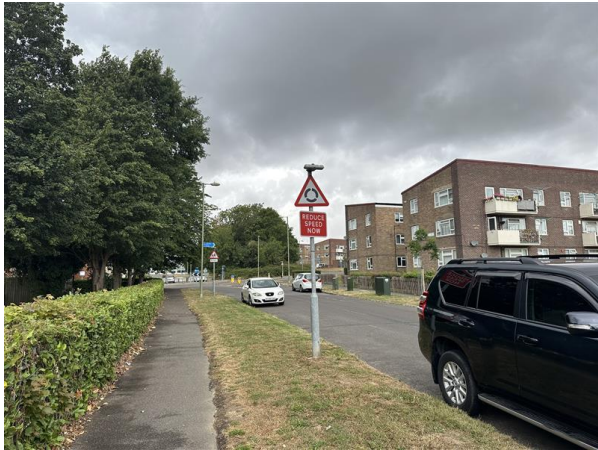
**Photograph 40:** Footway on Woolston Road (Heading towards Fitzwygram Way)

- 5.3 Footways are provided along both sides of the carriageway on Woolston Road which are of sufficient width (**Photograph 40**) measuring approximately 1.2-1.5m wide and are separated from the carriageway by a grass verge and this is in excess of the minimum width of 1m required by Inclusive Mobility guidance. Further to this, along the southern edge of the carriageway a section of the footway is provided as shared footway/cycleway measuring c.2.5m between the grass verges (**Photograph 41**). This should measure 3m wide to meet the requirements in HCC TG10 and LTN 1/20 for routes with under 300 cyclist flows per hour.

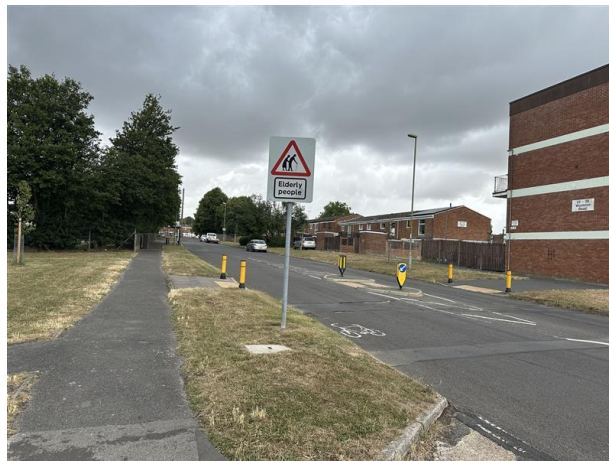
**Photograph 42:** Crossing Point and refuge island across Woolston Road

5.4 Travelling south, the crossing of side roads is supported by dropped kerbs and tactile paving crossing points to aid safe movement to the local shops and additional bus stops. Approximately 250m south of the Woolston Road/Calshot Road/Freeley Road/Fitzwygram Way Roundabout there is an LTN1/20 compliant crossing including dropped kerb/tactile paving and a refuge island to support movements across Woolston Road (**Photograph 42**), with visibility at each junction assessed and considered appropriate. The image also shows on-road cycle markings, supporting carriageway cycling.

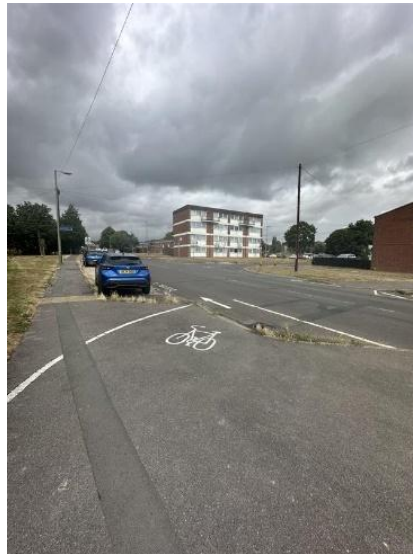
**Photograph 43:** Road markings on Woolston Road for cyclists to rejoin the carriageway

island) to support cyclist travelling off-road to or from the south, towards the Woolston Road/Middle Park Way roundabout junction.

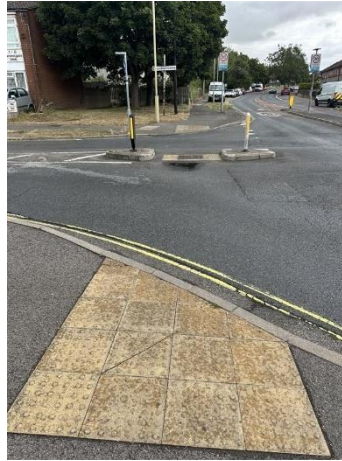
**Photograph 44:** Crossing Point across Woolston Road junction with Middle Park Way

- 5.8 Footways (on the eastern side) and shared footway/cycleways (on the western side) continue from Woolston Road onto Middle Park Way. Pedestrians can utilise the crossing in **Photograph 44** to cross from the south-western footway on Woolston Road to the north-eastern footway (which then continues northeast) along Middle Park Way. The crossing point is in good condition accompanied by a pedestrian refuge island with dropped kerbs and tactile paving, with suitable visibility achieved and provides a safe connection for pedestrians.

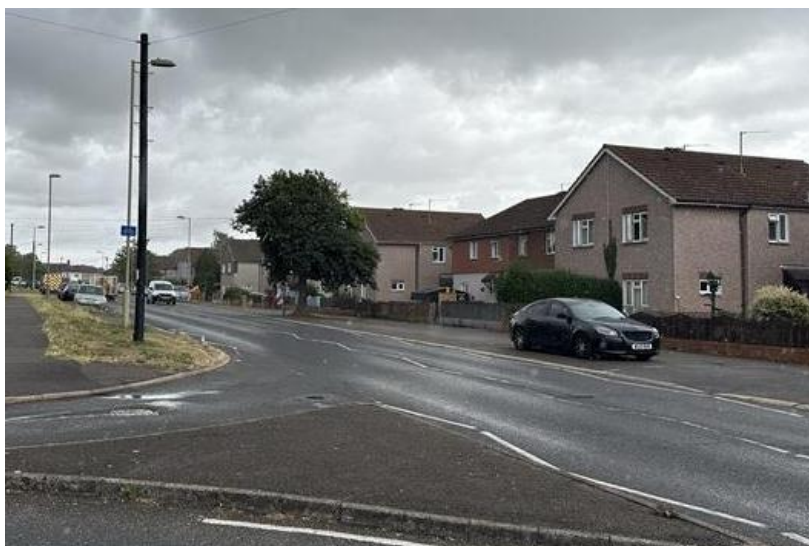
**Photograph 50:** Signage to indicate cyclists can utilise the carriageway on Middle Park Way and on-footway parking

- 5.15 Pedestrians are expected to use the signalised crossing to move onto the southern footway, which runs along Middle Park Way. Pedestrians then travel east towards Dunsbury Road which is c. 30m away. This section of Middle Park Way is still 20mph and supported by speed cushions, however the footway accommodates on-footway parking (**Photograph 50**). There is also a c1.5m footway present supporting pedestrian movements, which complies with Inclusive Mobility.
- 5.16 The route is seen to be sufficient as cyclists can cycle on-road with signage provided (**Photograph 50**). However, as aforementioned HBC LCWIP (section 362.3.1) suggested the desire to provide corridor improvements in this area such as a two-way cycle track or stepped cycle lanes, however it is noted this may require the removal of trees and existing footway parking.

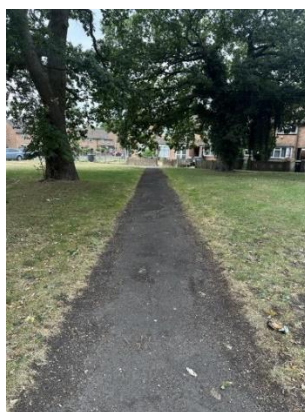
**Photograph 59:** Footway between Middle Park Way and Park House Farm Way.

- 6.8 It is noted the footway connection from Middle Park Way to Park House Farm Way, along the northern side of the junction, uses a footway that crosses diagonally over a grassed area in front of houses, on the corner (**Photograph 59**), as the footway terminates along the northern side of Park House Farm for a distance of approximately 25m to allow for on-street parking. This footway measures at least 1m wide which is the absolute minimum accepted by Inclusive Mobility guidance. No corduroy paving is provided on this route, however corduroy paving is provided on the northern footway (where the footway terminates for on-street parking) and southern footway of Park House Farm Way, after the junction with Middle Park Way, confirming the end of the shared footway/cycle way from Middle Park Way.

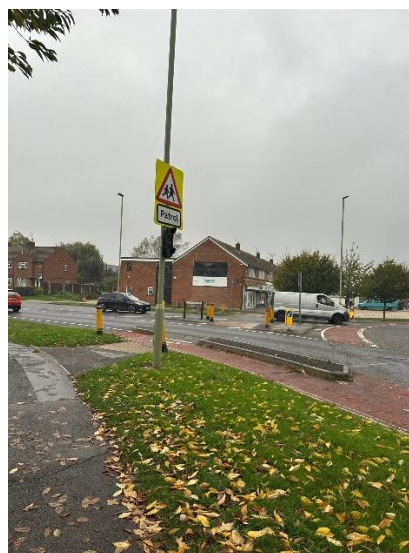
**Photograph 72:** Cycle infrastructure on Purbrook Way (W) leading on from Middle Park Way/Purbrook Way/Park Lane roundabout

- 7.7 It is noted within the HBC LCWIP (section 362.3.2) thought that potential upgrades are suggested for this roundabout given that cyclists are not given priority across the exits from the roundabout. It is suggested that greater priority should be given to cyclists, potentially with a Dutch style roundabout.

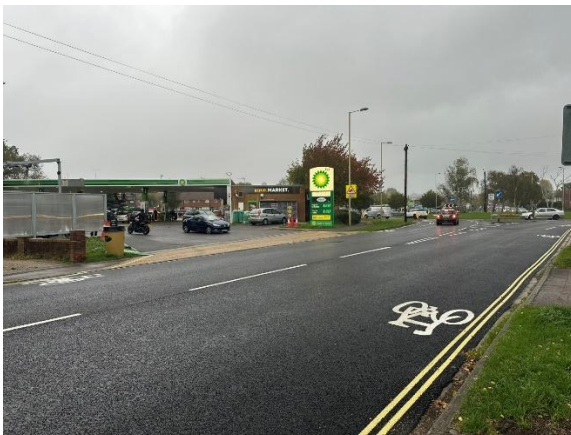
**Photograph 73:** Cycle lanes terminate on Park Lane – looking north

- 7.8 Heading south onto Park Lane the marked on-road cycle lane continues until after the BP garage where it then terminates (**Photograph 73**), a cyclist was noted during the site visit to utilise the cycle lane along Park Lane heading northwest whereby they carried on along the cycle route onto Purbrook Way (W) (**Photograph 73**). Cyclists can then continue along the carriageway with it considered suitable given the 30mph posted speed limit, the residential nature of the road and because the carriageway measuring c.7m which will accommodate for the 1.5m cycle clearance for a 30mph road in LTN 1/20, with a cyclists noted during the site visit to utilise the cycle lane along Park Lane and then continue south along the carriageway (**Photograph 75**).
