DUNSBURY PARK, PORTSMOUTH

# Dunsbury Park, Plot 400

Phase 1 Desk Study

Prepared for:  
Portsmouth City Council

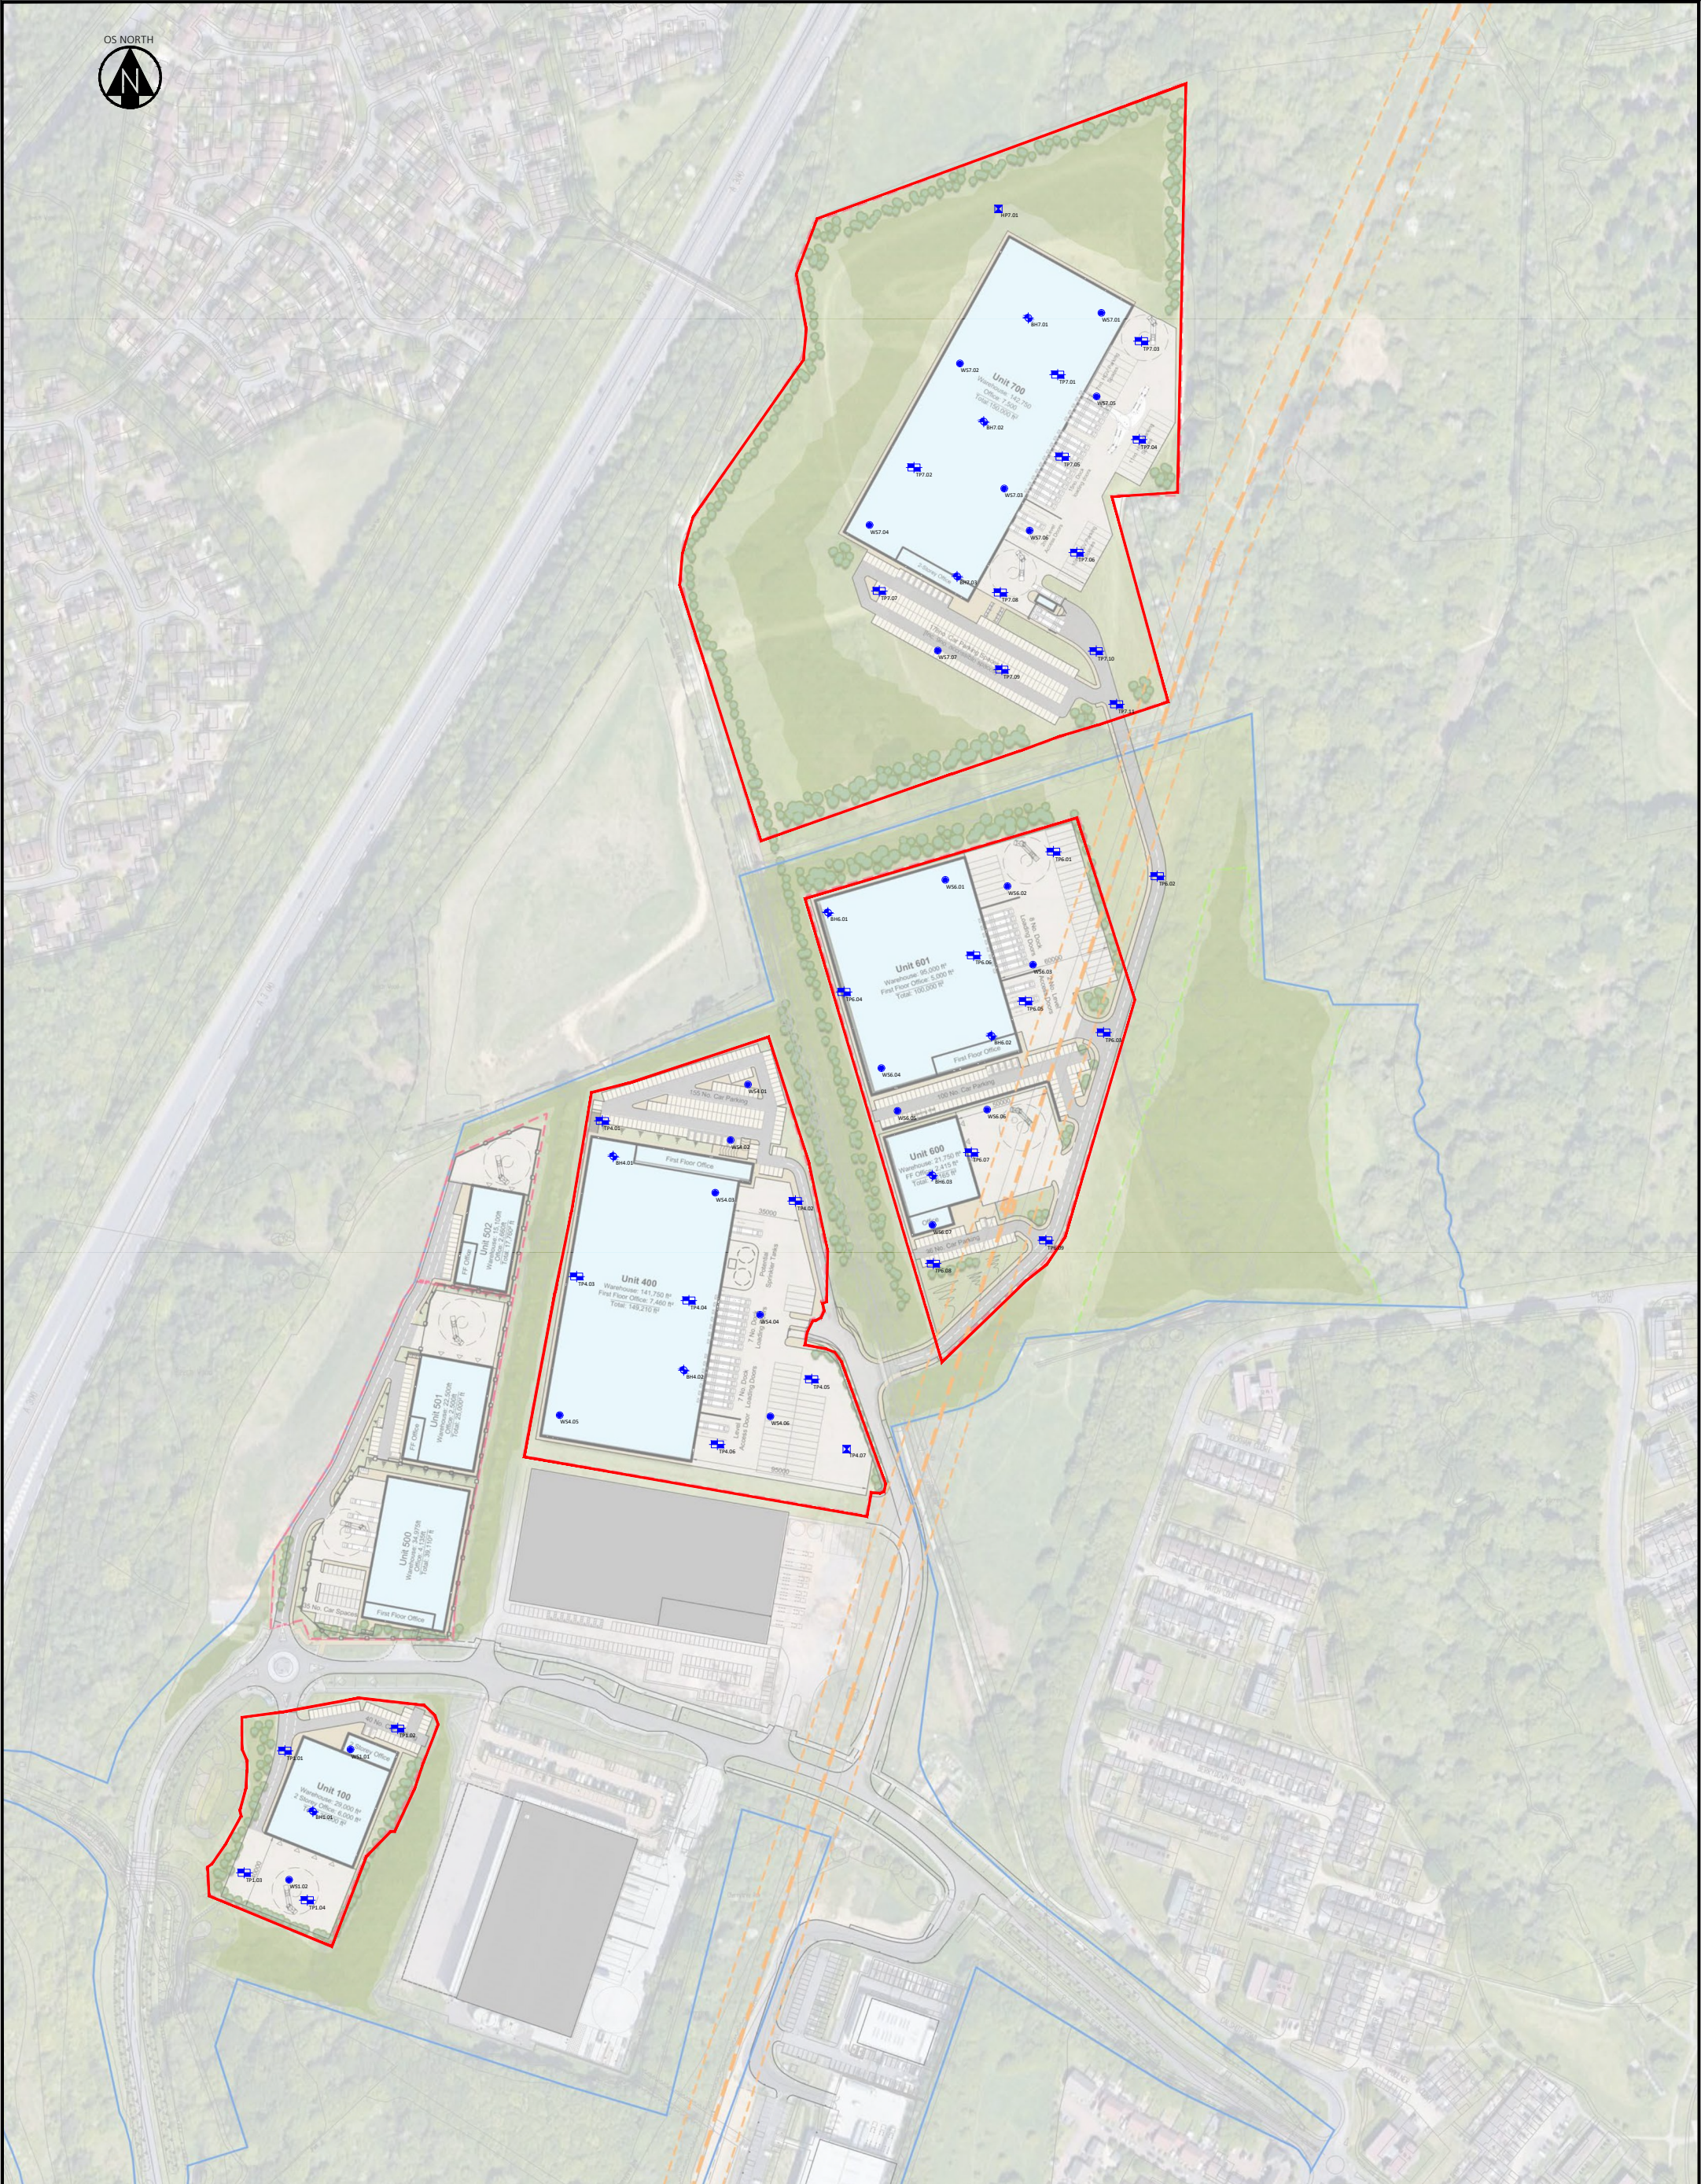
| KEY | | NOTES | | | | Hydrock | | TITLE | |
|---|--|---|--|--|--|---|--|---|--|
| <div>Key:</div> <div><div><div></div><div>BH##</div><div>Borehole</div></div><div><div></div><div>WS##</div><div>Windowless sampler borehole</div></div><div><div></div><div>TP##</div><div>Trial pit - mechanically excavated</div></div><div><div></div><div>TP##</div><div>Trial pit - hand dug pit</div></div></div> | | | | | | CLIENT | | EXPLORARY HOLE LOCATION PLAN -<br>Plots 100, 400, 600 and 700 | |

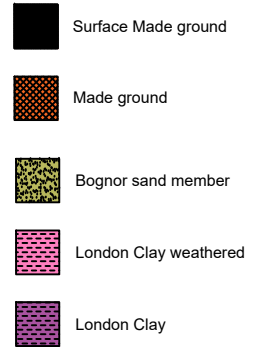
## Potential on-site sources of contamination

- Made Ground, associated with historical landfill activities and current earthworks/construction works, possibly including elevated concentrations of metals, metalloids, asbestos fibres, Asbestos Containing Materials, PAH and petroleum hydrocarbons (S1).
- Ground gases (carbon dioxide and methane) from organic materials in the Made Ground / landfill / earthworks and Head Deposits (S2).

## Potential off-site sources of contamination

- Made Ground, associated with landfill, historical mining activities (old clay pit, brick and tile works), possibly including elevated concentrations of metals, metalloids, asbestos fibres, Asbestos Containing Materials, PAH and petroleum hydrocarbons (S3).
- Made Ground, associated with earthworks for the construction of A3 (M) in the west boundary on the site, possibly including elevated concentrations of metals, metalloids, asbestos fibres, Asbestos Containing Materials, PAH and petroleum hydrocarbons (S4).
- Ground gases (carbon dioxide and methane) from organic materials in the Made Ground / landfill / backfilled clay pits/brick works. (S5).
- Hydrocarbon vapours from potential VOC and petroleum hydrocarbon spillages/leaks from unspecified tank located at 110m N of the site. (S6).

## Potential receptors

- People (neighbours, site end users) (R1).
- Development end use (buildings, utilities) (R2).
- Groundwater: Secondary A aquifer status of the Bognor Sand Member (R3).
- Surface water: on-site Hermitage Stream in the south east area of the site and an unnamed stream on the eastern boundary of the site (R4).
- Soft landscaping areas (R5)
- Ecology: Habitat Creation Area at the west side of the site (R6).
- Ecology: Designated Ancient and Seminal Woodland / Ancient Replanted Woodland in the surrounding areas of the site (R7).
- Aquatic ecosystem in the Hermitage Stream (R8).

## Potential pathways

- Ingestion, skin contact, inhalation of dust and outdoor air by people (P1).
- Direct contact with substances deleterious to building materials (P2).
- Ground gas (Methane, carbon dioxide, etc.) ingress via permeable soils and/or construction gaps (P3).
- Root uptake by plant (P4).
- Migration of contaminant via leachate migration through the unsaturated zone in Bognor Sand Member (P5).
- Surface water via overland flow (P6).
- Surface water, via drainage discharge (P7).
- Surface water via base flow from groundwater (P8).
- VOC and petroleum hydrocarbon vapour ingress via permeable soils and/or construction gaps (P9).

| Conceptual Site Model - Plot 400 | | | | | |

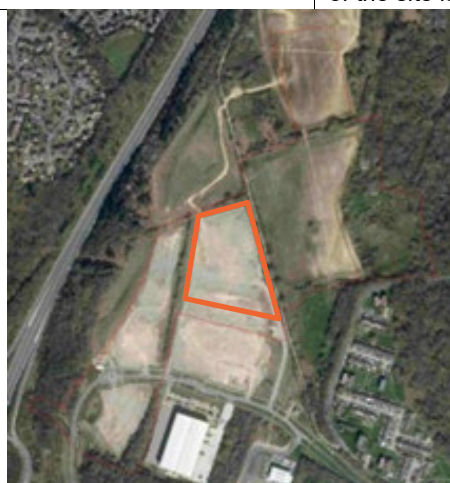
Figure 2-1: Site location

The site is referenced in Table 2-1 and the location is indicated in Figure 2-1 and Figure 2-2. The approximate Plot 400 location is outlined in orange.

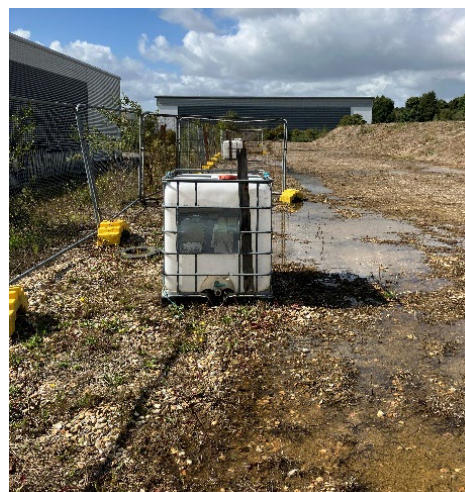
*Figure 2-4: Looking W towards Plot 500*

A basic site description is presented in Table 2-2 and selected photographs are presented in Figure 2-3 to Figure 2-5. Additional photographs are presented in Appendix B.
