# UNIT 400, 600 AND 601 DUNSBURY PARK, HAVANT

## Walking, Cycling and Horse-Riding Assessment

**COMMERCIAL SCHEME  
UNIT 400, 600 AND 601 DUNSBURY PARK  
HAVANT**

**WALKING, CYCLING AND HORSE-RIDING ASSESSMENT**

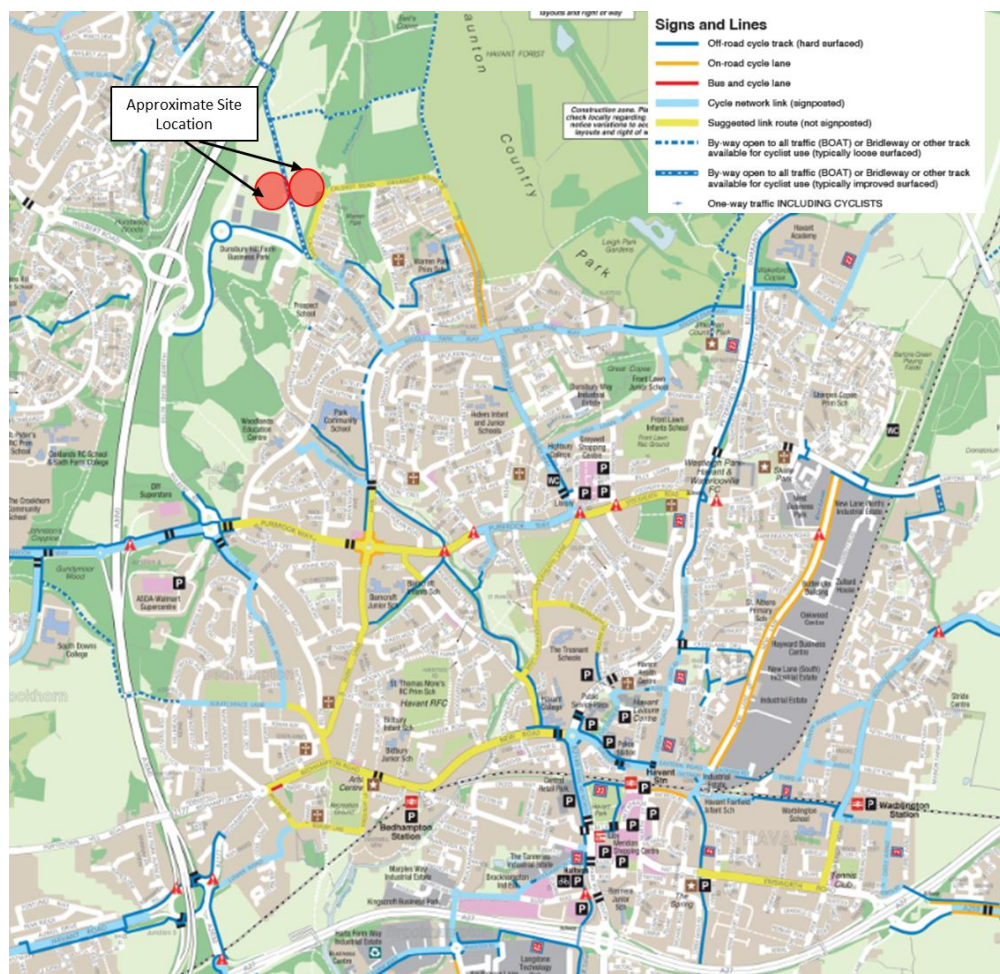
**Figure 4:** Cycle Routes in the vicinity of the site

- 2.15 There is a clear route for cyclists within Dunsbury Park given the provision of a shared footway/cycleway that runs to the north of Fitzwygram Way within the Park itself, and along the south-eastern side of the carriageway to the west of the Park, to the Hulbert Road Roundabout. It is also considered that the Dunsbury Park built road network is suitable for cyclists due to the wide carriageways and low vehicle speed limit, within the site.
- 2.16 Within the wider area the residential provision to the east and south makes the local road network attractive to cycle on, in addition to the presence of a number of cycle routes and bridleways. This includes the Park Lane bridleway route north, into Waterlooville and connections to the south and east to Leigh Park and Havant, as shown in **Figure 4**.

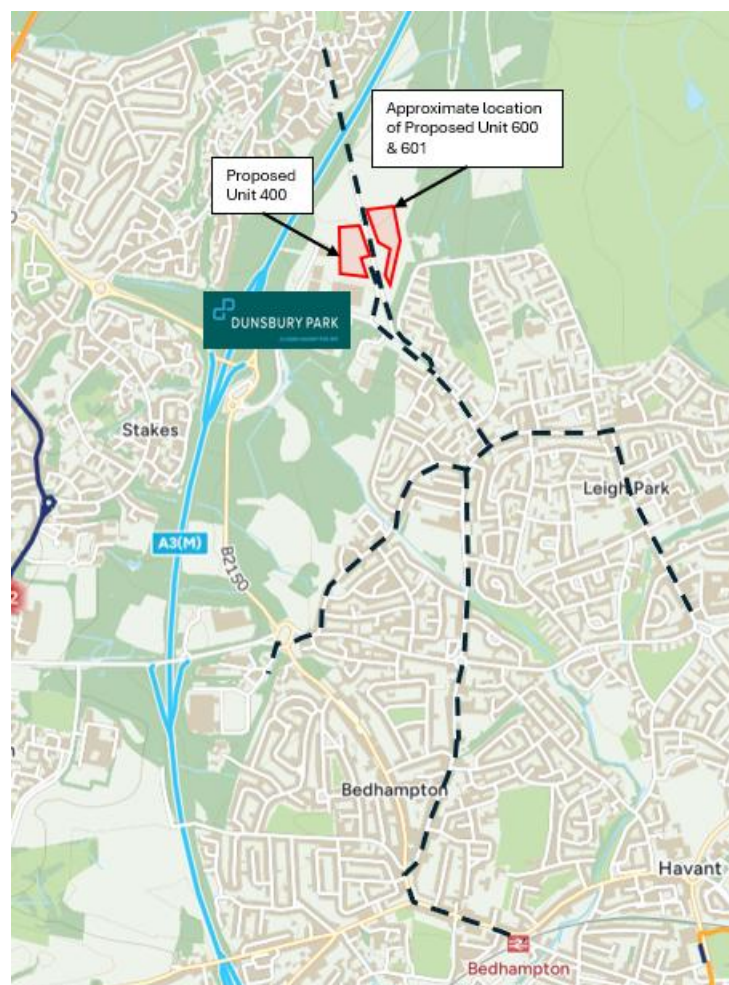
Figure 5: Walkover Route

- 2.31 In support of this WCHAR a site visit was conducted on 15th July 2025 during daylight hours by Eleanor Geary (Lead Assessor), with a further site visit completed on 17<sup>th</sup> October 2025. The weather was dry for the majority of the site visit on the 15<sup>th</sup> July and for all of the site visit on the 17<sup>th</sup> October and both were undertaken outside of peak traffic times. The site visit included walking the key routes that staff would most likely utilise to access local services or potentially utilise to travel to work, within the surrounding area. This also included walking the cycle route to Bedhampton Train Station located 3.6km from the site. The report has then been written in accordance with the guidance sets out in HCC's Technical Guidance Note 19 (TG19), which itself is based upon Design Manual for Roads and Bridges (DMRB) GG142. The walkover route is in **Figure 5**.

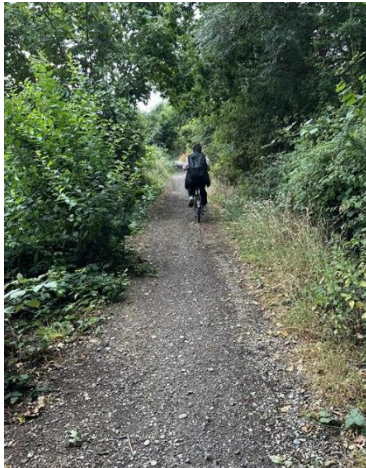
**Photograph 1:** A cyclist was observed utilising Park Lane (Heading East)

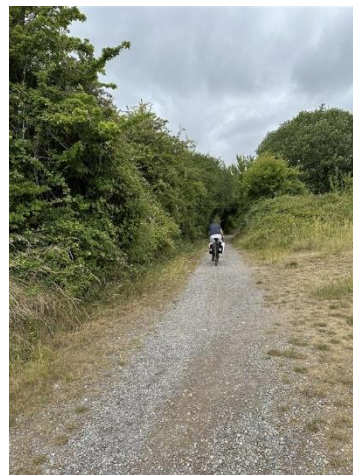
**Photograph 2:** A cyclist was observed utilising Park Lane (Heading West)

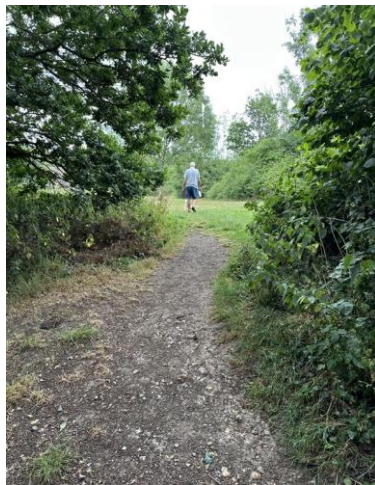
**Photograph 3:** A pedestrian was observed using the greenspace near park lane on the western side of the A3

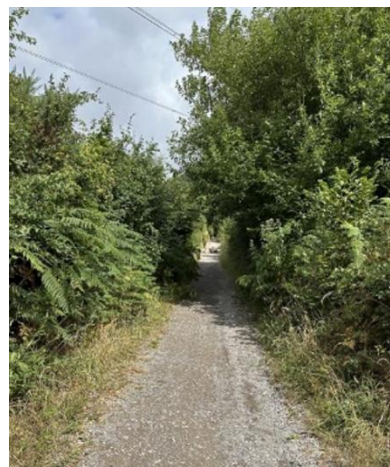
**Photograph 4:** A pedestrian was observed walking on Park Lane

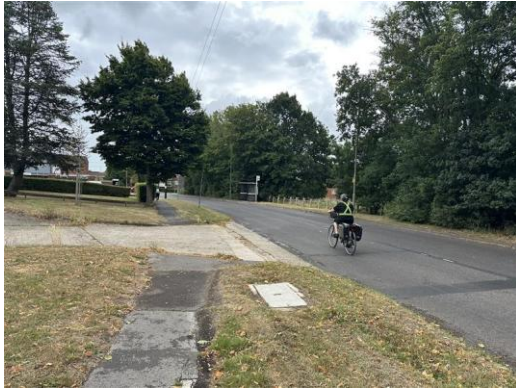
**Photograph 5:** A cyclist was observed on Calshot Road

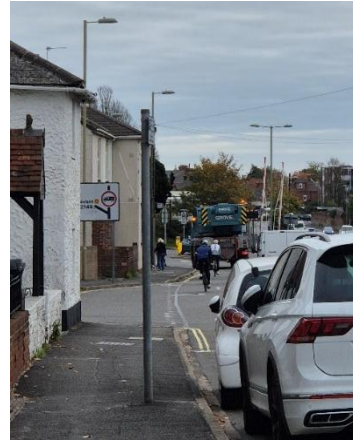
**Photograph 6:** Cyclists on Bedhampton Road

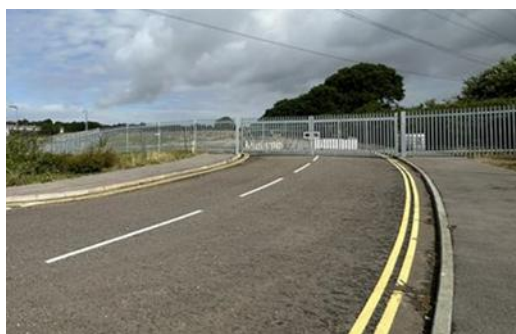
- 3.2 As discussed, the access to the proposed units will be taken via an unnamed access road off Fitzwygram Way which currently provides access to Unit 5 (Biopure Technology) solely. Footways measuring at least 2m wide, which is in line with the Inclusive Mobility, MfS and HCC TG10 minimum footway width of 2m, are provided on both sides of the carriageway (**Photograph 7**), with the existing access, which is currently gated, shown in **Photograph 8**.

**Photograph 7:** Footways leading up to gated access

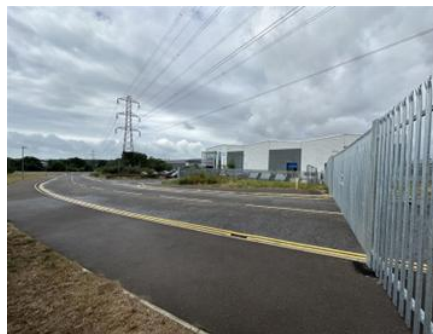
**Photograph 8:** Gated access to proposed Unit 400 location

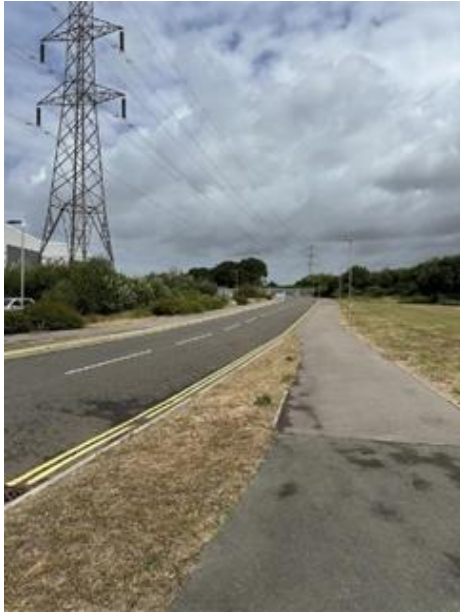
- 3.3 The footway along the eastern side measures 3m wide (**Photograph 9**) and therefore may also be an extension of the footway/cycleway that is present on Fitzwygram Way. Due to the incomplete nature of the road network this is not currently clear, however there is no corduroy paving or continuation signage in place north of the Fitzwygram Way shared footway/cycleway to indicate the end or continuation of the route. (**Photograph 10**)

**Photograph 9:** Footway on the eastern side of the unnamed road

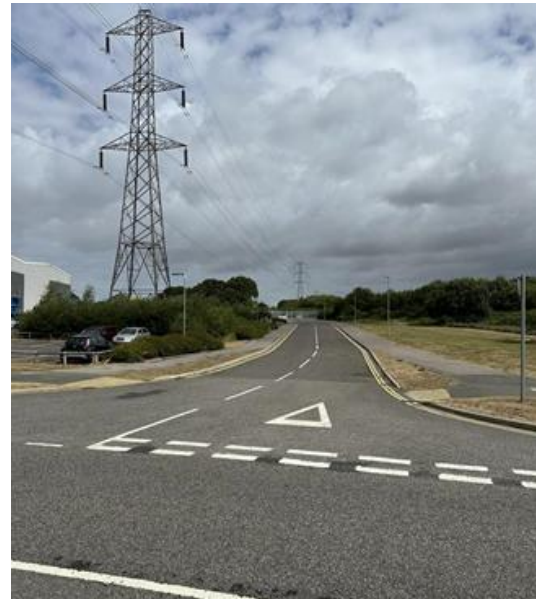
**Photograph 10:** Access Road off Fitzwygram Way towards Unit 400

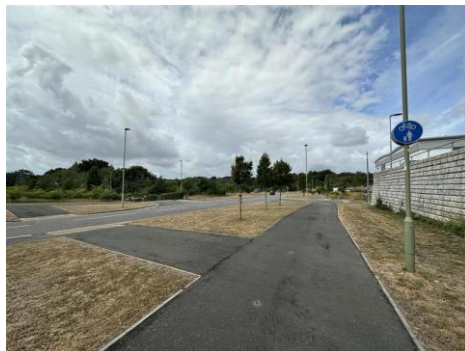
- 3.4 Fitzwygram Way runs in an east-west alignment in the vicinity of the junction to Unit 400, 600 and 601 and benefits from a 3m shared footway/cycleway on the northern side of the carriageway (**Photograph 11**) which meets the requirements in HCC TG10 and LTN 1/20 for routes with under 300 cyclist flows per hour. Whilst a footway is provided on the southern side of the carriageway (**Photograph 12**) that varies in width but measures least 2m wide in line with the Inclusive Mobility, MfS and HCC TG10

**Photograph 11** Shared footway/cycleway within Dunsbury Park

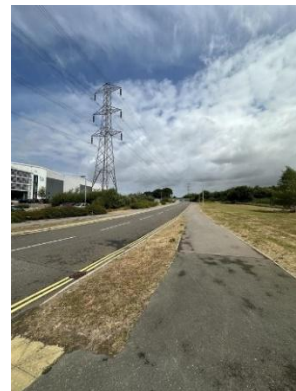
**Photograph 12:** Existing Conditions on Fitzwygram Way (West of the proposed site on the southern side of the carriageway)

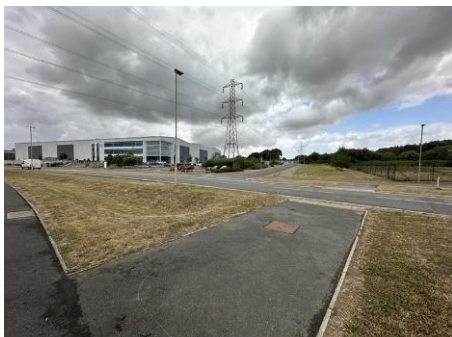
- 3.5 Where crossing facilities are provided within Dunsbury Park these have been constructed to a high standard in the form of uncontrolled crossing points, accompanied by tactile paving and dropped kerbs shown in **Photographs 13** and **14**.

**Photograph 13:** Crossing point across the Fitzwygram Way to the south of unnamed road

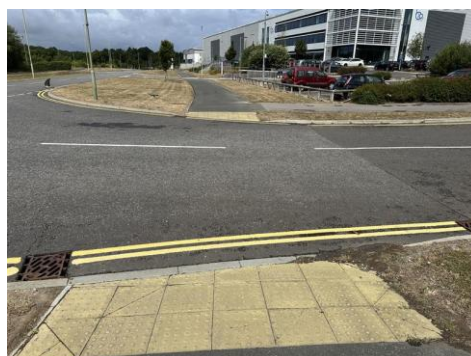
**Photograph 14:** Crossing Point across the access road to the north of Fitzwygram Road towards proposed site

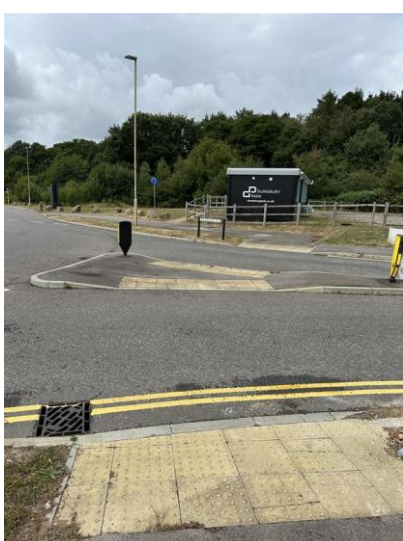
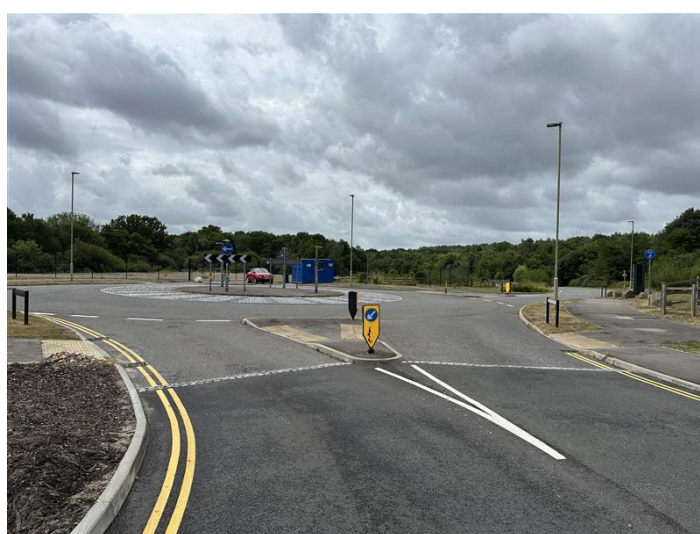
- 3.6 As noted above Fitzwygram Way travels east/west through Dunsbury Park. To the west of the existing gated access for Unit 400, 600 and 601 the shared use footway/cycleway continues along the northern side of the carriageway, whilst the footway continues along the southern side, up to the roundabout junction with Brooklime Way, at which point the off-road provision around the roundabout is 3m wide and supports shared footway/cycleway provision across all arms (**Photographs 15** and **16**). The footway on the southern side of the Fitzwygram Way ends with corduroy paving, whilst the shared footway/cycleway provision around the roundabout terminates to the immediate west of the roundabout, with dropped kerbs providing access onto the carriageway.

**Photograph 15-16:** Existing conditions in Dunsbury Park where the shared footway/cycleway terminates to the west

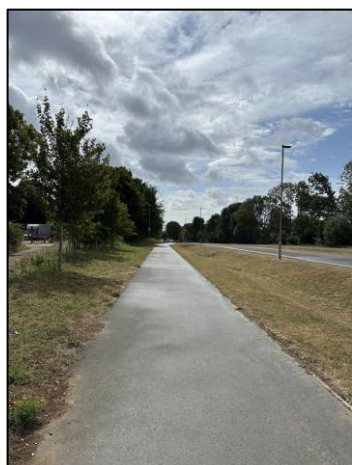
3.9 Heading to the east from the unnamed road, along Fitzwygram Way, the shared footway/cycleway provision on the northside continues, as does the footway provision on the southern side. Existing conditions of these footways are shown in **Photographs 17** and **18**.

**Photograph 17:** Footway connection on the northern side of the carriageway towards Woolston Road (Heading East from Dunsbury Park)

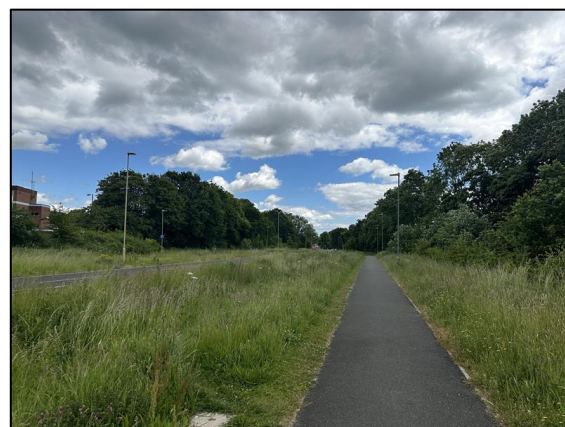
**Photograph 18:** Footway connection on the southern side of the carriageway towards Woolston Road (Heading East from Dunsbury Park)

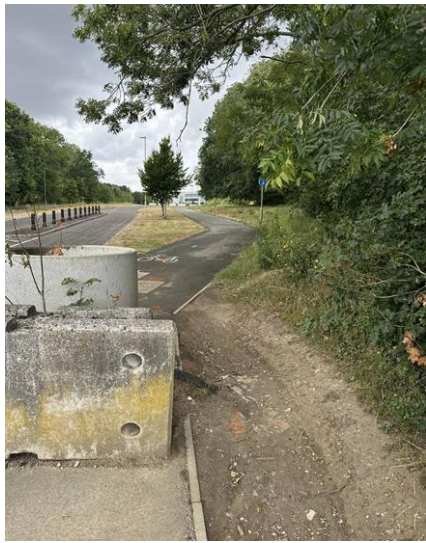
- 3.10 Approximately 300m east of the junction with the unnamed Road, Fitzwygram Way terminates at the Calshot Road/Woolston Road/Freeley Road roundabout (**Photograph 19**).
- 3.11 Shortly before the roundabout however there are bollards in place preventing through traffic from using Fitzwygram Way, from the roundabout (**Photograph 20**). These bollards also extend over the footway and shared footway/cycleway preventing their full use. The plan however is for a bus gate to be implemented on this section of Fitzwygram Way, by Summer 2026, with the shared footway/cycleway then formalised near the roundabout.

**Photograph 19:** Footway on Fitzwygram Way heading towards Woolston Road (Facing west towards Dunsbury Park)

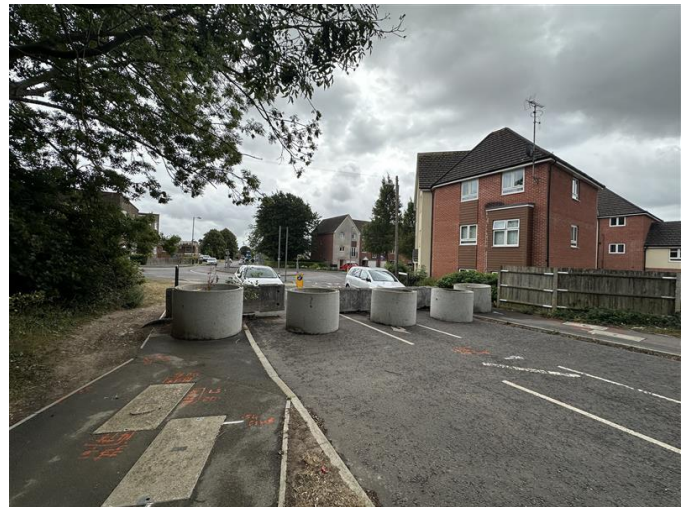
**Photograph 20:** Bollards to the south of Dunsbury Park near the roundabout (Calshot Road/Woolston Road/Freeley Road/Fitzwygram Way) & where Fitzwygram Way shared footway/cycleway terminates

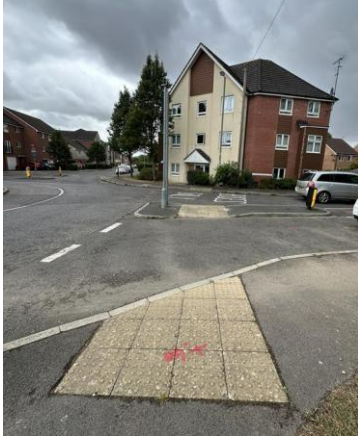
- 3.12 At the location of the bollards, the shared footway/cycleway is understood to end with footways provided onto the roundabout. Footways are then present on all arms of the roundabout, which are also supported with dropped kerbs accompanied by tactile paving and refuge islands, with examples shown in **Photograph 21** and **22**. These footways measure between 1.5m and 2m wide, which is in line with the Inclusive Mobility, MfS and HCC TG10 minimum footway width of 2m and the constrained minimum width of 1.5m states in Inclusive Mobility.

**Photograph 21:** Crossing Point on the roundabout (Calshot Road/Woolston Road/Freeley Road/Fitzwygram Way) across Freeley Road

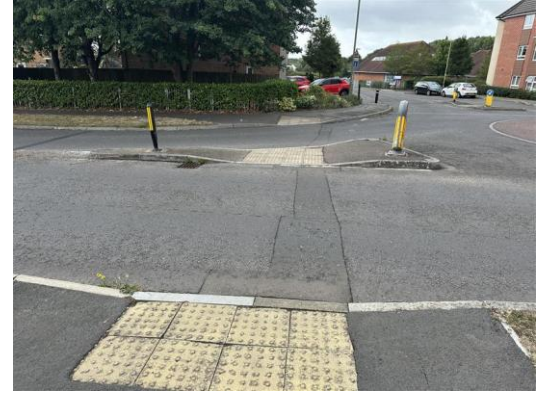
**Photograph 22:** Crossing Point on the roundabout (Calshot Road/Woolston Road/Freeley Road/Fitzwygram Way) Woolston Road

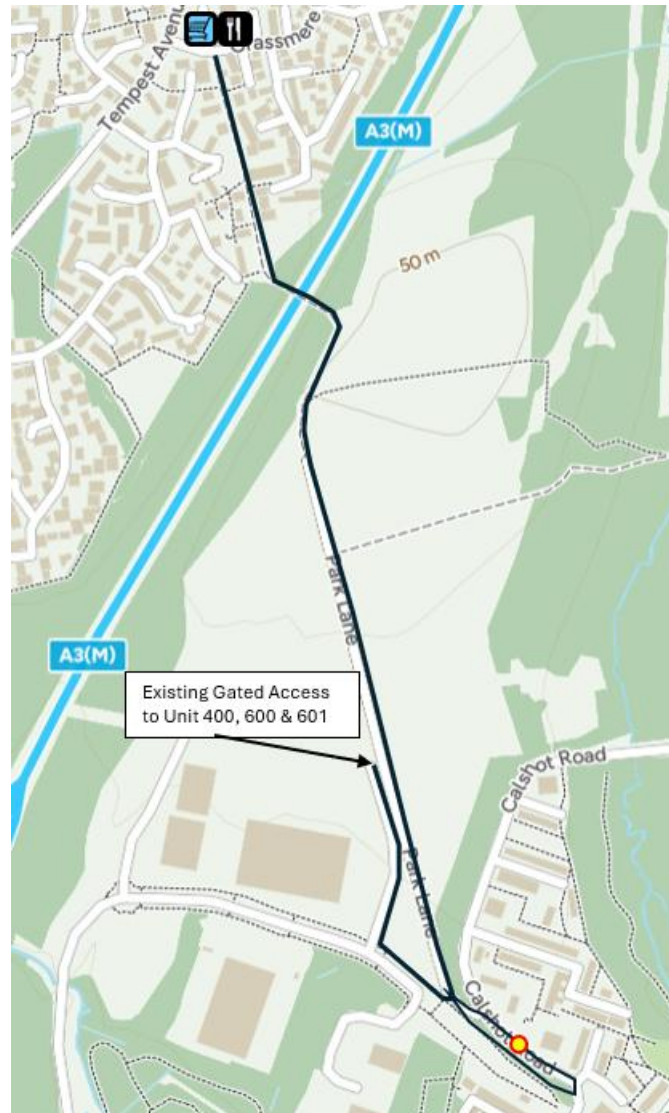
**Figure 7:** Park Lane Assessment Route

- 4.1 To the north of the site is the residential area of north WaterlooVille and a Tesco express, along with further amenities, which can be reached via the bridleway known as Park Lane. To reach Park Lane pedestrians and cyclists would also travel past the closest bus stop to the site, 'Larkwhistle' on Calshot Road. This northern route therefore travels the route shown in **Figure 7**.

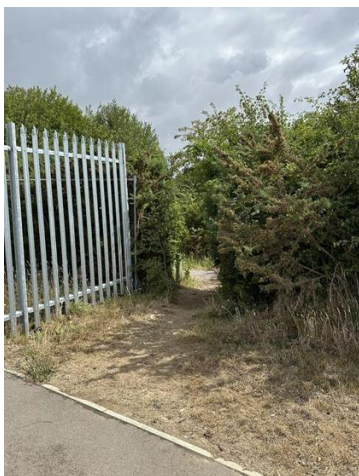
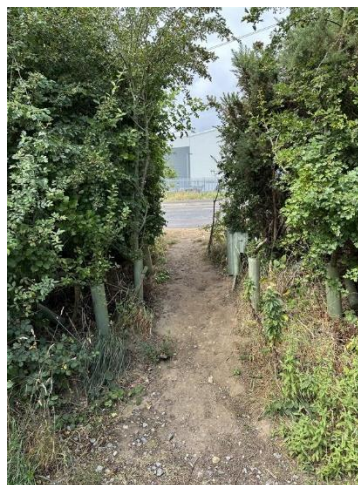
- 4.3 One is located adjacent to the current gated access to Unit 400, 600 and 601 which is shown in **Photographs 23 and 24**, providing access from the unnamed road to Park Lane.

**Photographs 23-24:** Informal access link onto Park Lane off the unnamed Road to the north of Fitzwygram Way

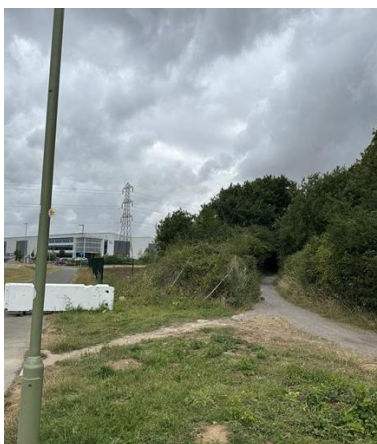
- 4.4 From Unit 400, 600 and 601, both pedestrian and cyclists use Fitzwygram Way, as discussed in **Section 3**. However, there is a further informal connection to Park Lane, from the shared footway/cycleway, which is located near the proposed location of the bus gate, as shown in **Photograph 25**.

**Photograph 25:** Informal route from Fitzwygram Way onto Park Lane

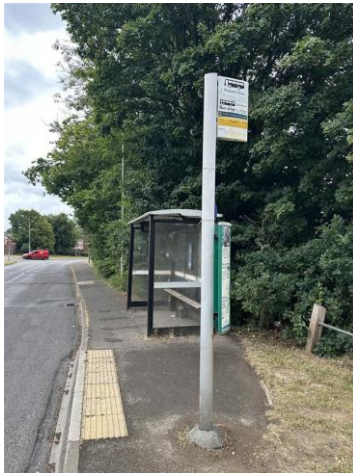
- 4.6 Approximately 75m from the roundabout the footway on the southwestern side of Calshot Road provides access to the Larkwhistle Way Bus Stop (**Photograph 26**) before the footway on that side of the road terminates and becomes grass verge. Pedestrians wishing to continue north can use an uncontrolled crossing supported with dropped kerbs and tactile paving, approximately 20m south of the bus stop (shown in **Photograph 27**). This crossing provides access to the northeastern footway, which aids pedestrian movement travelling north on Calshot Road.

**Photograph 26:** Footway and bus stop condition on Calshot Road (Southern edge of carriageway)

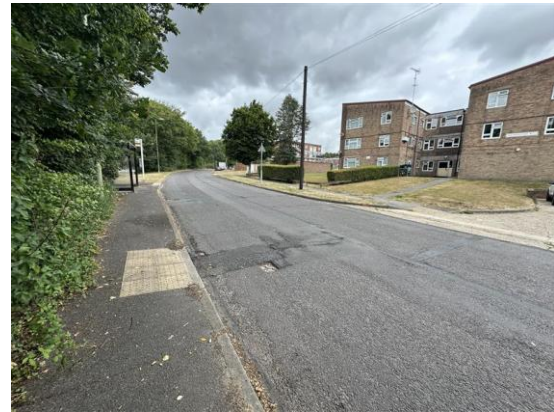
**Photograph 27:** Footway leading to the bus stop on Calshot Road & crossing point across carriageway (Southern edge of carriageway)

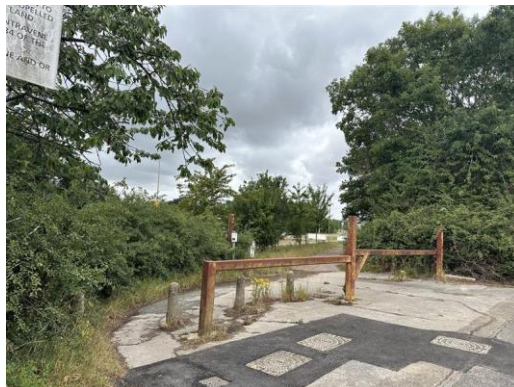
- 4.8 Approximately 100m north of the pedestrian crossing point is the access to Park Lane, which is on the western side of Calshot Road. There is no pedestrian crossing provision in the vicinity of the Park Lane access although Park Lane is on the same level as the carriageway and was noted to be utilised by pedestrians during the site visit. The access is opposite an area of dedicated car parking therefore a pedestrian crossing in this location would be challenging to deliver, without impacting on the current parking area.

**Photograph 28:** Park Lane access from Calshot Road.

- 4.9 An alternative could be to extend the footway from the Larkwhistle Way bus stop, north to the Park Lane access.
- 4.10 Cyclist using Calshot Road will do so on-carriageway. This is considered acceptable as the road measures over 6m wide and therefore is sufficient to accommodate the 1.5m minimum overtaking clearance stated with LTN 1/20 for a 30mph road. Cyclists are also able to cycle onto Park Lane, which is surfaced at its entrance. Although the entrance is gated to prevent motor vehicle access, and both cyclists and pedestrians must manoeuvre past this feature (**Photograph 28**) It is also noted within the HBC LCWIP that Calshot Road (section 362.2.4) should be upgraded to include appropriate traffic calming and allow for mixed traffic within a 20mph speed limit.

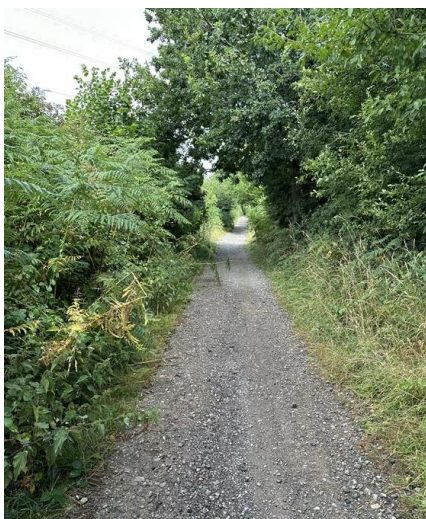
- 4.11 Park Lane a continuous bridleway which facilitates safe movement for pedestrians and cyclists. The bridleway varies in width, in part due to vegetation growth (**Photograph 29**). As well as this, as shown in **Photograph 30** sections can measure less than 3 metres, which is below LTN1/20 and TG10 guidance for shared use. It is noted however that this is a rural route, supported by the unbound surface, and the loss of boarding vegetation would need to be managed by Hampshire's Public Rights of Way Team.

**Photograph 29:** Park Lane existing conditions

- 4.19 Within the HBC LCWIP it is noted that Park Lane (section 362.2.3) could be widened with an improved surface for pedestrians and cyclists, utilising bollards and barriers if needed. As well as this it is indicated about the potential to increase lighting along the route.

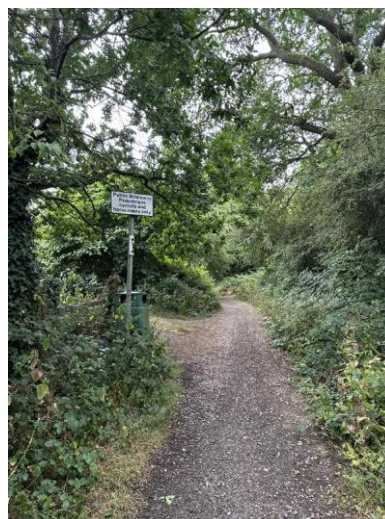
**Photograph 30:** Park Lane existing conditions & signage

- 4.20 There was no equestrian use while attending the site visit, though there was equestrian infrastructure in place along Park Lane with signage provided as shown in **Photographs 29** and **30** for routes heading east of Park Lane. Further to this, equestrian use is unlikely for the proposed use, therefore the infrastructure is deemed sufficient.

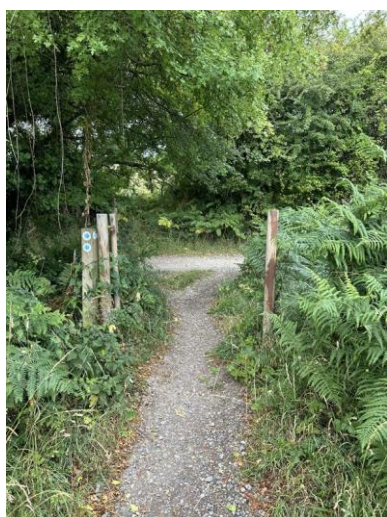
- 4.12 Along this route a number of further PRoW routes and bridleways are provided to the east, examples of which are shown in **Photographs 31** and **32**.

**Photograph 31:** Access onto a PRoW/Bridleway (Facing onto Park Lane)

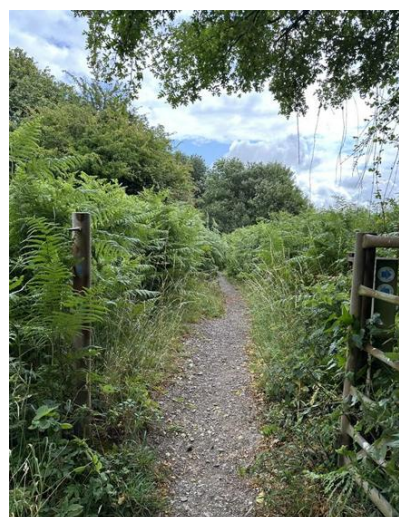
**Photograph 32:** Access onto a PRoW/Bridleway

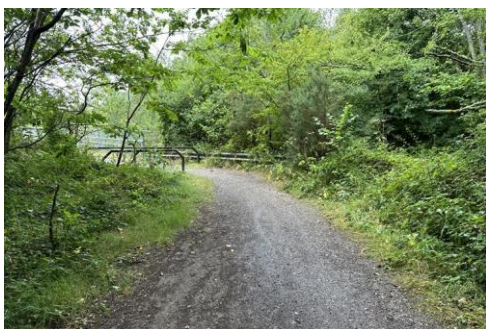
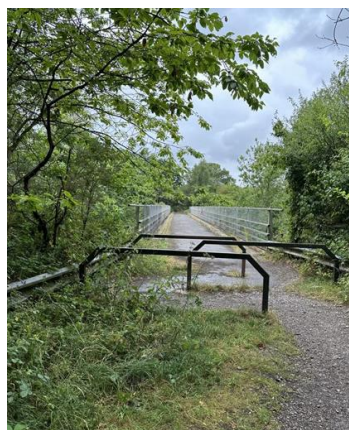
- 4.13 Park Lane continues to the northwest with a wide route provided across the A3(M) bridge, barriers are in place to encourage cyclists to demount and slow down while crossing the bridge. The existing conditions of this section of the route are shown in **Photograph 33-35**.

**Photographs 33-34:** Park Lane existing conditions heading onto bridge across A3(M) (Heading West)

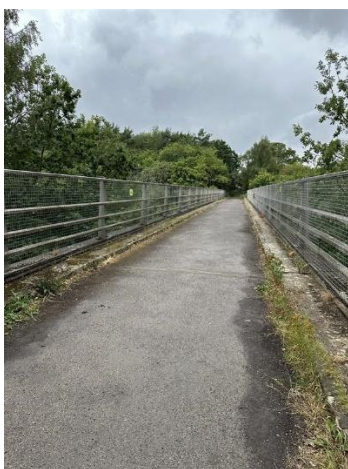
**Photograph 35:** Park Lane existing conditions heading over the bridge

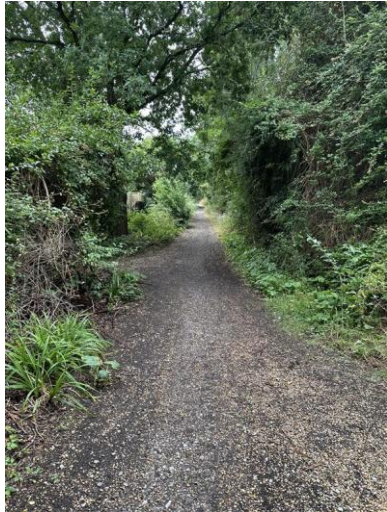
- 4.14 Once on the western side of the A3(M) Park Lane continues to provide a route towards Grassmere Way (**Photograph 36**), where the route terminates. Along this section there are connections provided along Park Lane to neighbouring residential roads, further enhancing connections to the neighbouring residential area. Whilst Park Lane is a bridleway these connections are designed for pedestrian use, as shown in **Photograph 37**.

**Photograph 36:** Existing conditions of Park Lane on the western side of the A3(M)

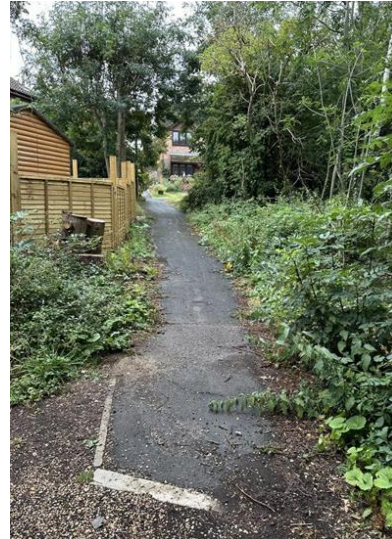
**Photograph 37:** Example of a residential link off Park Lane

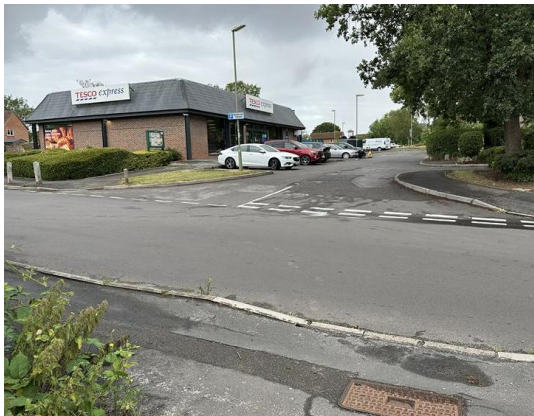
- 4.15 At the end of Park Lane there is a dropped kerb arrangement across Grassmere Way, which connects to a dropped kerb on the north-eastern side of the access road into The Westbrook Centre car park (**Photographs 38 and 39**). There is also a dropped kerb on the north-western side of the access road for pedestrian movements.

**Photograph 38:** Access of Park Lane onto Grassmere Way (Facing onto Grassmere Way)

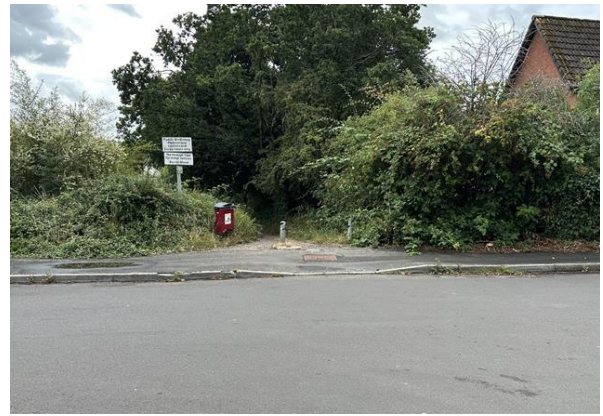
**Photograph 39:** Access of Park Lane onto Grassmere Way (Facing towards Park Lane Route)

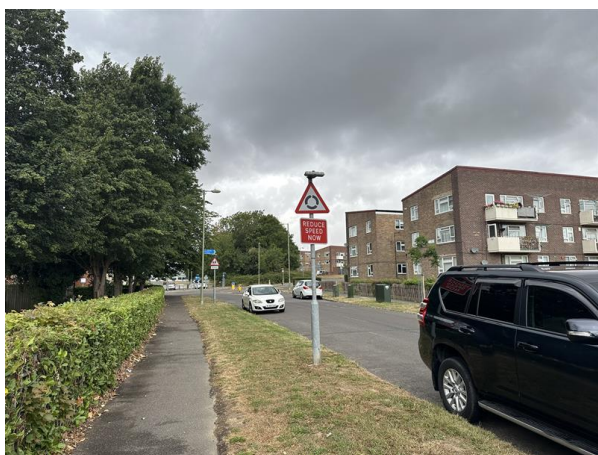
- 5.3 Footways are provided along both sides of the carriageway on Woolston Road which are of sufficient width (**Photograph 40**) measuring approximately 1.2-1.5m wide and are separated from the carriageway by a grass verge and this is in excess of the minimum width of 1m required by Inclusive Mobility guidance. Further to this, along the southern edge of the carriageway a section of the footway is provided as shared footway/cycleway measuring c.2.5m between the grass verges (**Photograph 41**). This should measure 3m wide to meet the requirements in HCC TG10 and LTN 1/20 for routes with under 300 cyclist flows per hour.

**Photograph 40:** Footway on Woolston Road (Heading towards Fitzwygram Way)

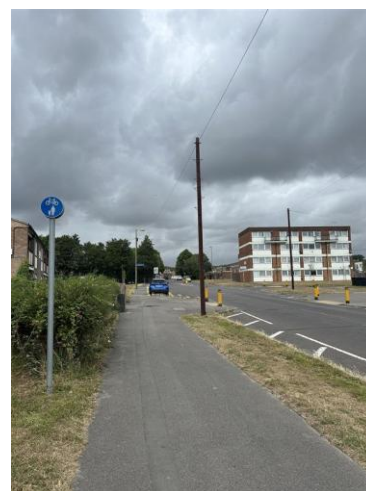
**Photograph 41:** Shared footway/cycleway on Woolston Road

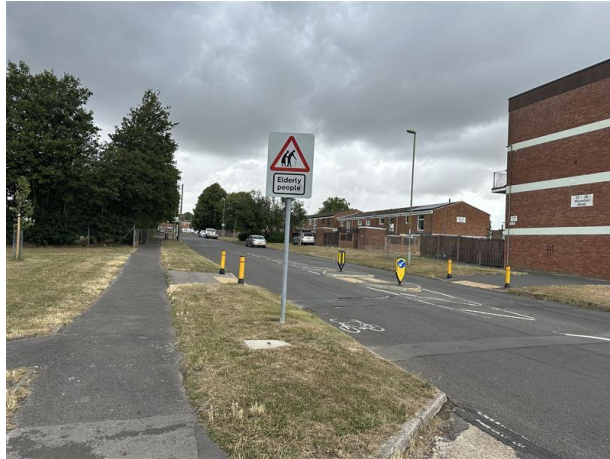
**Photograph 42:** Crossing Point and refuge island across Woolston Road

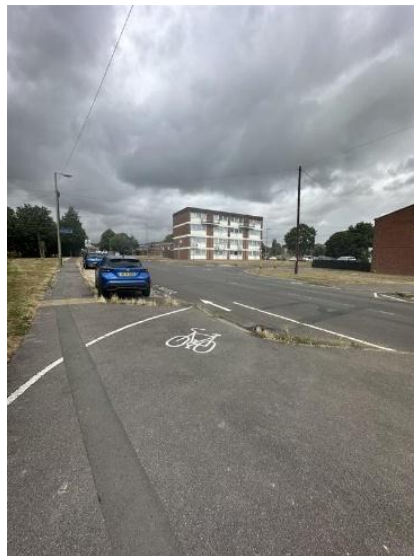
- 5.5 Approximately 50m south of the LTN1/20 crossing point cyclists travelling south are directed onto the footway, whilst cyclists heading north are directed onto the carriageway (**Photograph 43**). This location also includes a cycle crossing point including tactile paving and dropped kerbs (without central refuge island) to support cyclist travelling off-road to or from the south, towards the Woolston Road/Middle Park Way roundabout junction.

**Photograph 43:** Road markings on Woolston Road for cyclists to rejoin the carriageway

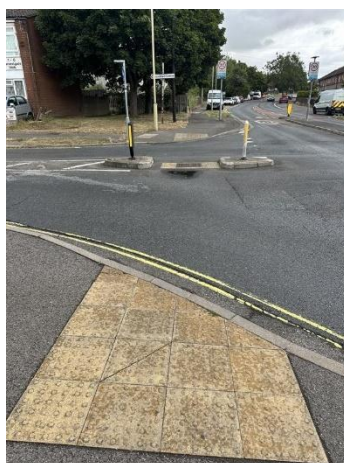
- 5.8 Footways (on the eastern side) and shared footway/cycleways (on the western side) continue from Woolston Road onto Middle Park Way. Pedestrians can utilise the crossing in **Photograph 44** to cross from the south-western footway on Woolston Road to the north-eastern footway (which then continues northeast) along Middle Park Way. The crossing point is in good condition accompanied by a pedestrian refuge island with dropped kerbs and tactile paving, with suitable visibility achieved and provides a safe connection for pedestrians.

**Photograph 44:** Crossing Point across Woolston Road junction with Middle Park Way

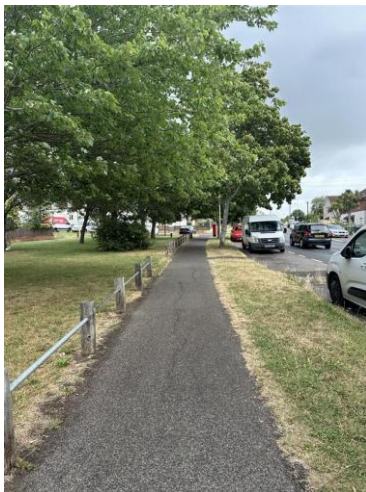
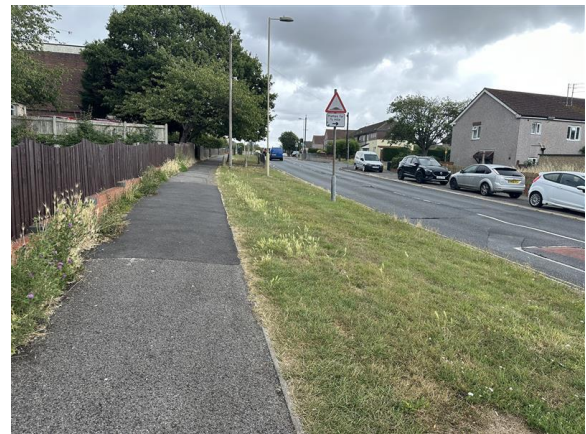
**Photographs 45-46.** The footway is of suitable width measuring c.1.5m-2m and the surfacing is in good condition. With the footway measuring at a minimum c.1.5m it is considered to be in line with the minimum width of 1.5m stated within Inclusive Mobility.

**Photograph 45-46:** Middle Park Way Footway (Northern side of carriageway leading on from Woolston Road)

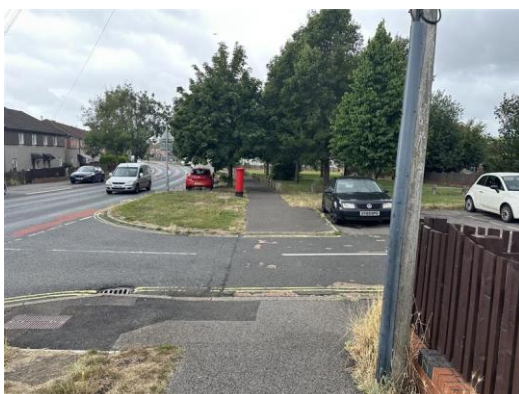
**Photograph 47:** Dropped kerbs across Locksheath Close junction on Middle Park Way

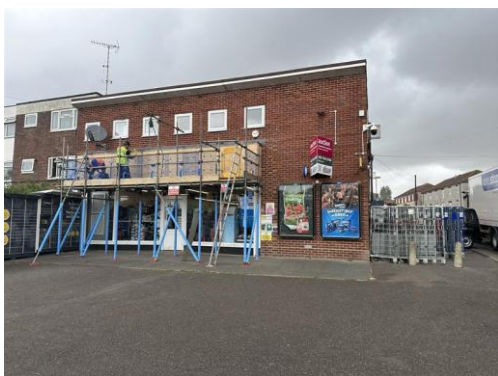
5.13 The pedestrian route continues along Middle Park Way with the footways in good conditions and of suitable width to reach the One Stop convenience store (**Photograph 48**) located on the corner of Middle Park Way and Swaythling Road.

**Photograph 48:** One Stop on Middle Park Way

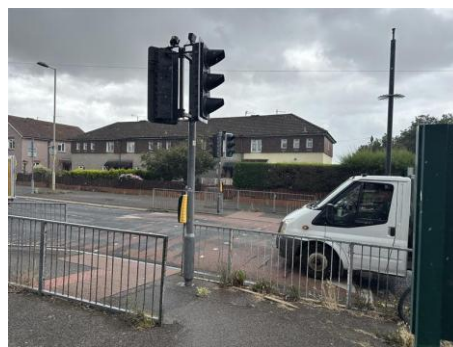
**Photograph 49:** Signalised crossing point across Middle Park Way near One Stop

5.14 Once at the One Stop a signalised pedestrian crossing is provided across Middle Park Way to allow pedestrians a safe place to cross Middle Park Way (**Photograph 49**).

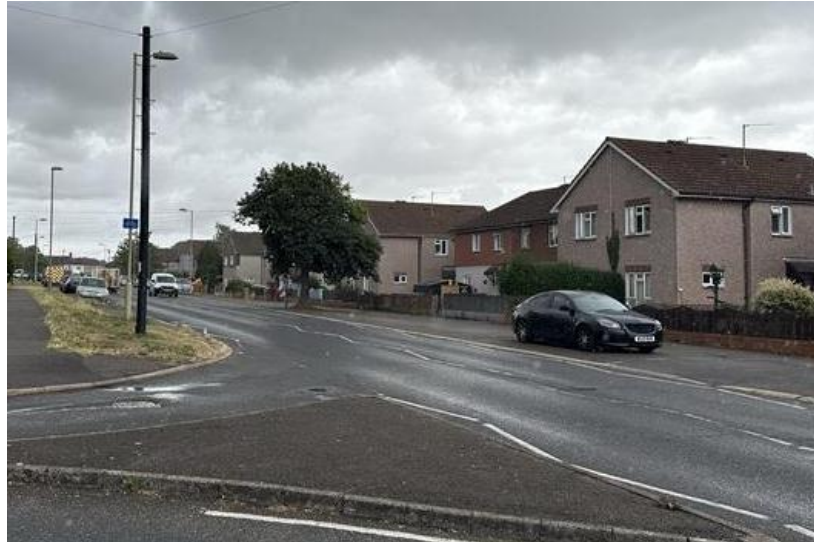
5.16 The route is seen to be sufficient as cyclists can cycle on-road with signage provided (**Photograph 50**). However, as aforementioned HBC LCWIP (section 362.3.1) suggested the desire to provide corridor improvements in this area such as a two-way cycle track or stepped cycle lanes, however it is noted this may require the removal of trees and existing footway parking.

**Photograph 50:** Signage to indicate cyclists can utilise the carriageway on Middle Park Way and on-footway parking

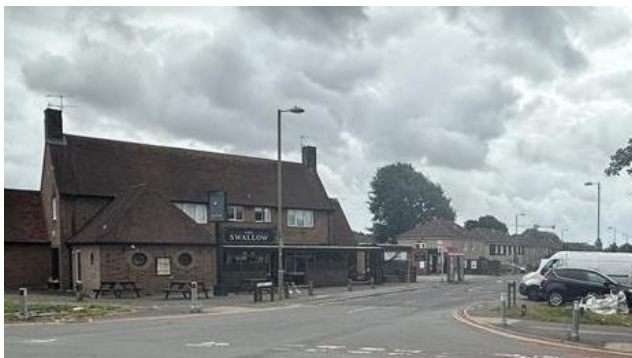
**Photographs 51:** The Swallow Pub (looking south)

- 5.18 To the south of Middle Park Way, Dunsbury Way provides a route to Leigh Park Centre which benefits from various local facilities.
- 5.19 At its junction with Middle Park Way (on the south-eastern corner) is The Swallow Pub. Crossing from the south-western side of Middle Park to the pub is supported by dropped kerbs and tactile paving provided at the junction. Behind the pub, c 50m south of the junction with Middle Park Way is the Dunsbury Way Family Shopper located at the junction with Middle Park Way (**Photograph 51 & 52**) therefore pedestrians would be expected to use the provided crossing point to access both services.

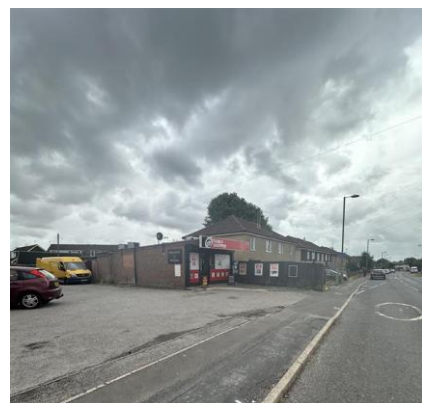
**Photograph 52:** Dunsbury Way Family Shopper

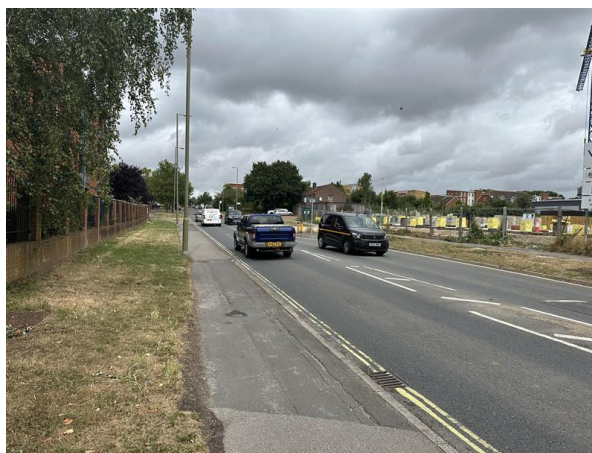
**Photograph 53:** Dunsbury Way

- 5.20 Dunsbury Way provides a connection south from Middle Park Way, towards the centre of Leigh Park, approximate 800m south. The road supports 20mph vehicle speeds with speed cushions and signage. Cyclists are expected to travel on carriageway with signage and lining to support this. Parking is a mix of on and off-street, with some parking occurring on verges and there are footways provided on both sides of the carriageway (**Photograph 53**).

- 5.21 Footway widths vary but generally measure between c.1.5-2m, which is in line with the minimum width of 1.5m stated within Inclusive Mobility. Along the route, side roads are supported by dropped kerbs to aid safe pedestrian movement. The route using the eastern carriageway includes tactile paving on all crossings except Great Copse Drive.
- 5.22 A dropped kerb/tactile paving pedestrian crossing point with refuge island is also provided across Dunsbury Way approximately 500m south of the Middle Way Park junction to facilitate the safe movement between the footways (**Photograph 54**) and support access to Leigh Park shops for those who travelled along the western footway.

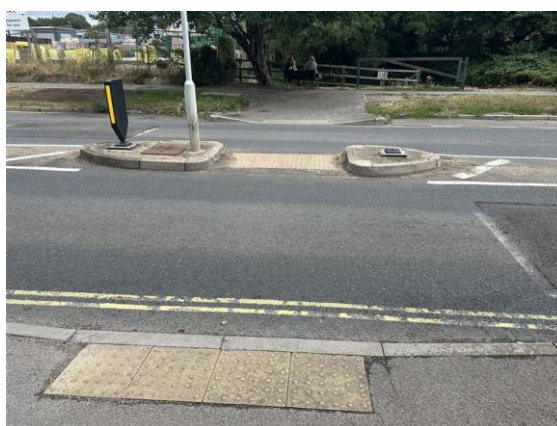
**Photograph 54:** Crossing point on Dunsbury Way

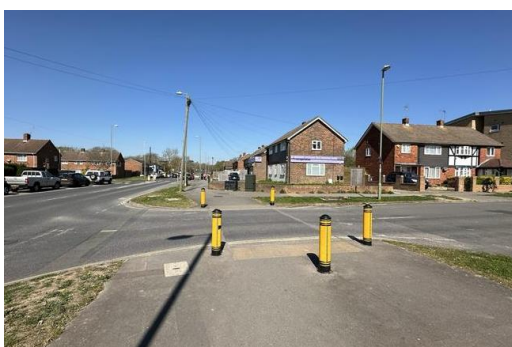
**Photograph 55:** Crossing point on Bishopstoke Road

5.23 Pedestrians are then expected to travel south using the eastern footway. Side roads with High Lawn Way and Bishopstoke Road (**Photograph 55**) benefit from tactile paving and dropped kerbs whilst the footway south of the High Lawn Way junction is sign-posted as a shared footway/cycleway. This sees the footway widen from 1.5m plus verge to 2.5m plus verge. This should measure 3m wide to meet the requirements in HCC TG10 and LTN 1/20 for routes with under 300 cyclist flows per hour, however the provision does widen after the Bishopstoke Road junction.

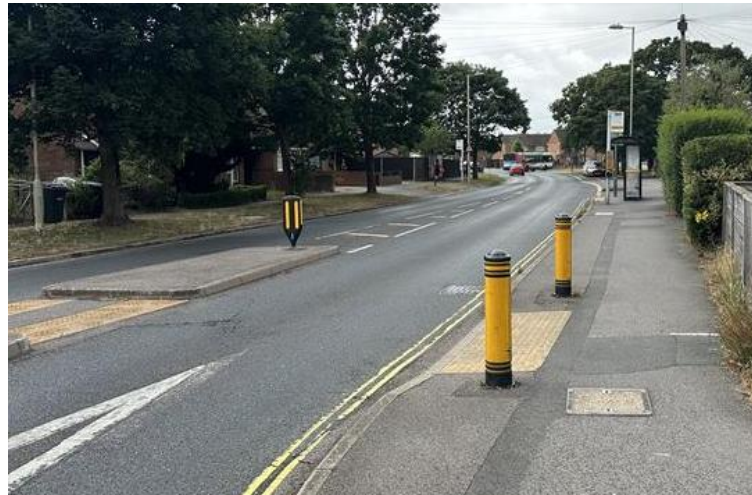
- 6.4 The north-western footway/cycleway measures approximately 2.5m wide. There is a bus stop shortly after the roundabout junction however the shared provision reduces to c. 1.5m wide for the length of the bus stop (which is supported by a shelter), as shown in **Photograph 58**, meaning the provision is less than 3 metres, which is below LTN1/20 and TG10 guidance for shared use.

**Photograph 58:** Middle Park Way (looking west)

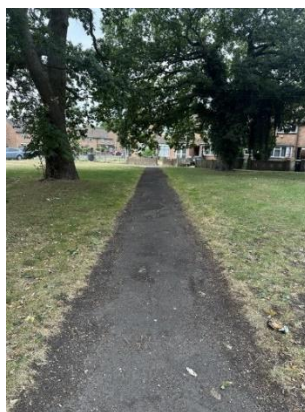
- 6.8 It is noted the footway connection from Middle Park Way to Park House Farm Way, along the northern side of the junction, uses a footway that crosses diagonally over a grassed area in front of houses, on the corner (**Photograph 59**), as the footway terminates along the northern side of Park House Farm for a distance of approximately 25m to allow for on-street parking. This footway measures at least 1m wide which is the absolute minimum accepted by Inclusive Mobility guidance. No corduroy paving is provided on this route, however corduroy paving is provided on the northern footway (where the footway terminates for on-street parking) and southern footway of Park House Farm Way, after the junction with Middle Park Way, confirming the end of the shared footway/cycle way from Middle Park Way.

**Photograph 59:** Footway between Middle Park Way and Park House Farm Way.

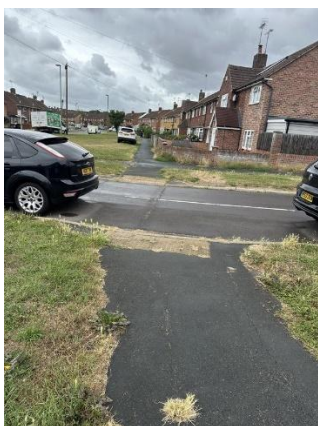
**Photograph 60:** Crossing point on Park House Farm Way heading towards Purbrook Way (western side of the carriageway across Quarely Road)

- 6.9 The footways provide a continuous route for pedestrians towards Purbrook Way (approximately 1km south-west of the Middle Park Way/Park House Farm Way junction) with pedestrian expected to use the north-western footway. Existing conditions along Park House Farm Way are shown in **Photographs 60 and 61**.

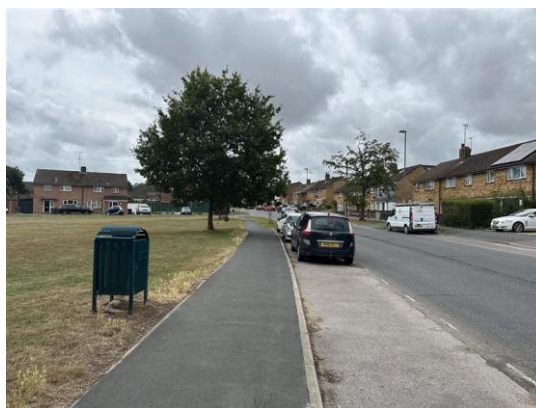
**Photograph 61:** Footway on Park House Farm Way heading towards Purbrook Way (eastern side of the carriageway)

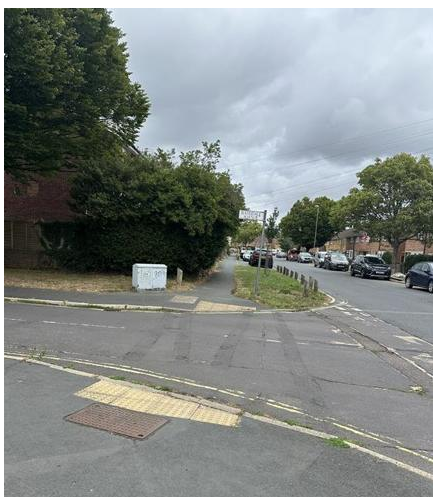
- 6.10 Along the route dropped kerbs accompanied by tactile paving are provided across junctions to aid movement as shown in **Photographs 62** and **63**. The only exception to this on the western side of the carriageway is at Sparsholt Close/Park House Farm Way junction where the northern side of the junction is missing a dropped kerb.

**Photograph 62:** Crossing point on Park House Farm Way across Ramsdale Avenue (looking north)

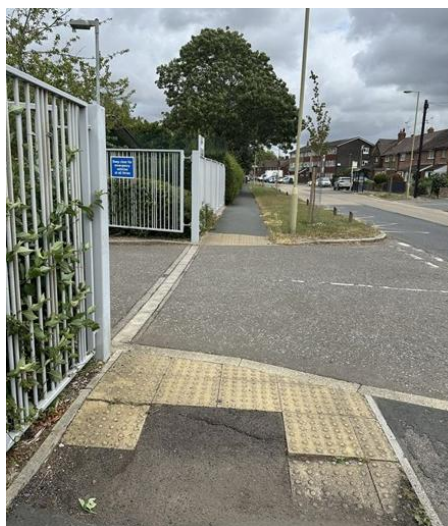
**Photograph 63:** Crossing point on Park House Farm Way across the Learning Centre entrance (looking north)

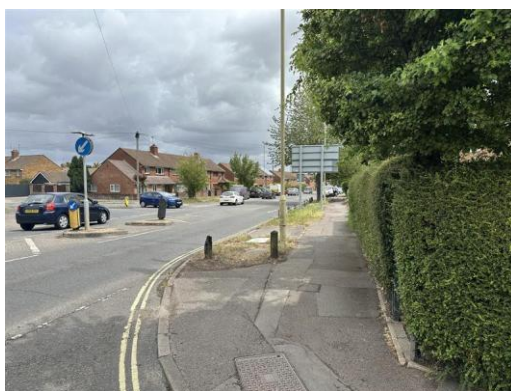
**Photograph 64:** Crossing point on Purbrook Way near Park House Farm Way

- 6.12 To access Asda supercentre pedestrians, continue west on Purbrook Way with in a 30mph road with footways provided on both sides of the carriageway.
- 6.13 Immediately to the west of the Purbrook Way/Park House Farm Way junction is an unsignalised pedestrian crossing with dropped kerbs supporting north/south movements on Purbrook Way (**Photograph 64**).

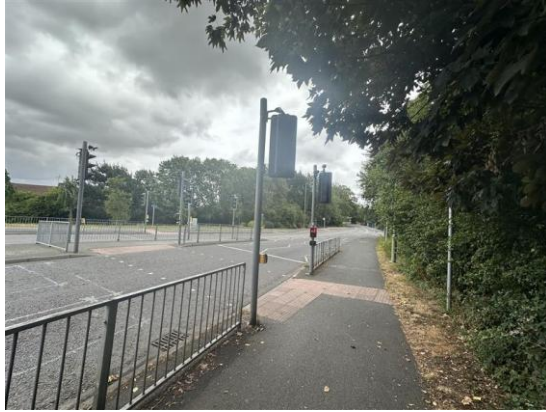
**Photograph 65:** Signalised crossing across the B2150

- 6.15 Shortly before the roundabout is a signalised toucan crossing which provides a connection to the refuge island on the eastern Purbrook Way arm of the junction (**Photograph 65**). A shared footway/cycleway that measures over 3m wide (in compliance with LTN1/20) is then provided, with associated crossing points both across the roundabout to access onward connections on the northern side of Purbrook Way to Waterlooville, and to the south of the roundabout on the B2150 Hulbert Road (southern arm). The southern Hulbert Road arm is supported with a toucan crossing enabling east/west movements. Pedestrians and cyclists then continue west to the Larchwood Avenue arm of the roundabout where they can continue south-east on Larchwood Avenue using the continuous footway/cycleway, south into Asda (**Photograph 66**).
