# UNIT 400, 600 AND 601 DUNSBURY PARK, HAVANT

## Walking, Cycling and Horse-Riding Assessment

**COMMERCIAL SCHEME  
UNIT 400, 600 AND 601 DUNSBURY PARK  
HAVANT**

**WALKING, CYCLING AND HORSE-RIDING ASSESSMENT**

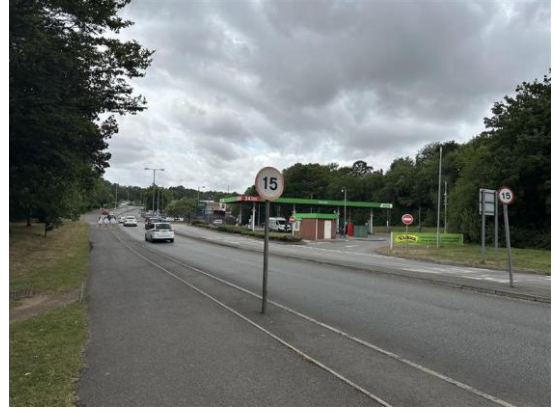
**Photograph 66:** Footway along access road to Asda Supercentre

- 6.15 Shortly before the roundabout is a signalised toucan crossing which provides a connection to the refuge island on the eastern Purbrook Way arm of the junction (**Photograph 65**). A shared footway/cycleway that measures over 3m wide (in compliance with LTN1/20) is then provided, with associated crossing points both across the roundabout to access onward connections on the northern side of Purbrook Way to Waterlooville, and to the south of the roundabout on the B2150 Hulbert Road (southern arm). The southern Hulbert Road arm is supported with a toucan crossing enabling east/west movements. Pedestrians and cyclists then continue west to the Larchwood Avenue arm of the roundabout where they can continue south-east on Larchwood Avenue using the continuous footway/cycleway, south into Asda (**Photograph 66**).

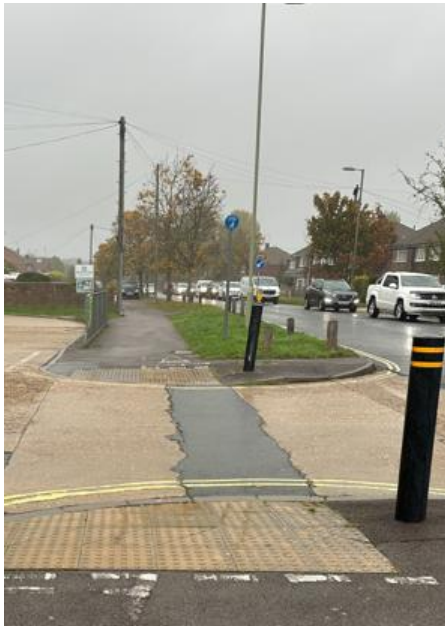
**Photograph 67:** Shared footway/cycleway on Middle Park Way (Heading north across the access to amenities including Co-op)

- 7.4 Continuing along Middle Park Way leading on from the junction with Park House Farm Way, a shared footway/cycleway is provided along the western edge of the carriageway (**Photograph 67**), which provides a continuous off-road route to the roundabout with Purbrook Way/Park Lane/Middle Park Way (**Photograph 68**). The shared footway/cycleway measures at least 2.5m wide, which is below the 3m width required by LTN1/20, although there are points where the provision is closer to 3m.

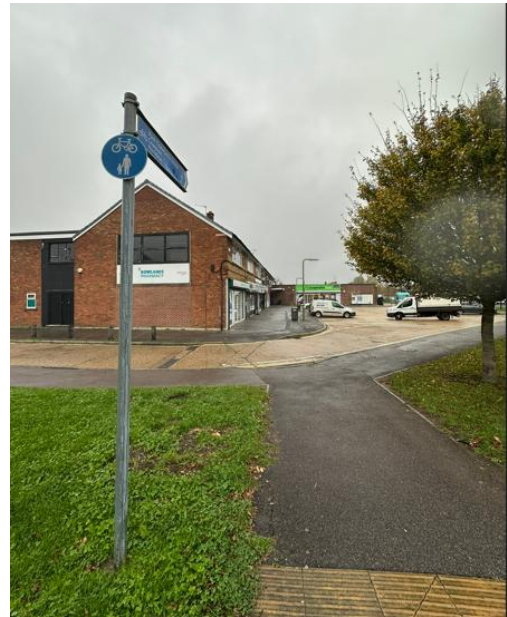
**Photograph 68:** Shared footway/cycleway on Middle Park Way near the Purbrook Way/Park Lane/Middle Park Way roundabout

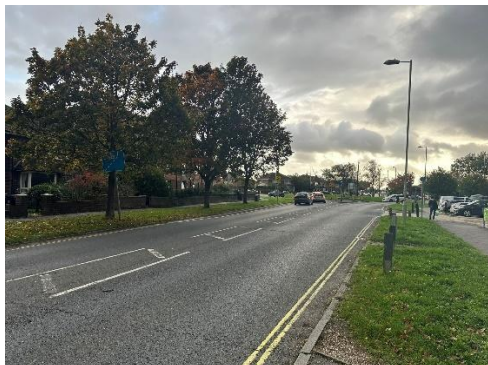
**Photograph 69:** Cycle signage on Middle Park Way leading onto Middle Park Way/Purbrook Way/Park Lane roundabout

- 7.5 All side roads between Woolston Road and the Purbrook Way/Park Lane/Middle Park Way roundabout include dropped kerbs and tactile paving.
- 7.6 Once at the four-arm roundabout (Purbrook Way/Park Lane/Middle Park Way) an on-road cycle lane is provided on the approaches, with signage provided on Middle Park Way (**Photograph 69**) and around the circumference (**Photograph 70-72**) of the roundabout, which aids cycle movement across the roundabout. This includes the use of coloured road markings and barriers/refuges to ensure cyclist can travel on-road.

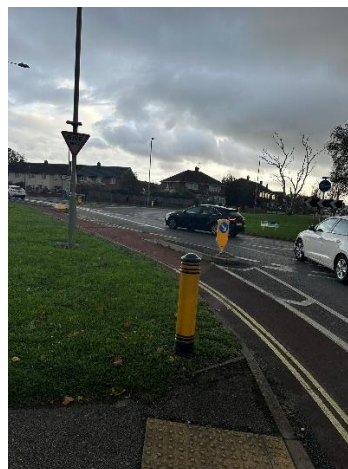
**Photograph 70:** Cycle infrastructure on Middle Park Way leading onto Middle Park Way/Purbrook Way/Park Lane roundabout

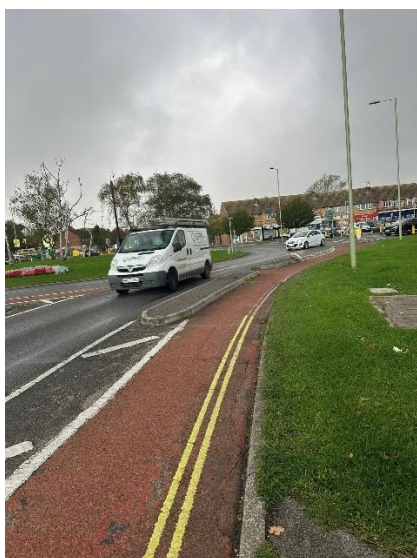
**Photograph 71:** Cycle infrastructure on Purbrook Way (E) leading on from Middle Park Way/Purbrook Way/Park Lane roundabout

7.7 It is noted within the HBC LCWIP (section 362.3.2) thought that potential upgrades are suggested for this roundabout given that cyclists are not given priority across the exits from the roundabout. It is suggested that greater priority should be given to cyclists, potentially with a Dutch style roundabout.

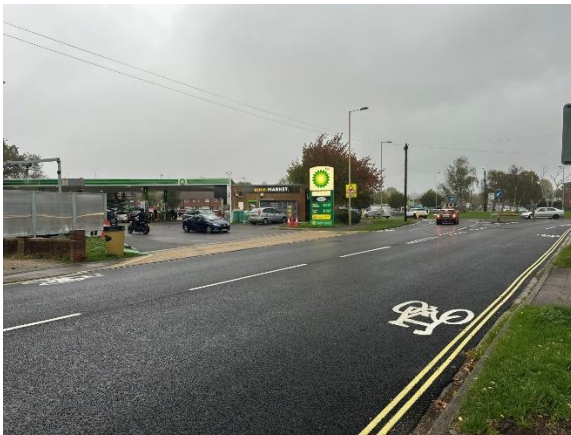
**Photograph 73:** Cycle lanes terminate on Park Lane – looking north

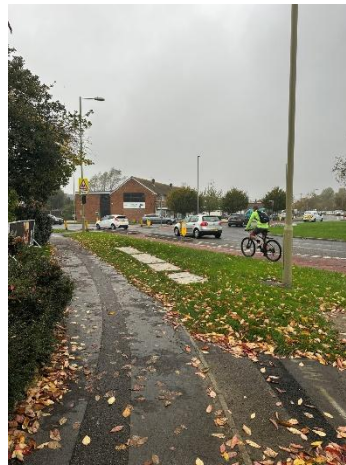
**Photograph 74:** Cyclist utilising the cycle lane leading on from Park Lane onto Purbrook Way (W)

- 7.8 Heading south onto Park Lane the marked on-road cycle lane continues until after the BP garage where it then terminates (**Photograph 73**), a cyclist was noted during the site visit to utilise the cycle lane along Park Lane heading northwest whereby they carried on along the cycle route onto Purbrook Way (W) (**Photograph 73**). Cyclists can then continue along the carriageway with it considered suitable given the 30mph posted speed limit, the residential nature of the road and because the carriageway measuring c.7m which will accommodate for the 1.5m cycle clearance for a 30mph road in LTN 1/20, with a cyclists noted during the site visit to utilise the cycle lane along Park Lane and then continue south along the carriageway (**Photograph 75**).

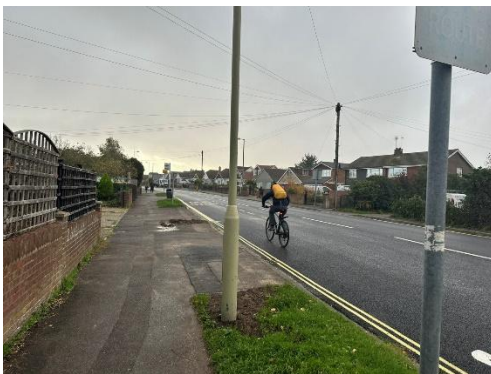
**Photograph 75:** Cyclists travelling along the carriageway on Park Lane – looking south

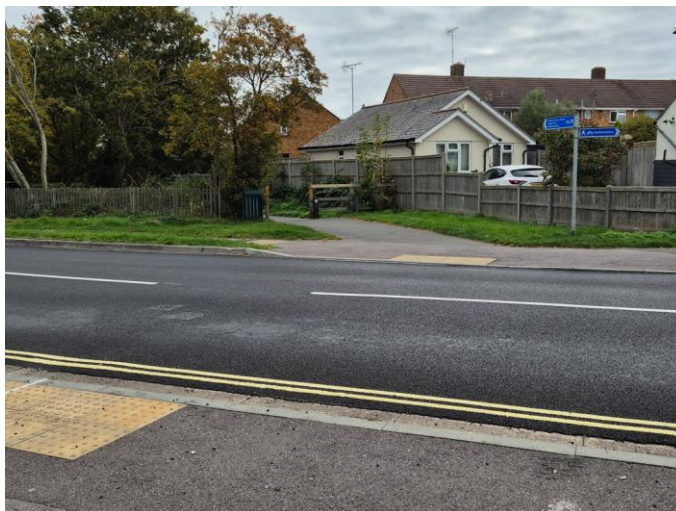
**Photograph 76:** Signage for cycle routes heading northwest across from Jessie Road

- 7.9 Continuing along Park Lane signage is provided near Jessie Road which provides an indication which direction additional routes are located, to enable those less familiar with the area to access their preferred cycle routes and facilities including Havant Town Centre and Leigh Park. This is shown in **Photograph 76**.

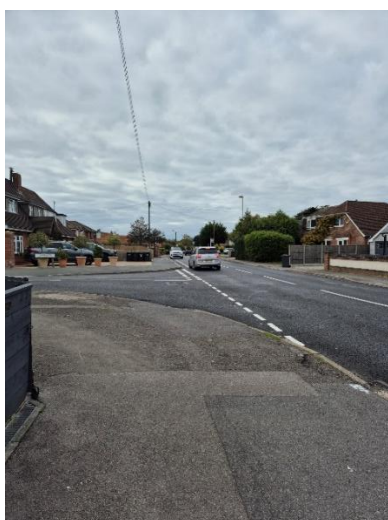
**Photograph 77:** Existing Conditions near Hooks Lane

- 7.10 Regarding Bedhampton Train Station, cyclists can continue heading south on Park Lane towards Hulbert Road (B2150) utilising the carriageway, with the existing conditions shown in **Photograph 77 and 78**.

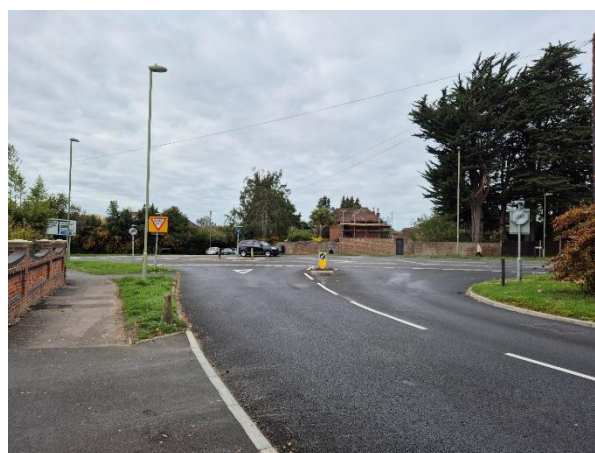
**Photograph 78:** Existing Condition heading towards Hulbert Road (B2150)

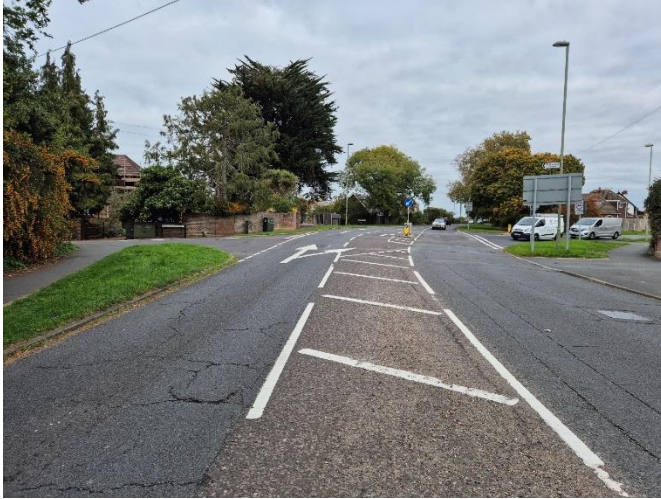
**Photograph 79:** Existing condition on Hulbert Road (B2150) (looking north heading towards Park Lane junction on right)

- 7.11 As aforementioned, at the southern extent of Park Lane, the road meets Hulbert Road (B2150) (**Photograph 79**), along which cyclists can continue to travel along the carriageway, which provides a continuous route onto Bedhampton Road towards the train station. The existing condition of the carriageway is shown in **Photograph 80**. Whilst the carriageway is wide enough to accommodate for the 1.5m cycle clearance for a 30mph road in LTN 1/20 the section of Hulbert Road is only 120m long, before the junction with Bedhampton Road (B2149)

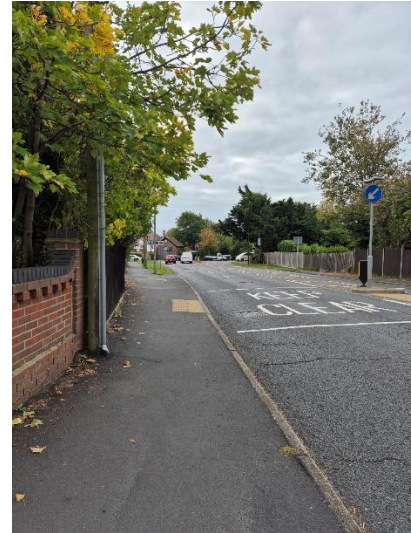
**Photograph 80:** Existing condition on Hulbert Road (B2150) towards Bedhampton Road

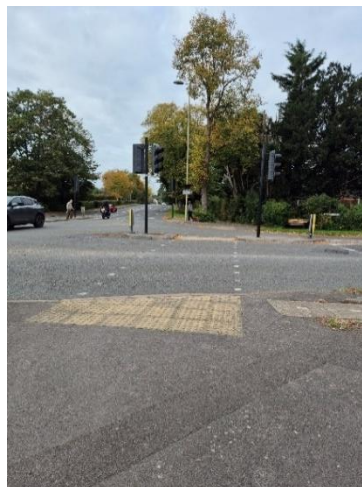
**Photograph 81:** Signalised crossing across Hulbert Road (B2150)

- 7.12 The junction of Hulbert Road/Bedhampton Road is signalised and includes on the Bedhampton Road arms pedestrian call buttons, whilst on the Hulbert Road arm there is tactile paving, dropped kerbs and a refuge island, but no pedestrian call button (**Photograph 81**).

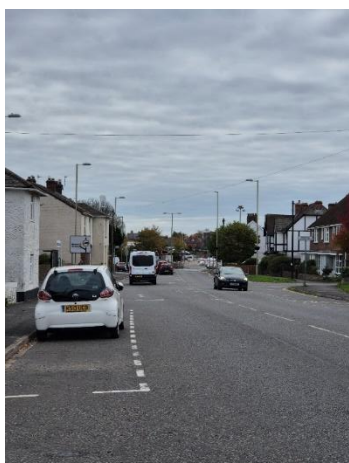
**Photograph 82:** Existing conditions on Bedhampton Road (B2149)

7.16 Continuing east along Bedhampton Road (B2149) towards Bedhampton Train Station it is observed that on-street parking takes place (**Photograph 82**). As well as this, during the site visit cyclists were noted to utilise the carriageway heading towards the train station (**Photograph 83**).

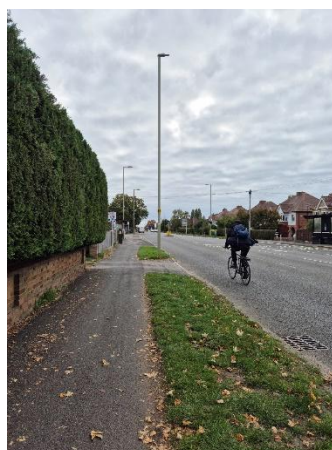
**Photograph 83:** Cyclist utilising the carriageway on Bedhampton Road heading towards the train station

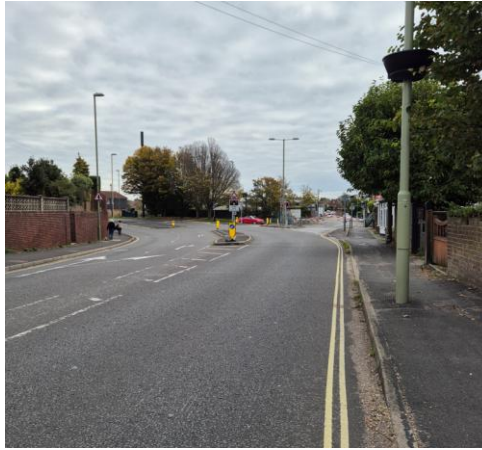
**Photograph 84:** Existing conditions on Bedhampton Road heading towards the train station (B2149)

7.17 Upon reaching the junction on Bedhampton Road for the train station (on West Street), a right turn lane is provided off Bedhampton Road to turn onto West Street to reach Bedhampton Train Station, which cyclists can utilise (**Photograph 84**).

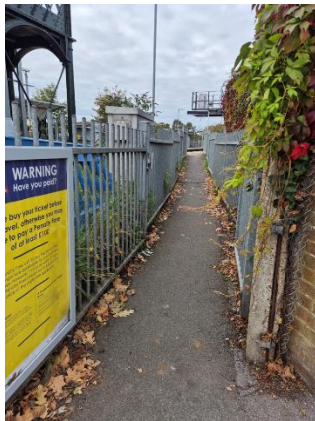
**Photograph 85:** Access to Platform 1

7.18 Bedhampton Station is reached from West Street, with the access (pedestrian) to platform 1 to the north of the level crossing (**Photograph 85**), and the access to platform 2 and the on-platform cycle storage is to the south of the level crossing. With cyclists noted during the site visit to utilise the carriageway as shown in **Photograph 86**.

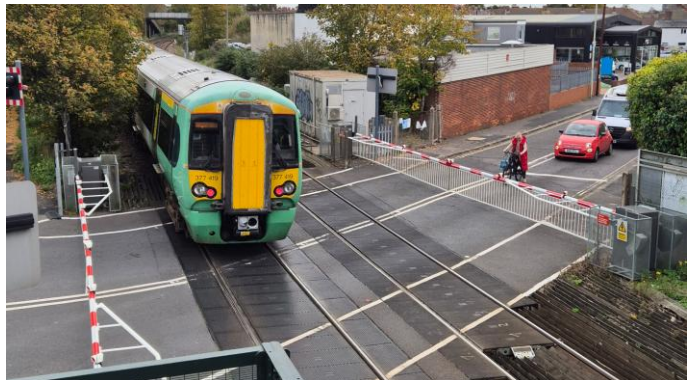
**Photograph 86:** A cyclist utilising the carriageway to cross the train track.

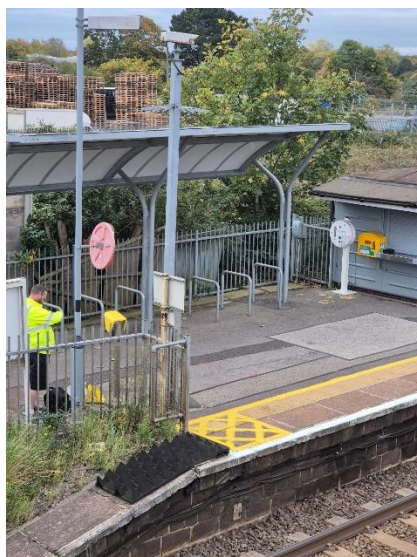
**Photograph 87:** Cycle Parking at Bedhampton Train Station

7.19 Within Bedhampton Train Station there is cycle parking provided in the form of Sheffield stands (**Photograph 87**).
