**REPORT ON  
GROUND INVESTIGATION  
AT  
LANGSTONE TECHNOLOGY  
PARK, HAVANT – PHASE 3A**

| <b>Report Title:</b> | Report on Ground Investigation at Langstone Technology Park, Havant – Phase 3A |
| <b>Report Number:</b> | AG3744-26-AV11 |
| <b>Date:</b> | 22/05/2026 |

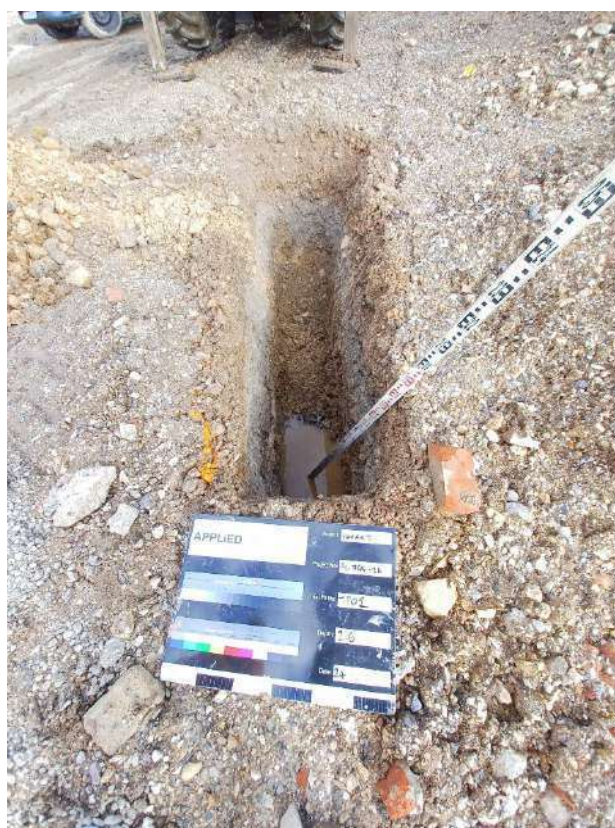
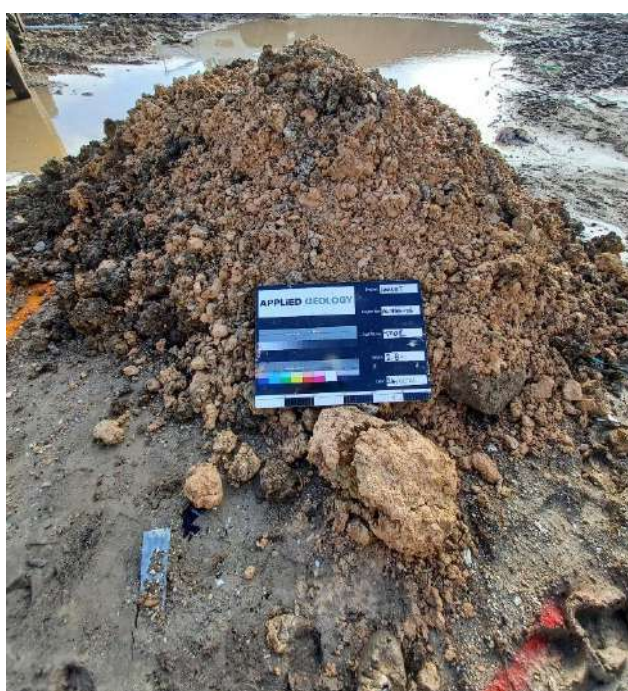
### TP01

**Stability:** Major spalling of trial pit walls from 1.40m bgl.

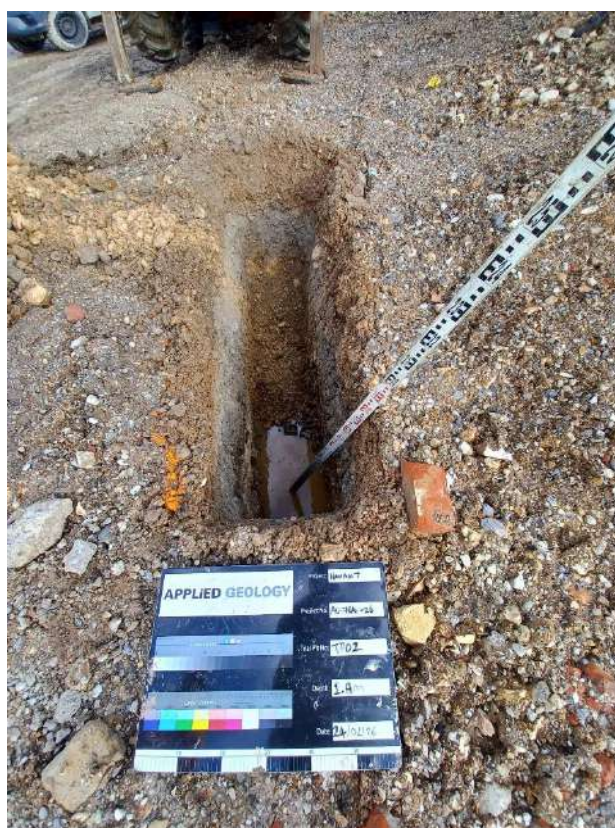
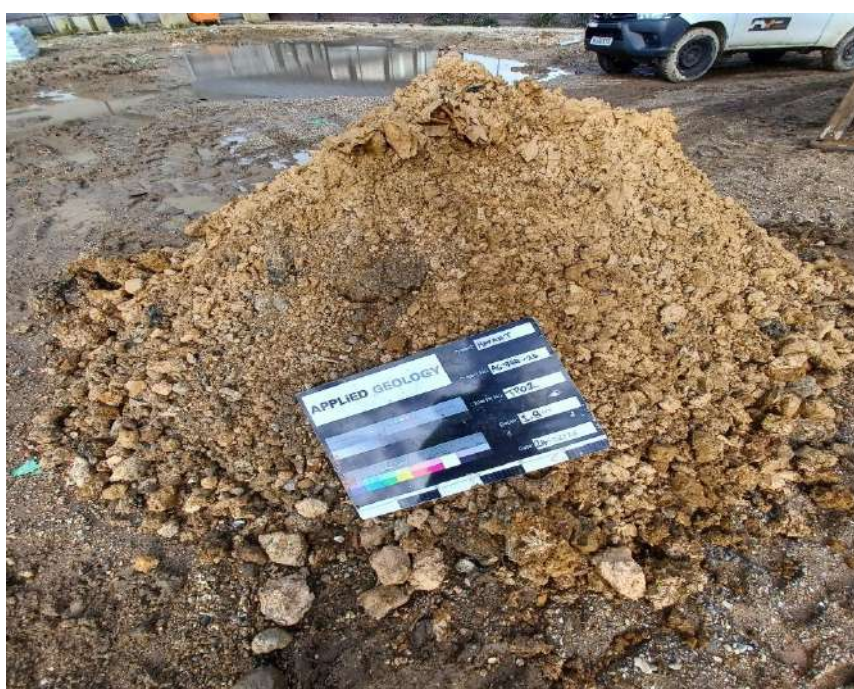
### TP02

**Stability:** Major spalling of northern trial pit wall from 0.60m bgl
