## Compliance Inspection

### Ventry Construction

**Downley Road, Havant**

**23.06.26**

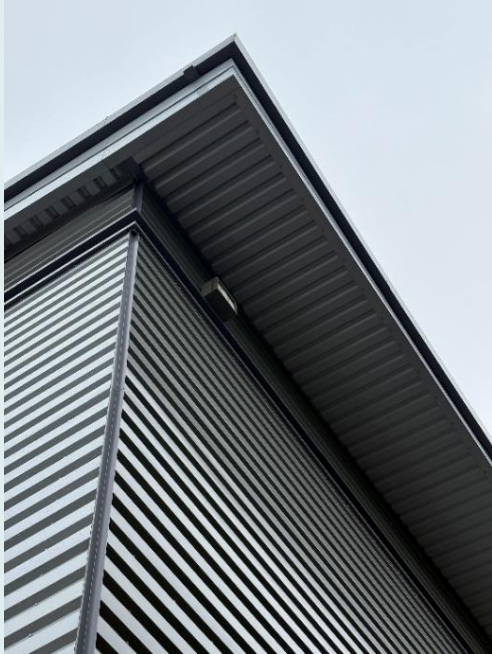
- 1.2 The inspection confirmed that the approved faunal enhancement measures had been installed in accordance with the LEMP. Six bird nesting boxes were present and securely installed on the rear elevation of the building (Photograph 0614).

**1. Swift Boxes in situ to the rear of the building (0613)**

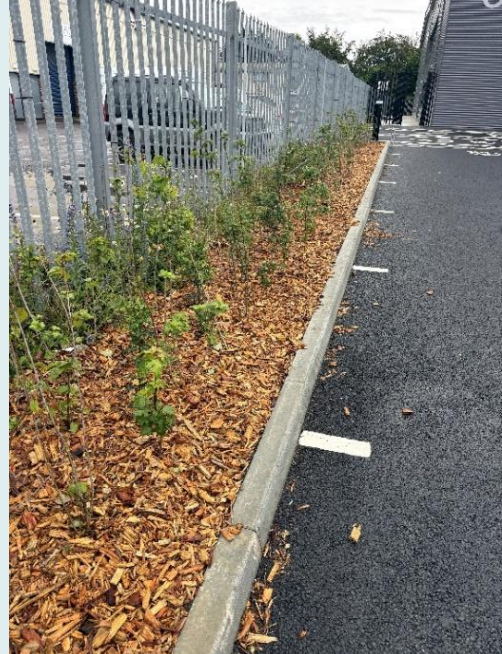
- 1.3 The majority of habitat creation and landscaping measures have been implemented in accordance with the approved plans and are generally establishing well.
- 1.4 The northern native hedgerow is establishing successfully (Photograph 0599), whilst the native scrub planting along the eastern boundary is also showing good establishment and healthy growth. Overall, the habitat creation areas inspected were found to broadly accord with the approved planting plans and management prescriptions.

**2. Northern hedgerow establishing (0599)**

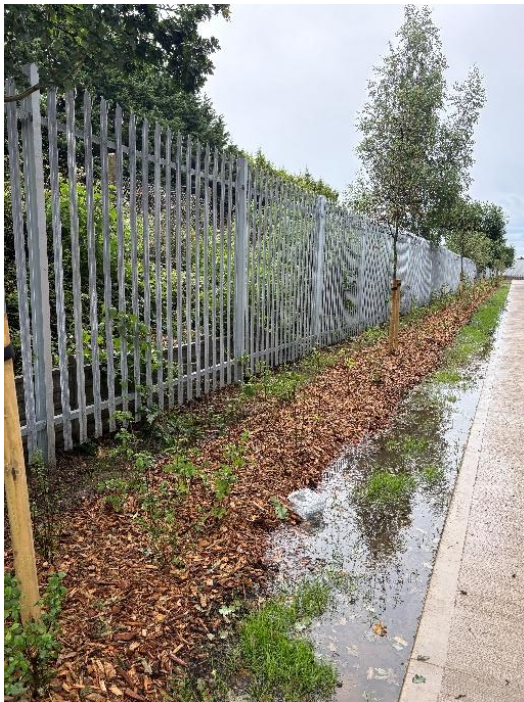
- 1.11 Discussions with the site contractor confirmed that a French drain is proposed within the eastern scrub planting area to improve site drainage (Photographs 0603, 0606, 0608 and 0609). As portions of this area have already been seeded with the approved flowering lawn mix, disturbed areas should be reinstated and reseeded during autumn 2026 following completion of the drainage works.

**3. Scrub planting to the east establishing well (0603)**

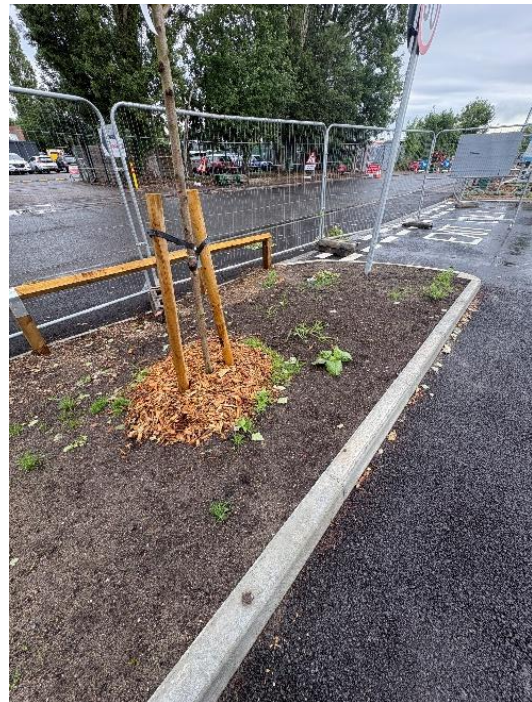
- 1.6 Several newly planted trees have been incorrectly staked and are not receiving adequate support (Photograph 0623). In a number of instances, stakes were found to be loose and could be removed from the ground by hand. Tree stakes and ties should therefore be reinstalled in accordance with the approved planting specification to ensure successful establishment. One rowan tree located centrally within the site was observed to be leaning significantly and requires immediate corrective staking and support (Photograph 0590).

- 1.10 Areas sown with the approved flowering lawn and wildflower grassland mixes have established only partially, with vegetation cover currently remaining sparse and patchy (Photographs 0597 and 0616–0624). This is not unusual during the first establishment year; however, additional overseeding is recommended during autumn 2026 to improve coverage and species establishment.

**4. Trees require re staking and grassland to be reseeded in autumn 2026 (0623)**

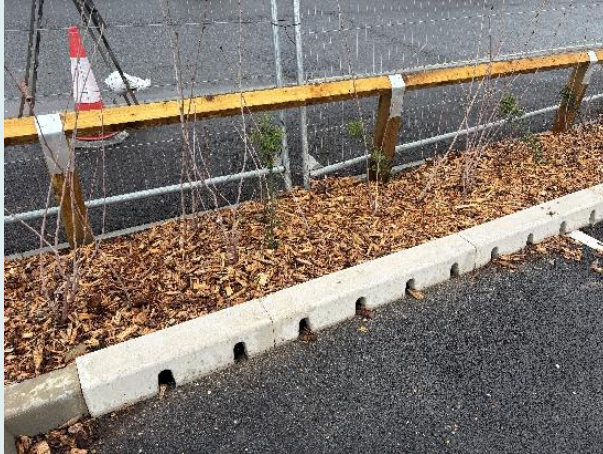
- 1.7 The native hedgerow adjacent to the site frontage has established poorly when compared to other planted hedgerows on site. Numerous whips appear to have been planted too shallowly and can be removed from the ground with minimal force, which is likely to adversely affect survival rates (Photographs 0592 and 0594).

**5. Roadside hedgerow, whips not planted deep enough, unlikely to establish in current state (0594)**

- 1.8 The hedgerow should be monitored during the remainder of the growing season and reviewed in autumn 2026. It is anticipated that supplementary bareroot planting will be required during the next planting season to replace failed specimens and achieve the intended hedge density.

- 1.9 Weed growth is currently competing with establishing hedgerow planting in several locations. Weeding should be undertaken and mulch depths increased where necessary to maintain effective weed suppression and improve establishment rates.

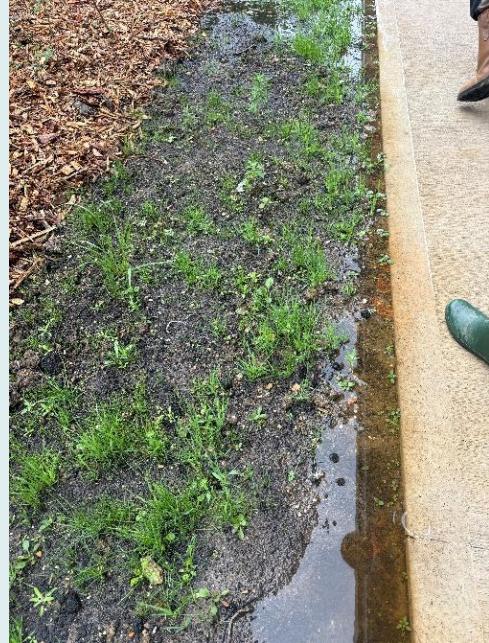
**6. Area to be reseeded following installation of French drain (0609)**

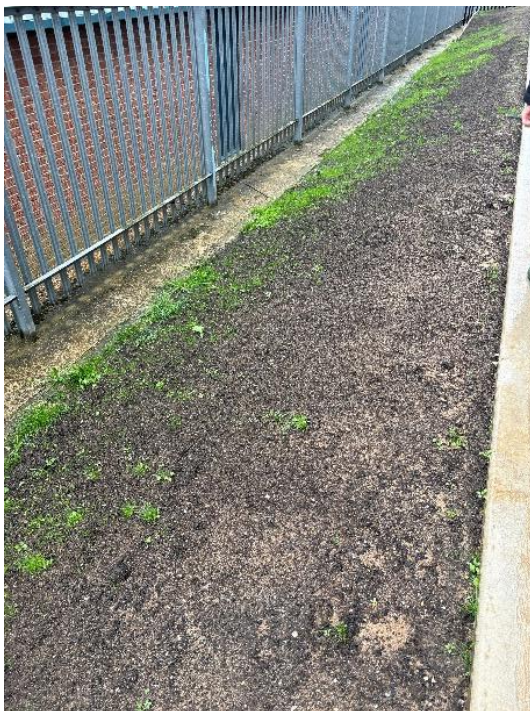
**7. Grassland to be reseeded in autumn 2026 (0619)**

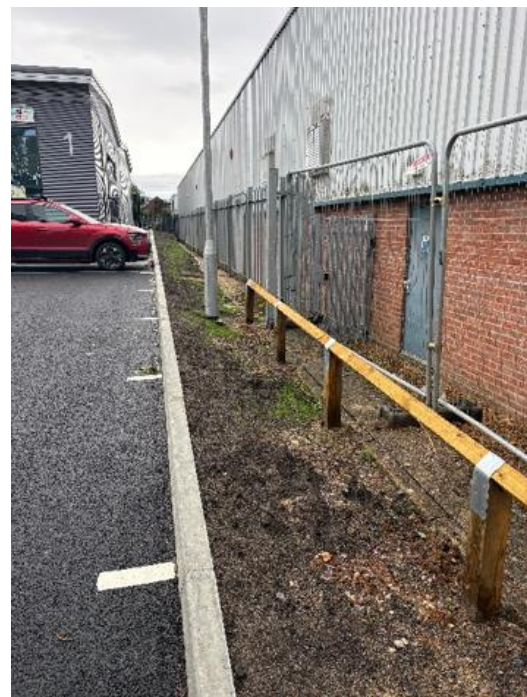
**8. Grassland to be reseeded in autumn 2026 (0624)**
