# Additional Geo- Environmental Site Investigation

## Bartons Road, Havant

**BRD4469-OR4-A**

**June 2026**

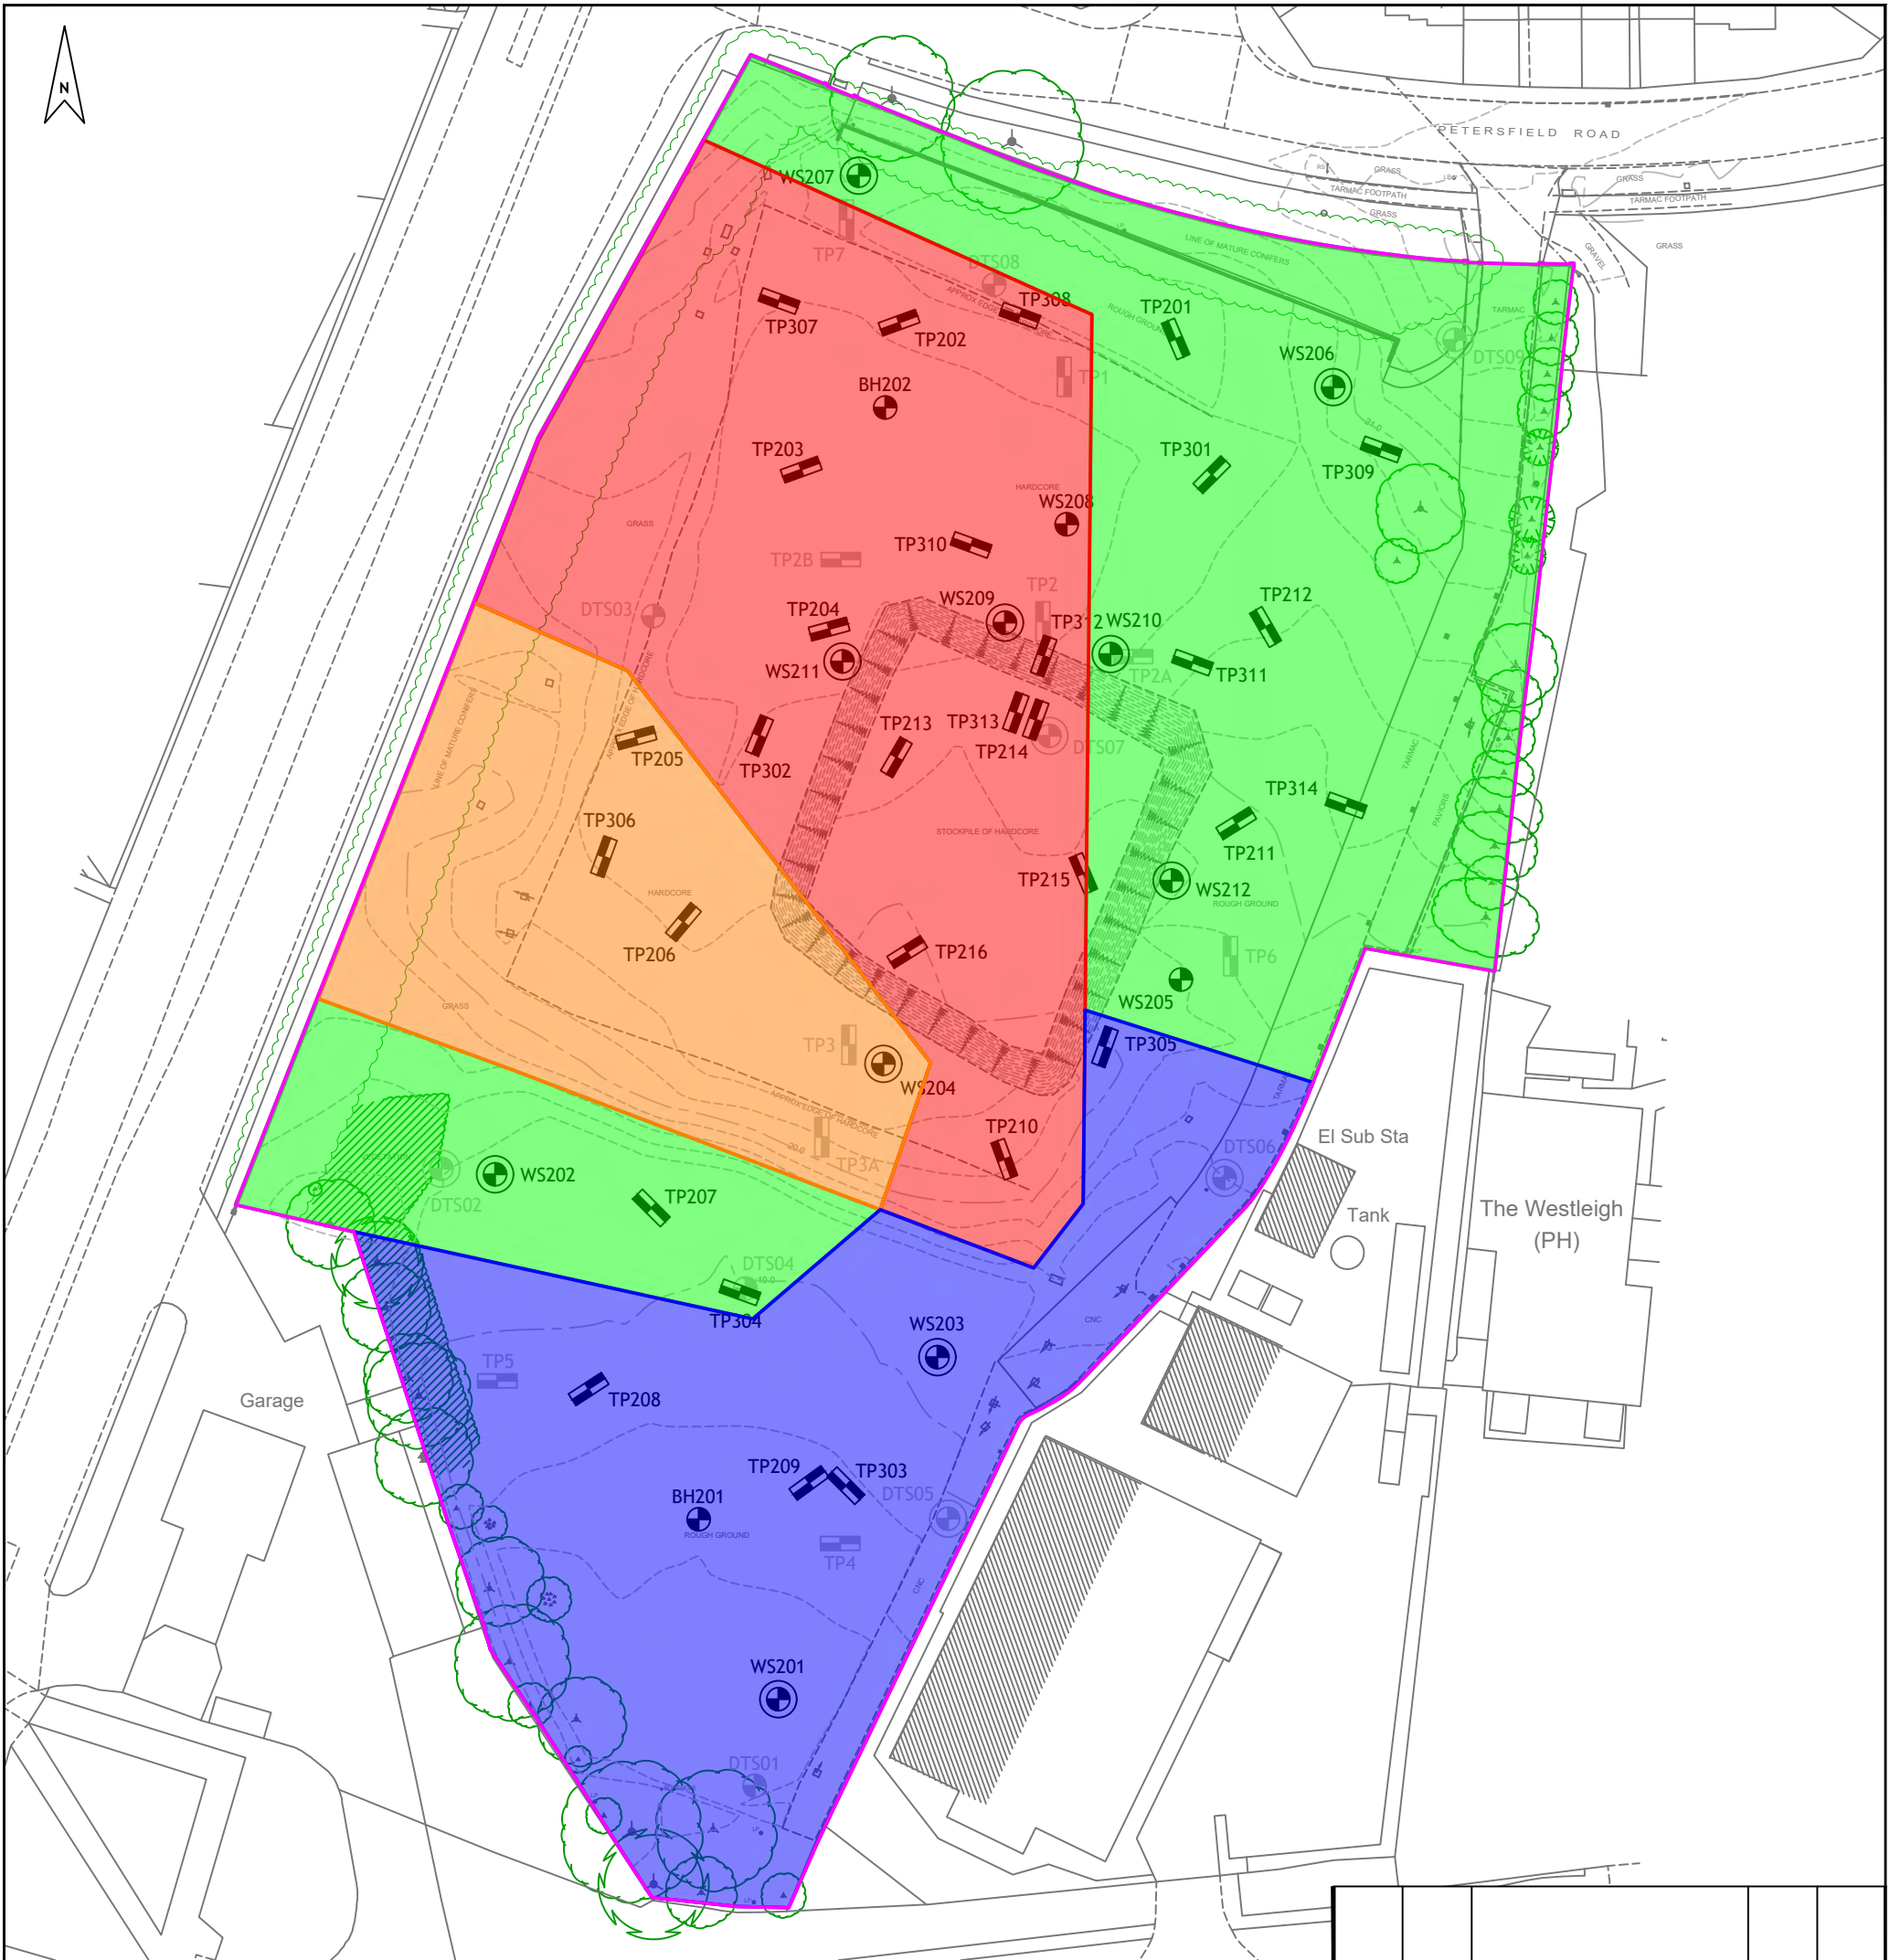
Preliminary Foundation Key:

- Piling due to Made Ground extending below groundwater at 1.00m bgl in wetter months.
- Piling due to Made Ground extending below groundwater at 1.00m bgl in wetter months. But if levels reduced by 0.5m or more, reinforced shallow footings may be possible but subject to tree influence of existing and removed trees.
- Reinforced shallow footings due to variable ground but subject to tree influence of existing and removed trees. Potential for dig and pour during wetter months.
- Conventional shallow footings due to shallow Bognor Sand Member but subject to tree influence of existing and removed trees.

The additional investigation has enabled the areas where the Bognor Sand Member is present at founding depth to be better delineated and this is identified on the Preliminary Foundation Zoning Plan included in the Appendices.
