# STOCKHEATH COMMON - BOUNDARY IMPROVEMENTS - EXISTING SITE PHOTOS & PROPOSALS

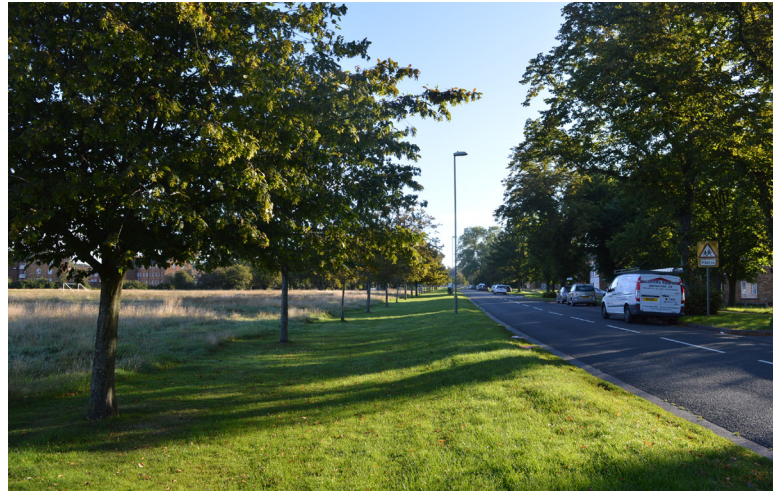
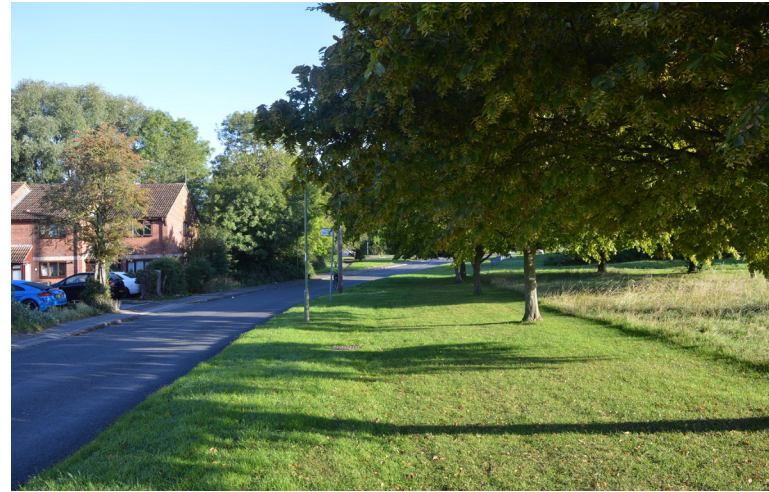
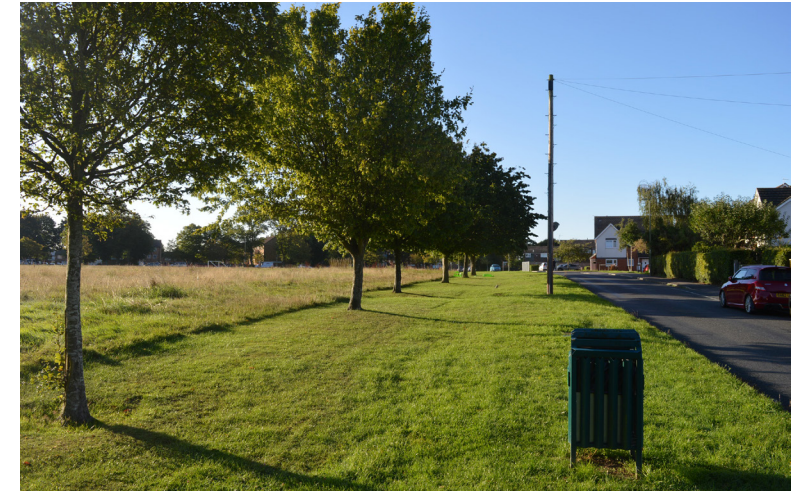
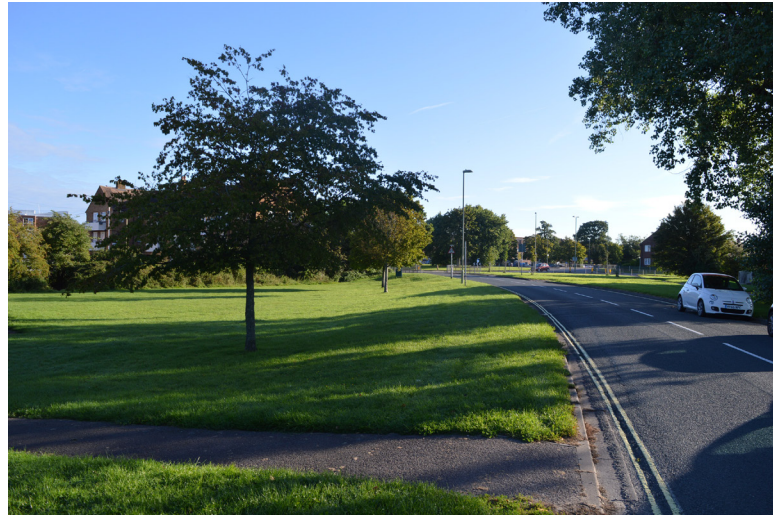
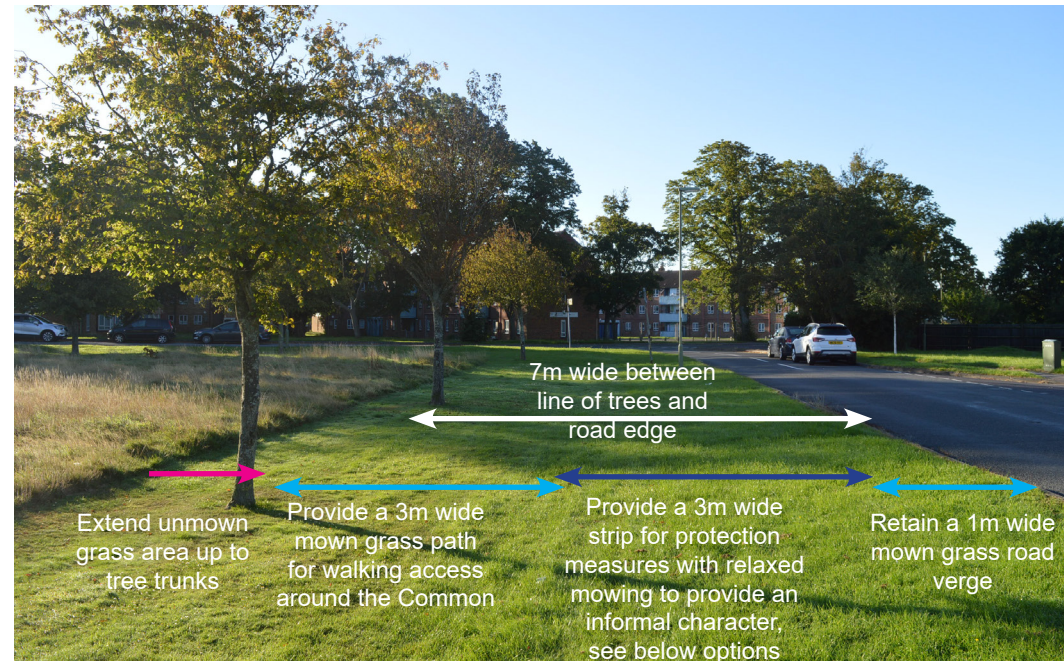
**Stockheath Common:**  
Photos showing current situation along Riders Lane and Stockheath Lane:  
**Wide verges between line of existing trees and road edge. Mown grass verges, vulnerable to being driven on and breached by travellers to reach open space in centre**

**Dimensions:**  
7m wide verge between line of existing trees and road edge.

**Proposal:**  
Break up verge into strips of access and protection measures using mowing regime and / or wildflower grass seeding to create a clear definition of protection area and walking areas.

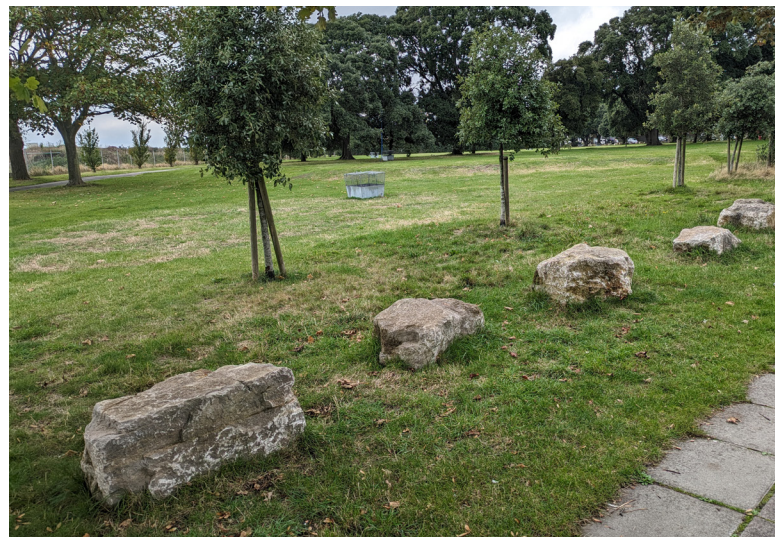
**Large Purbeck limestone boulders at key locations for access to the inner Common area. Combine with unmown grass to encourage more biodiversity and informal character**

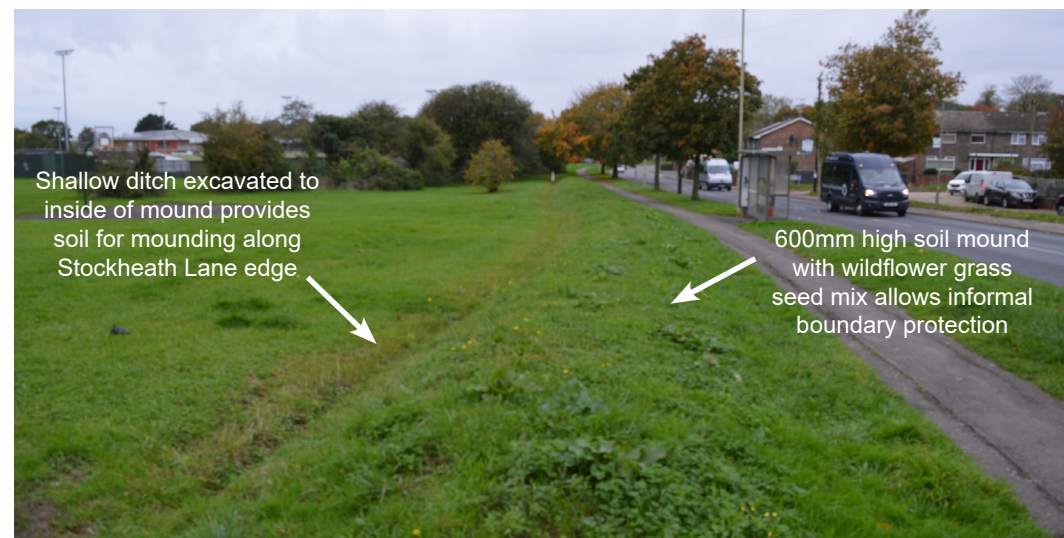
**Low mounds, 600mm high max. of nutrient-poor topsoil seeded with wildflower grass mix. Along Riders Lane these would be using new topsoil. Along Sockheath Lane these would be using site-won topsoil excavated from shallow ditches to the inside edge of the mounds. Combine with unmown grass for informal character. Break up mounds with narrow paths no wider than 1m to allow pedestrian access fom the roads into teh Common within. Example above is from Bartons Triangle in Leigh Park**

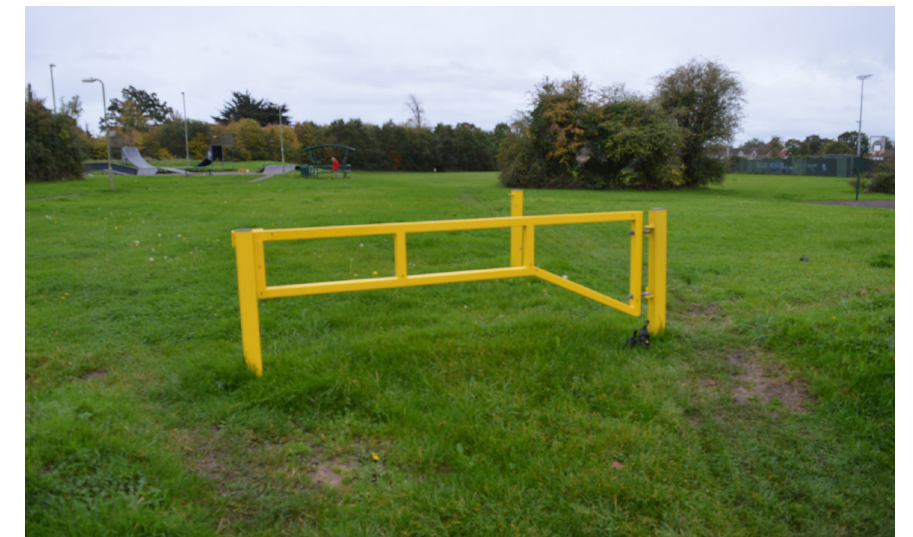
**Low gate barriers at two locations for maintenance access into Common within. Wide enough to accommodate ambulances for emergency access. should this be required.**
