# Additional Phase 2 Contamination Assessment and Remediation Strategy

## Bartons Road, Havant

**BRD4469-OR5-A**

**August 2026**

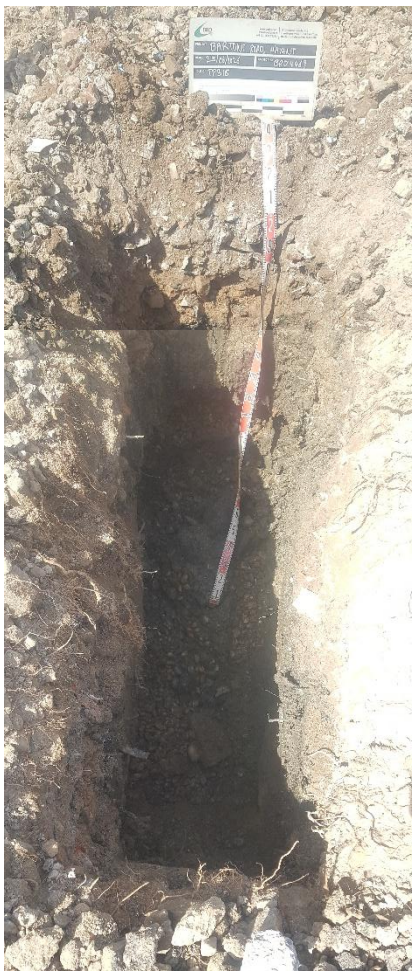
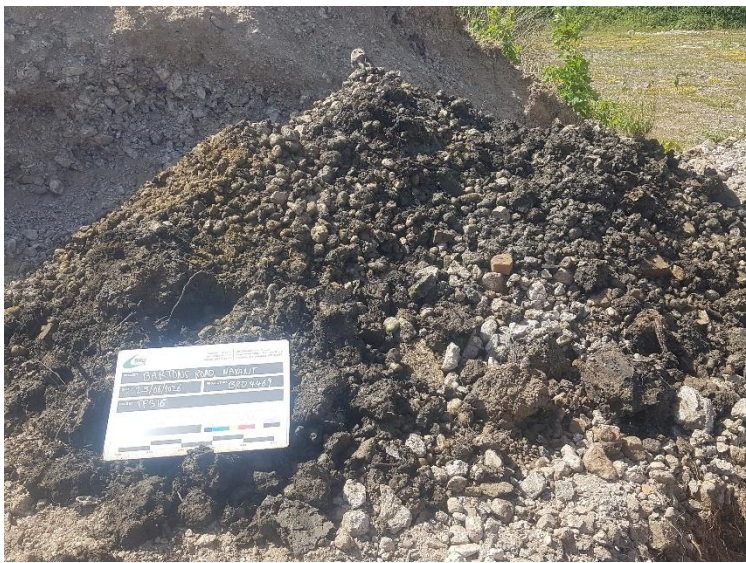
TP316

Trial pits TP316, TP319, TP321 and TP322 all encountered at depth what it considered to be a soakaway located in the centre of the site where the above ground fuel tank was formerly located. These trial pits encountered loose, grey brown, coarse, sub-angular to sub-rounded flint gravel with approximately 20mm diameter plastic drain pipes also present at depths from between 1.30m bgl and 1.40m bgl to depths of between 1.70m bgl and 2.20m bgl.

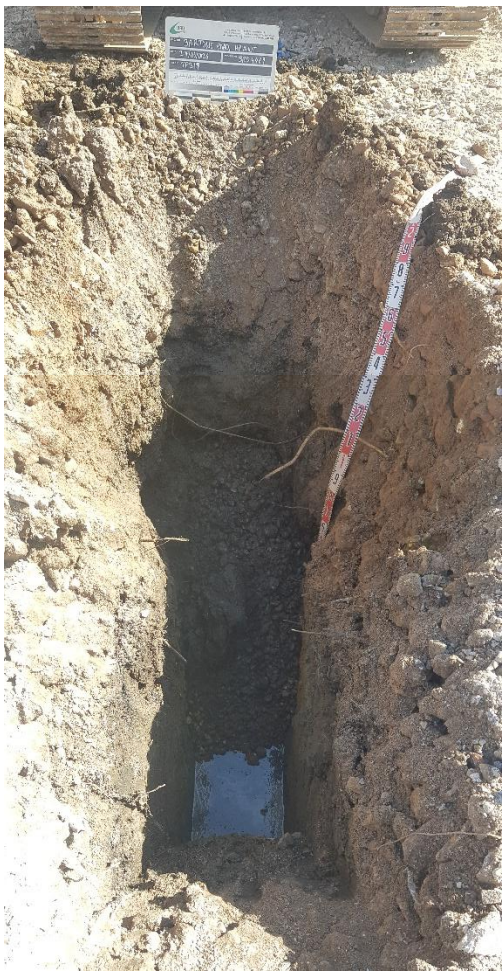
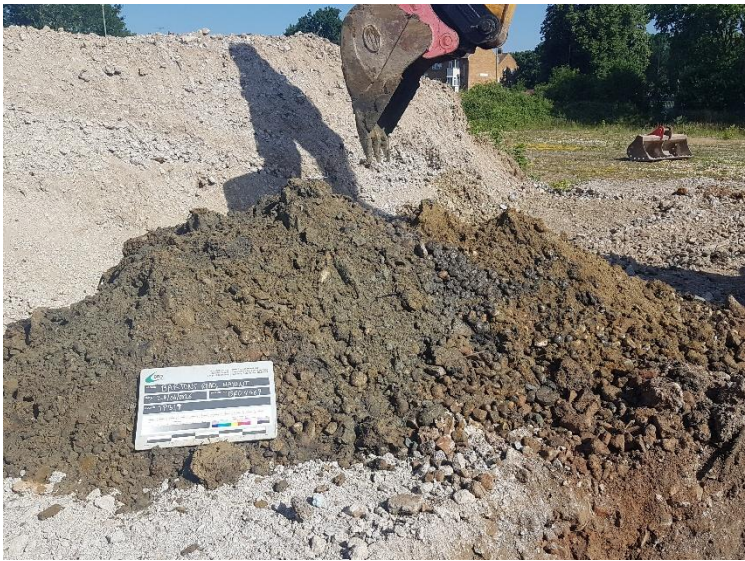
| <b>HYDROCARBON VAPOUR (PID)</b> | <p>5No. of the 26No. PID readings taken during the excavation of the trial pits recorded values above the assessment criteria of 50ppm. These readings were from trial pits TP319 at 2.60m bgl and 2.70m bgl, TP320 at 2.70m bgl, TP321 at 2.40m bgl and TP322 at 2.50m bgl, which were all in the location of the former above ground fuel tank and from olfactory or visually stained soils. The elevated PID readings ranged from 114.9ppm to 205.7ppm.</p> |

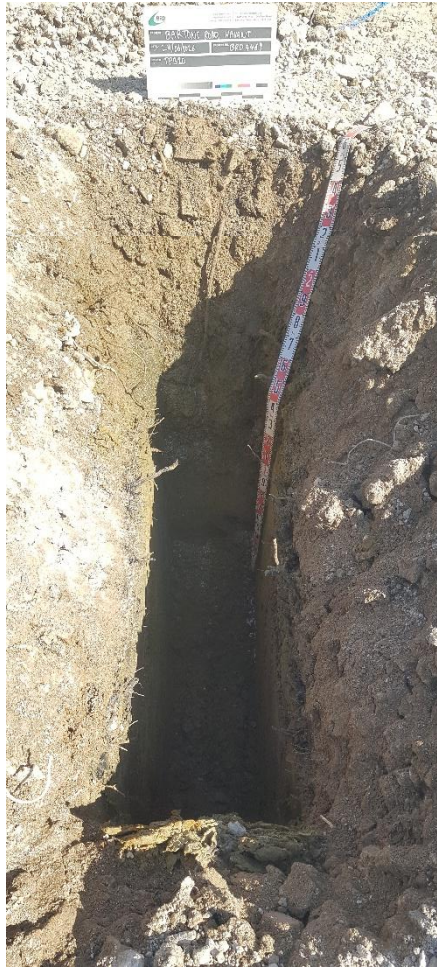
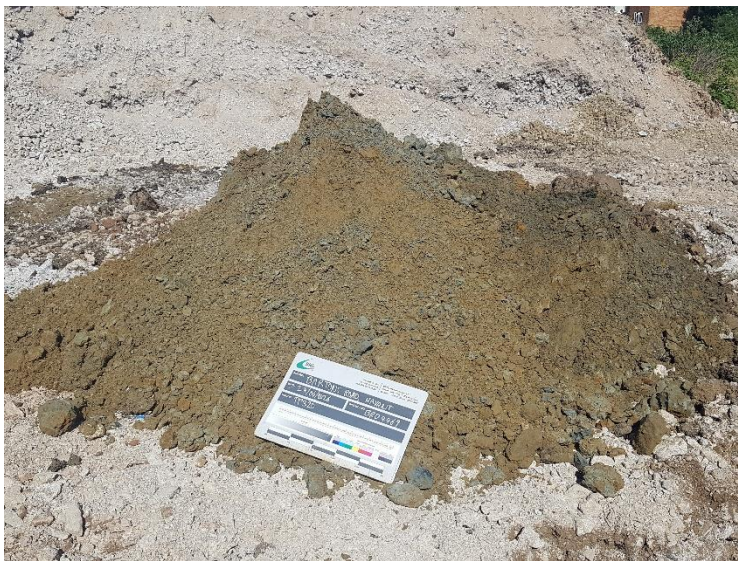
TP320

As discussed above within the trial pits undertaken around the former fuel tank location in the centre of the site, hydrocarbon odours and staining were noted in trial pits TP316, TP319, TP320, TP321 and TP322 at depths of from between 1.70m bgl and 2.60m bgl within the natural soils of the Bognor Sand Member. Strong hydrocarbon odours and staining were encountered in trial pits TP319 and TP322 at depths of from between 2.40m bgl and 2.50m bgl, also within the natural soils of the Bognor Sand Member. However, no significant visual or olfactory evidence of any hydrocarbon contamination was recorded in the near surface Made Ground soils in this area, with the hydrocarbon odours and staining only recorded within the natural soils at depth.
