**Land east of St. Patrick's RC Church,  
Hayling Island PO11 0QU**

**Drainage Strategy Report dated August  
2026**

**Ground Investigation Report**

**Reference: 22440/GIR Rev I.0  
July 2026**

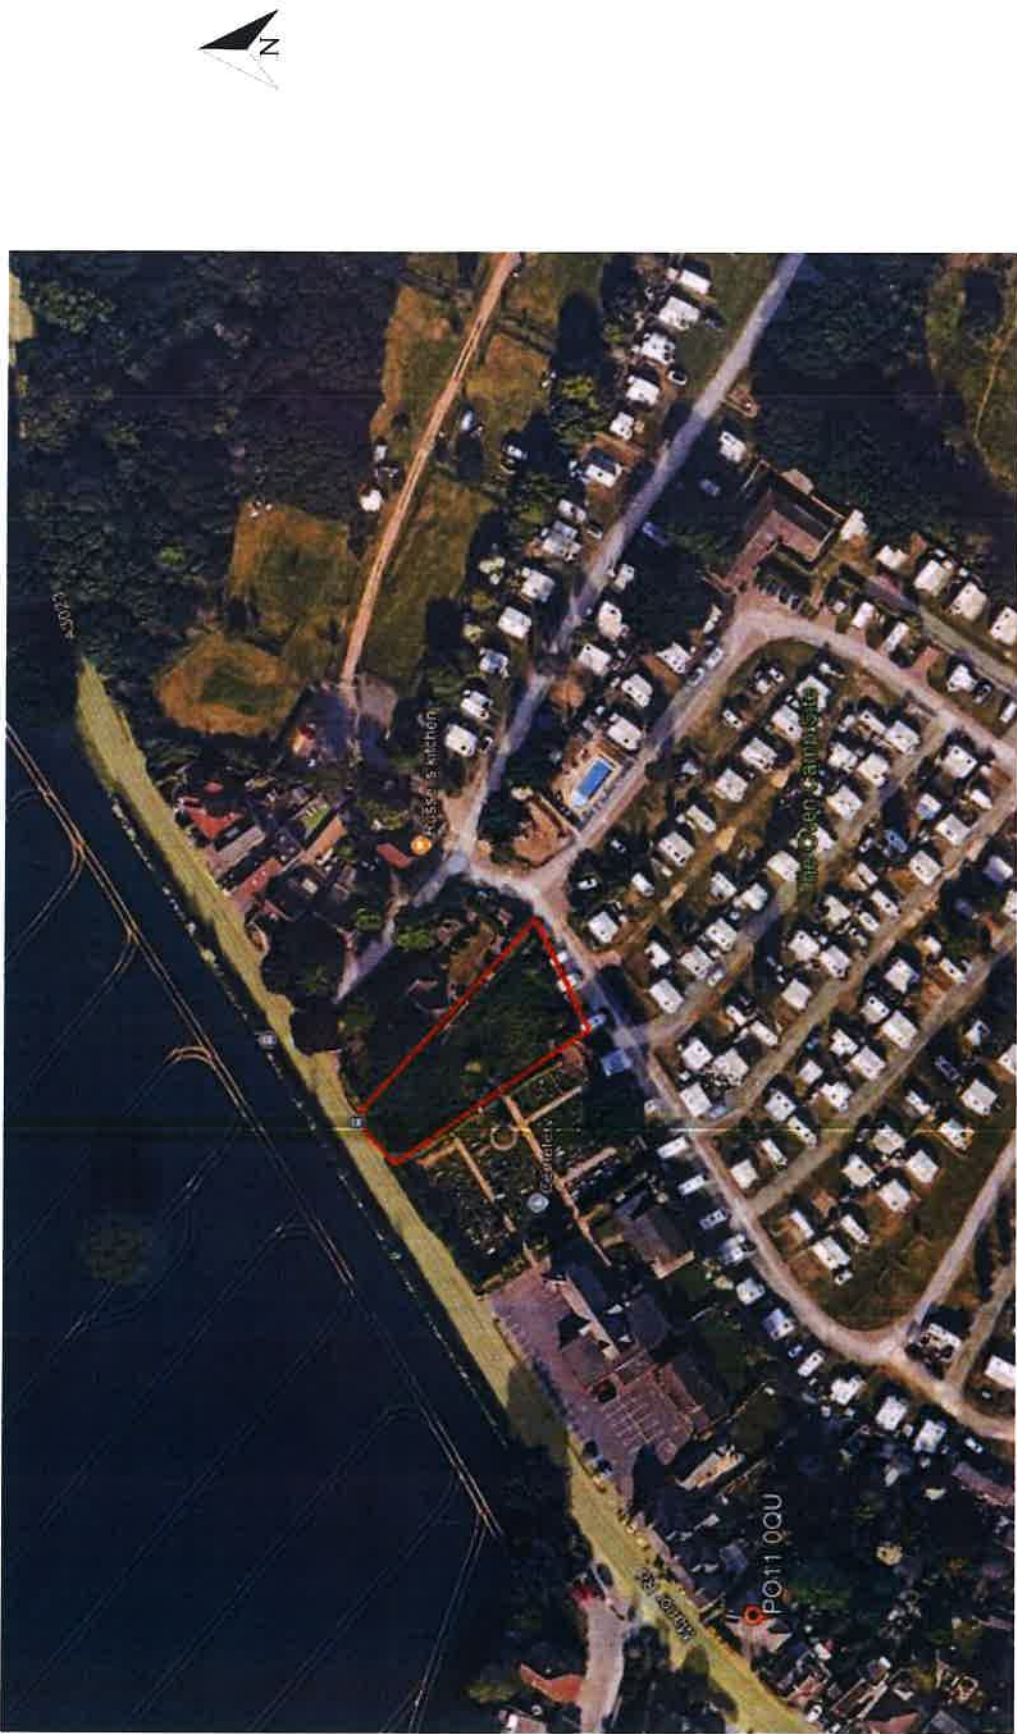
Figure 2 – Aerial Photograph

Figure 2 shows exploratory hole locations.

A site location plan is given in Figure 1. An aerial photograph of the site and its close environs has been included in Figure 2.

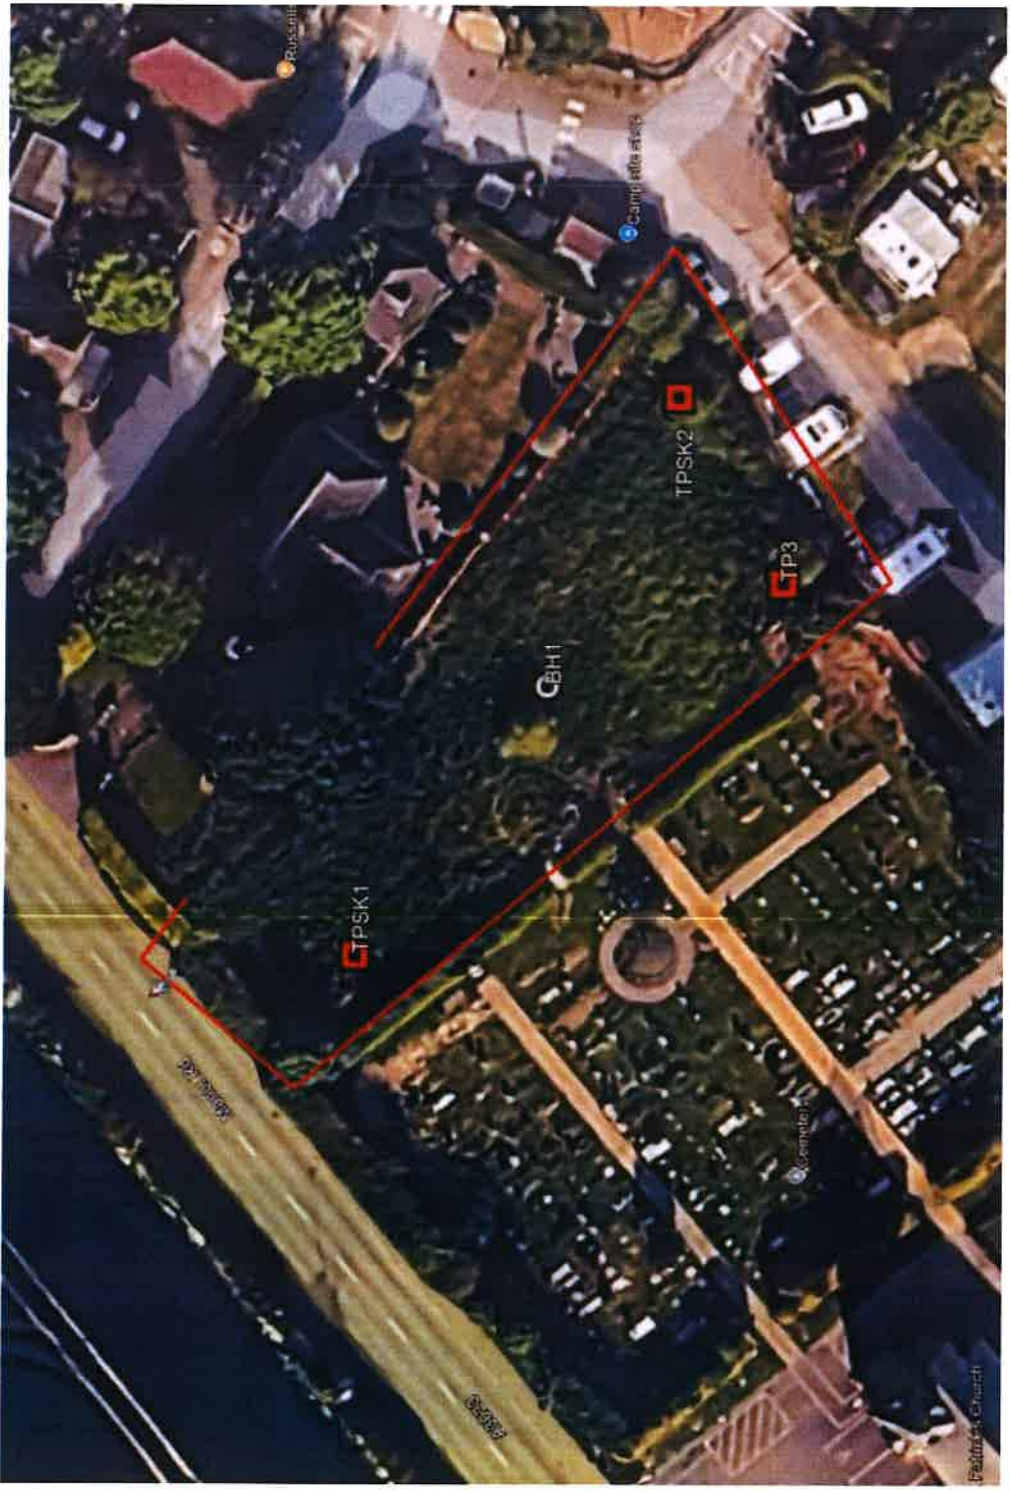
Figure 3 – Exploratory Hole Plan

- Scanning exploratory holes with a cable avoidance tool (CAT & Genny)
- 3No machine-excavated trial pits to depths ranging between 1.00m and 2.05m bgl
- 2No infiltration tests in TPSK1 and TSPK2 in accordance with BRE DG:2016
- 1No 15.00m deep cable percussive borehole with SPTs at every 1.00m to 5.00m and every 1.50m thereafter
- 10.00m deep groundwater monitoring standpipe
- Geotechnical laboratory testing
