**SOUTHLEIGH PARK HOUSE, EASTLEIGH ROAD, HAVANT, PO9 2PE**

**GROUND CONDITION ASSESSMENT**

**Project No.** J20-064

**Report No.** J20-064-R04

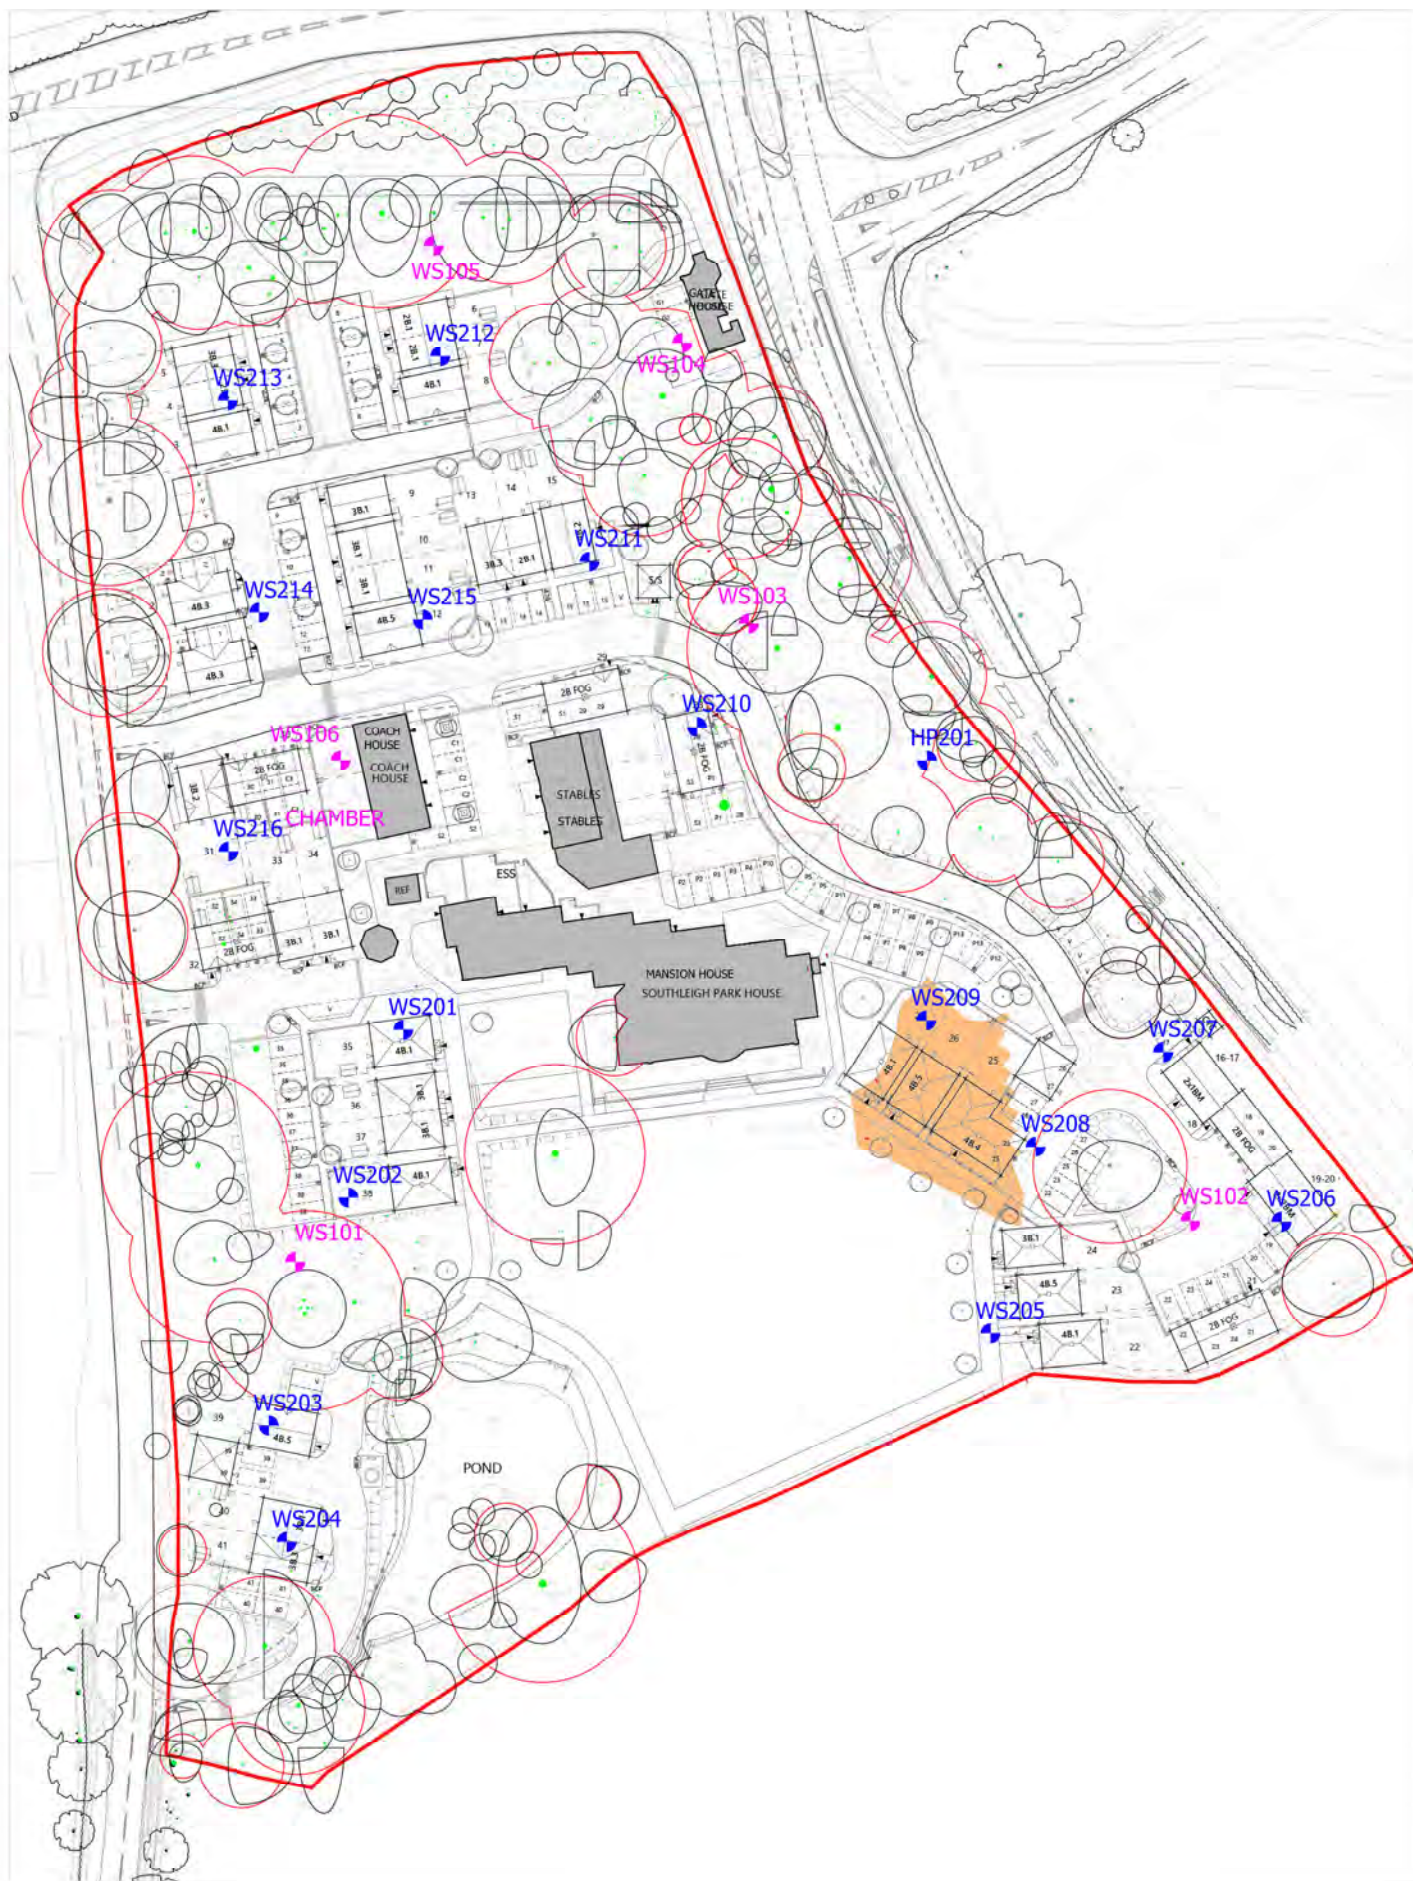
**FIGURE 2: SITE INVESTIGATION PLAN**

client BARGATE HOMES  
site SOUTHLEIGH PARK, HAVANT  
title INVESTIGATION LOCATION PLAN
