# Bat Survey Report – Preliminary Roost Assessment and Emergence Surveys

Crookhorn College, Stakes Hill Rd,  
Waterlooville PO7 5UD

For  
Hampshire County Council  
Property Services

September 2026

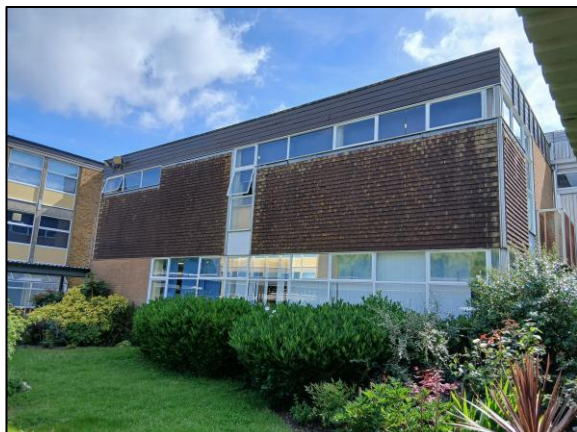
**Photo 1** Romsey Block – Western elevation

- 3.6. Romsey Block (Block 007X) is located to the south-east of the main building complex connected to Block 006 to the north and 007A to the south. It is a flat-roofed system-built SCOLA 2 building with brick exterior walls and metal framed glazing (see Photos 1 and 2).

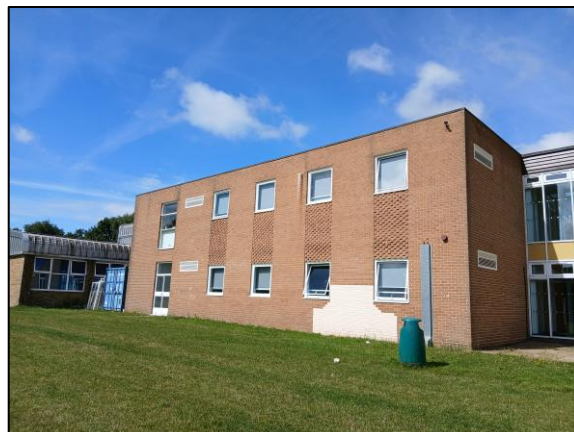
**Photo 2** Romsey Block – Eastern elevation

- 3.10. The eastern elevation is brick with some textured brick features and smaller sections of metal framed glazing (Photo 2). The brickwork is generally in good condition with no gaps. The overlap of the flat roof material at the top of the exterior wall has some gaps and lifting suitable for individual bats to roost in (Photo 8). There is no exterior lighting fitted to the western elevation.

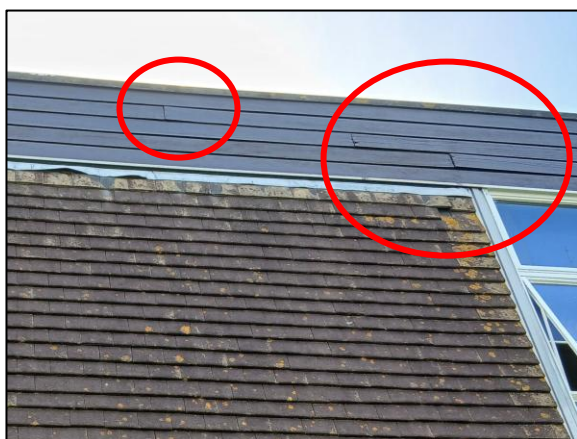
**Photo 3** Western elevation – gaps in timber cladding

- 3.8. The western elevation has extensive metal framed glazing. These are well fitted with no gaps between the frames and the brickwork. The upper section of the exterior walls has timber cladding, which is generally well fitted with no rotted sections although there appear to be some small areas of lifting where there may be gaps that could allow access for bats (Photo 3). There is an overlap of the flat-roof materials which has some lifting at the corners which may have suitability for crevice dwelling bats (Photo 4).

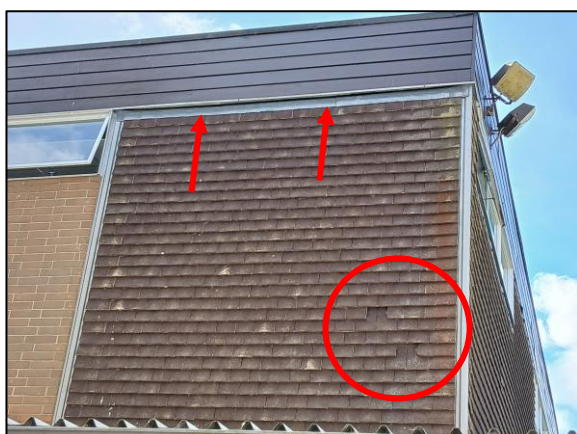
**Photo 5** Southern elevation – missing tiles (red circle), gap at top of lead flashing (red arrows)

- 3.9. There are sections of hanging tiles on the southern, western and northern elevations. These have gaps where there are lifted, broken or missing tiles (Photos 5 – 7). These are suitable locations for bat roosts. At the top of the hanging tile sections is lead flashing. There is a gap above the lead flashing and some lifting below the flashing which are also suitable for individual bats to roost underneath (Photos 5 – 7). There is exterior lighting which may reduce the likelihood of bats being present if this is consistently illuminated.
