GROUND INVESTIGATION REPORT

HAVANT RETAIL PARK, PORTSDOWN HILL ROAD,

LINDEN HOMES SOUTHERN LIMITED

Report:	**GROUND INVESTIGATION REPORT**
Site:	**HAVANT RETAIL PARK, PORTSDOWN HILL ROAD, HAVANT PO9 3NA**
Client:	**LINDEN HOMES SOUTHERN LIMITED**
Date:	**AUGUST 2012**
Reference:	**GE8756/GIR**
Version:	**1.0**

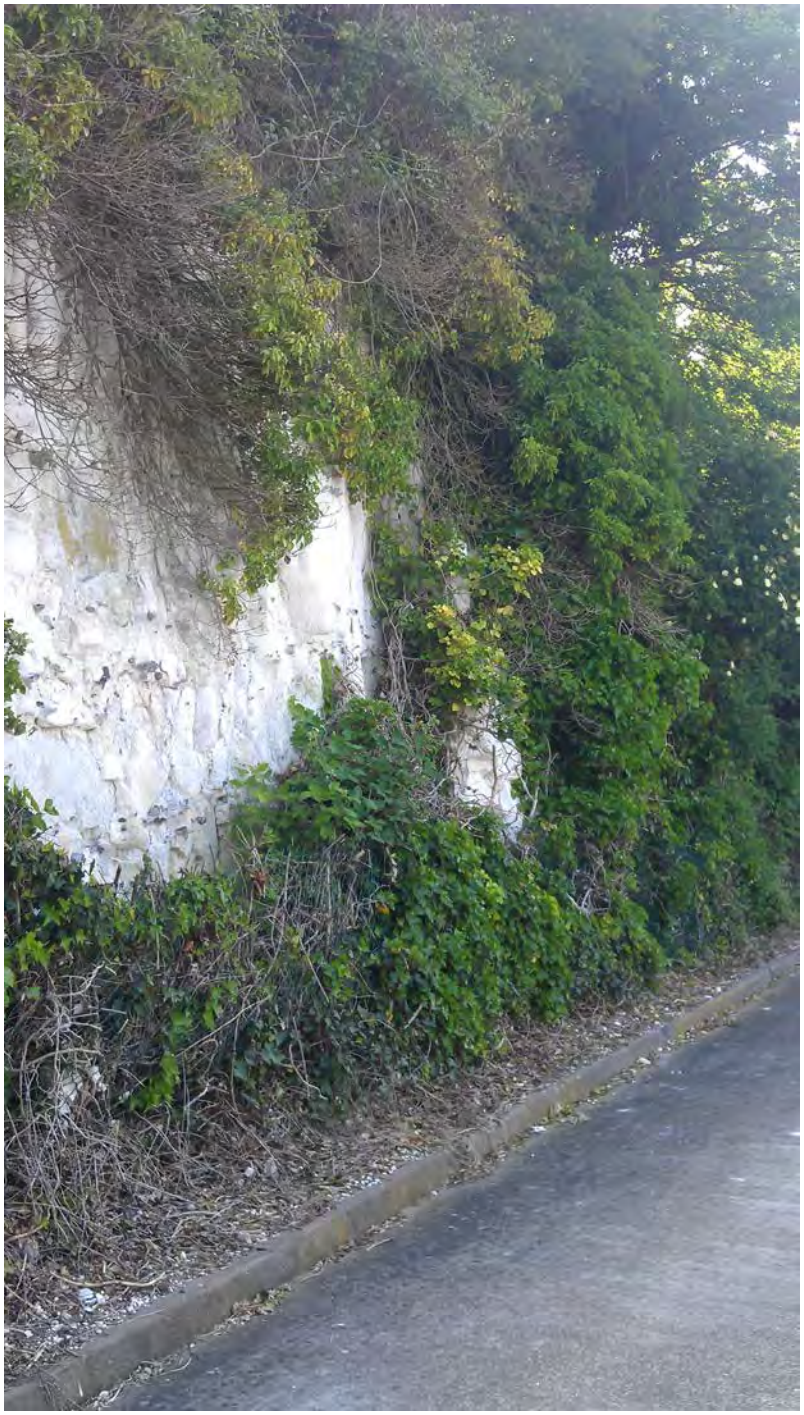
Plate 20 Chalk block size/joint spacing increasing and flints protruding from the chalk face

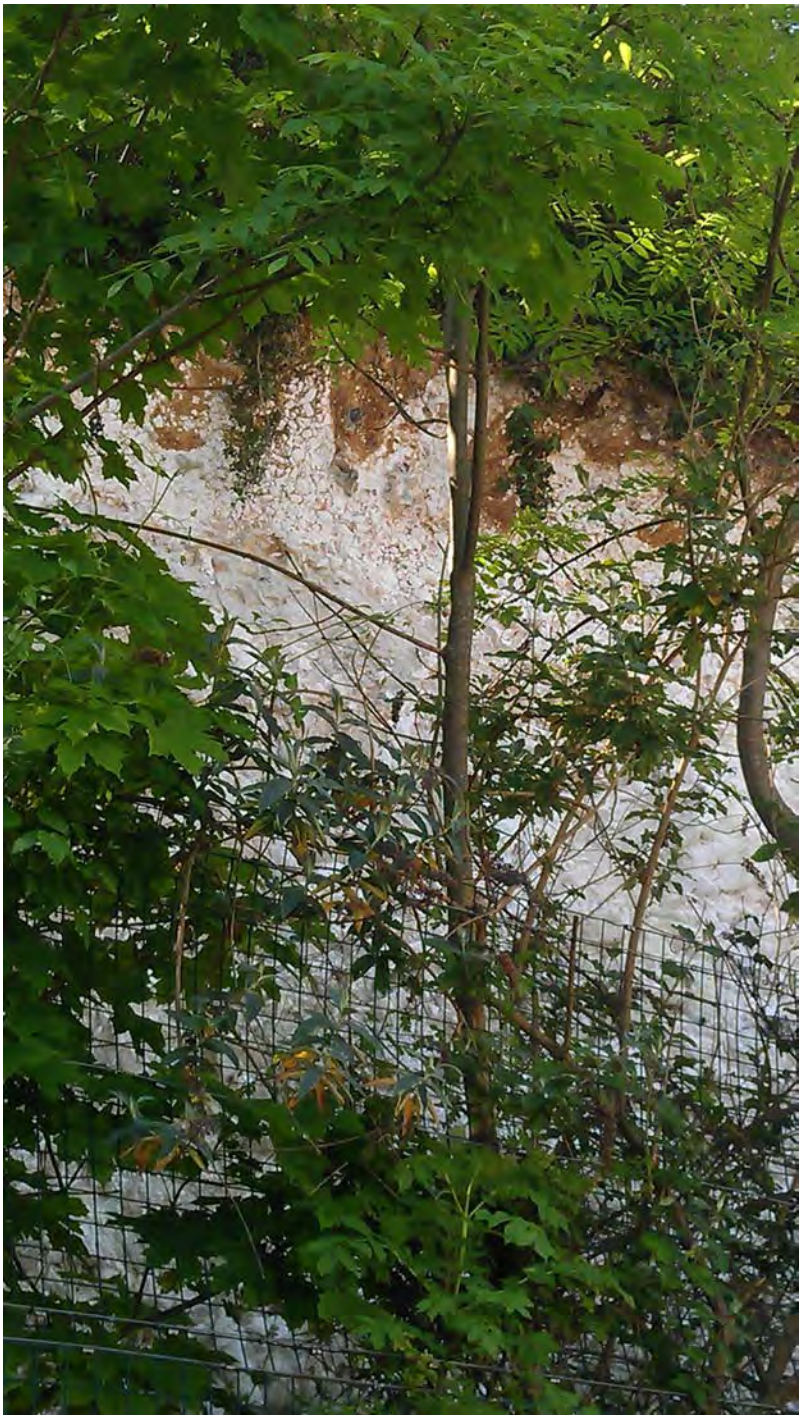
Plate 28 Upper portion of the southern boundary exposure shows typical bedrock weathering profile with decalcified/solution weathering at junction with overlying soil profile

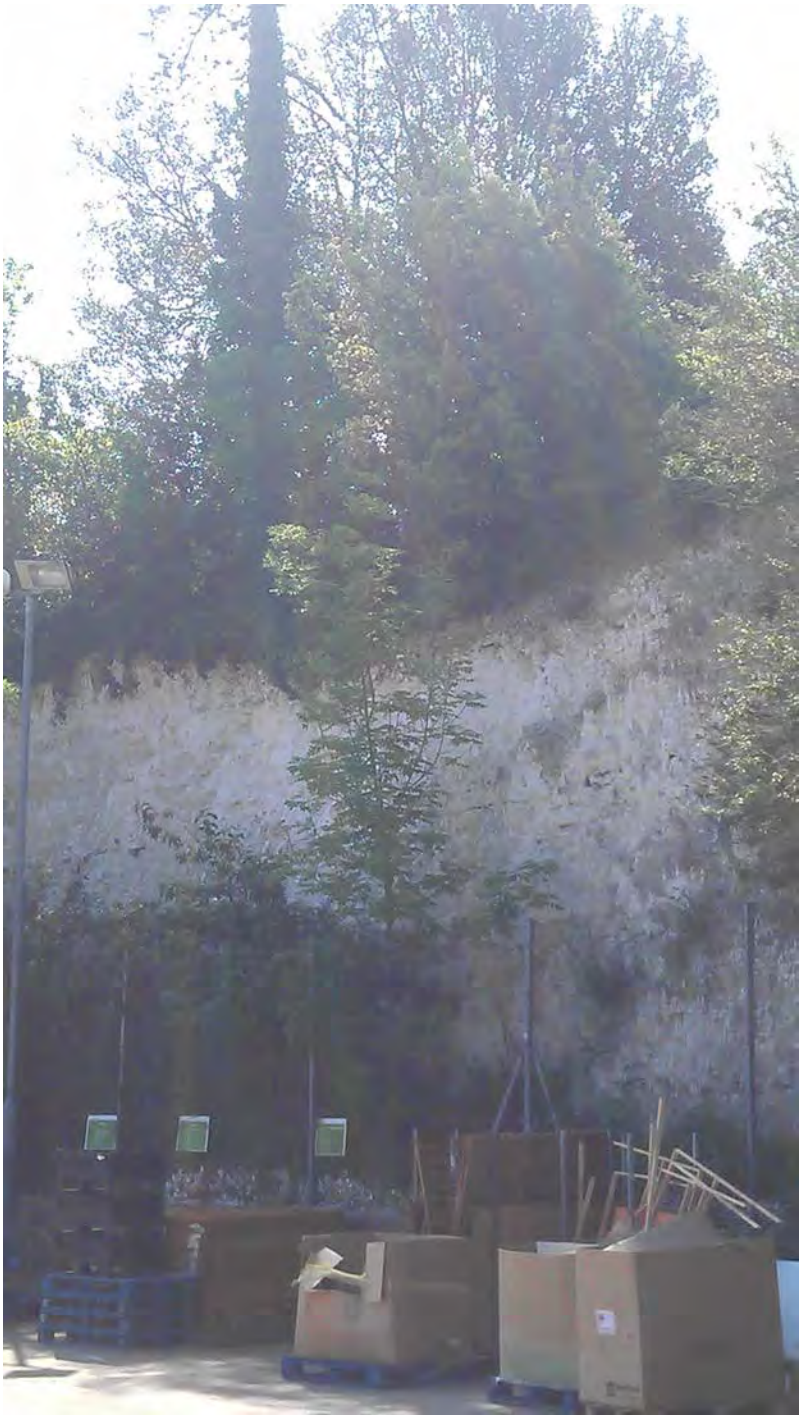
Plate 29 Near vertical chalk exposure in the SW corner of the site. The catch fence here was situated on top of a shallow block work retaining wall
