RILEY LARKIN Limited

LEVEL MONITORING - DISTORTION SURVEY READINGS

LEVEL MONITORING - DISTORTION MOVEMENT SKETCH

MONITORING DATA FROM : -
22 OAKMOUNT DRIVE
WATERLOOVILLE
HAMPSHIRE
PO8 8TH
CLIENT : - MRS K POURALLI
DATE : - 09/Mar/2011
JOB NO.:- 100336

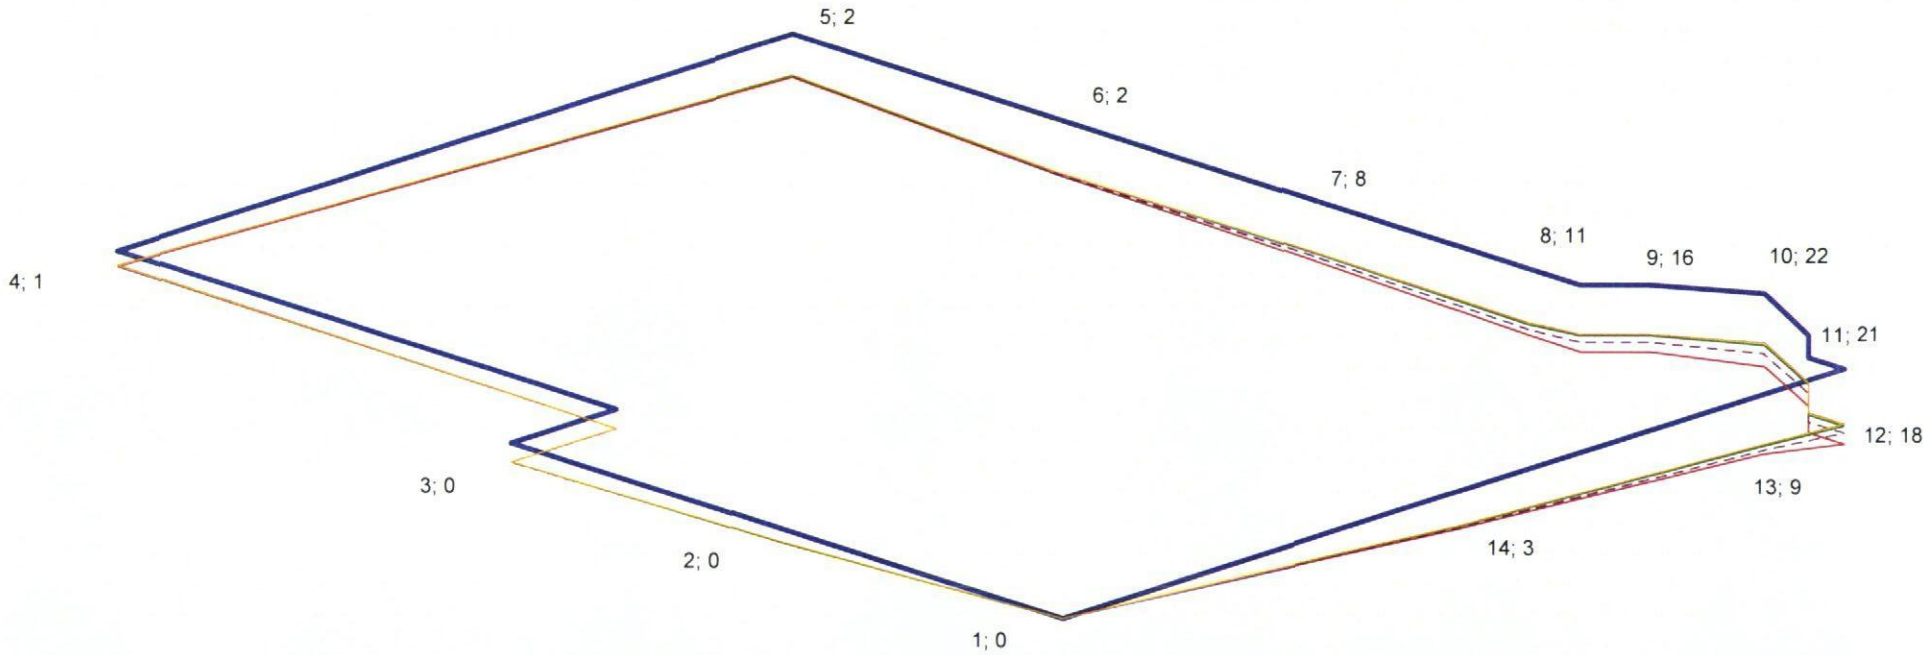
- 09/02/2011 The Occupier was not unduly worried
- All stations have been installed within the same brick course. There fore initial readings can be interpreted as Distortion Data
- Further readings to be taken in Apr '11

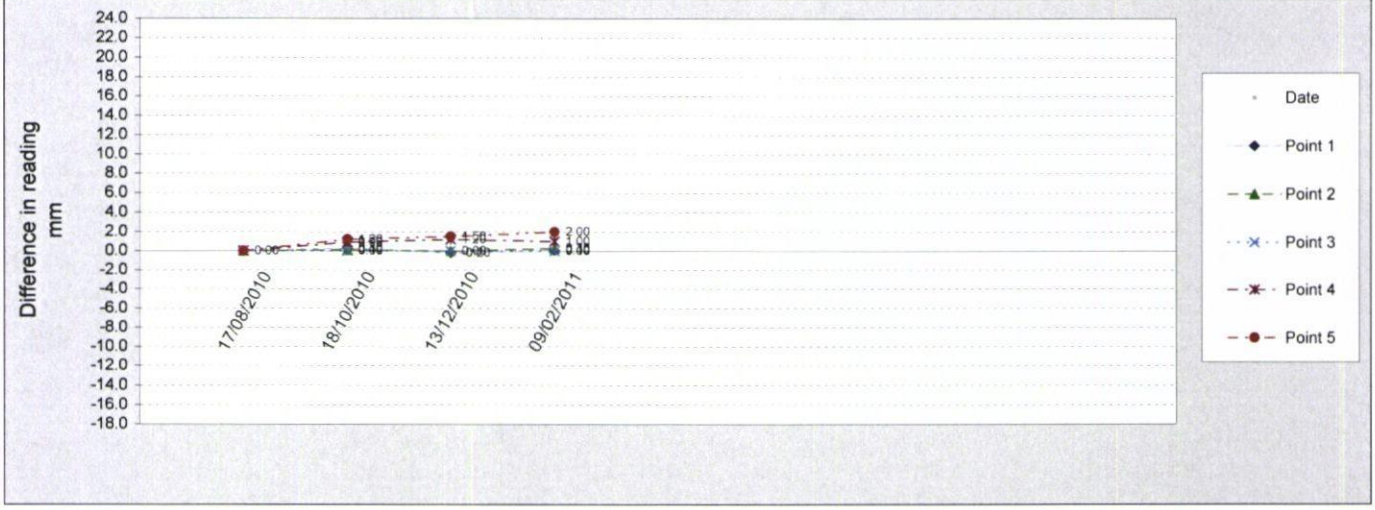
Notes:
Vertical distorted scale 1: 20

Point labels give level difference of last reading from original datum in mm.

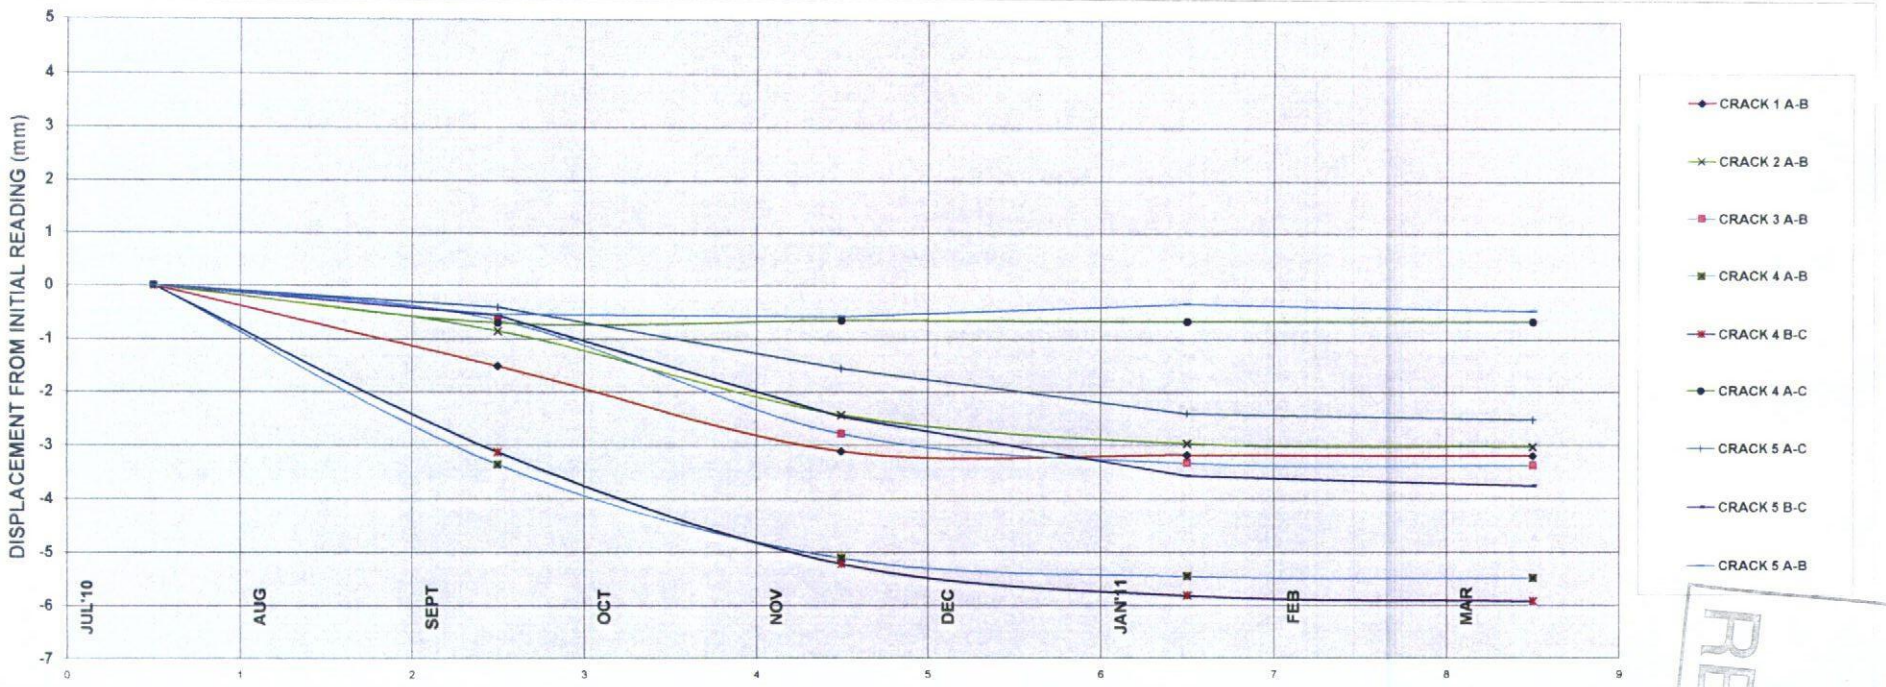
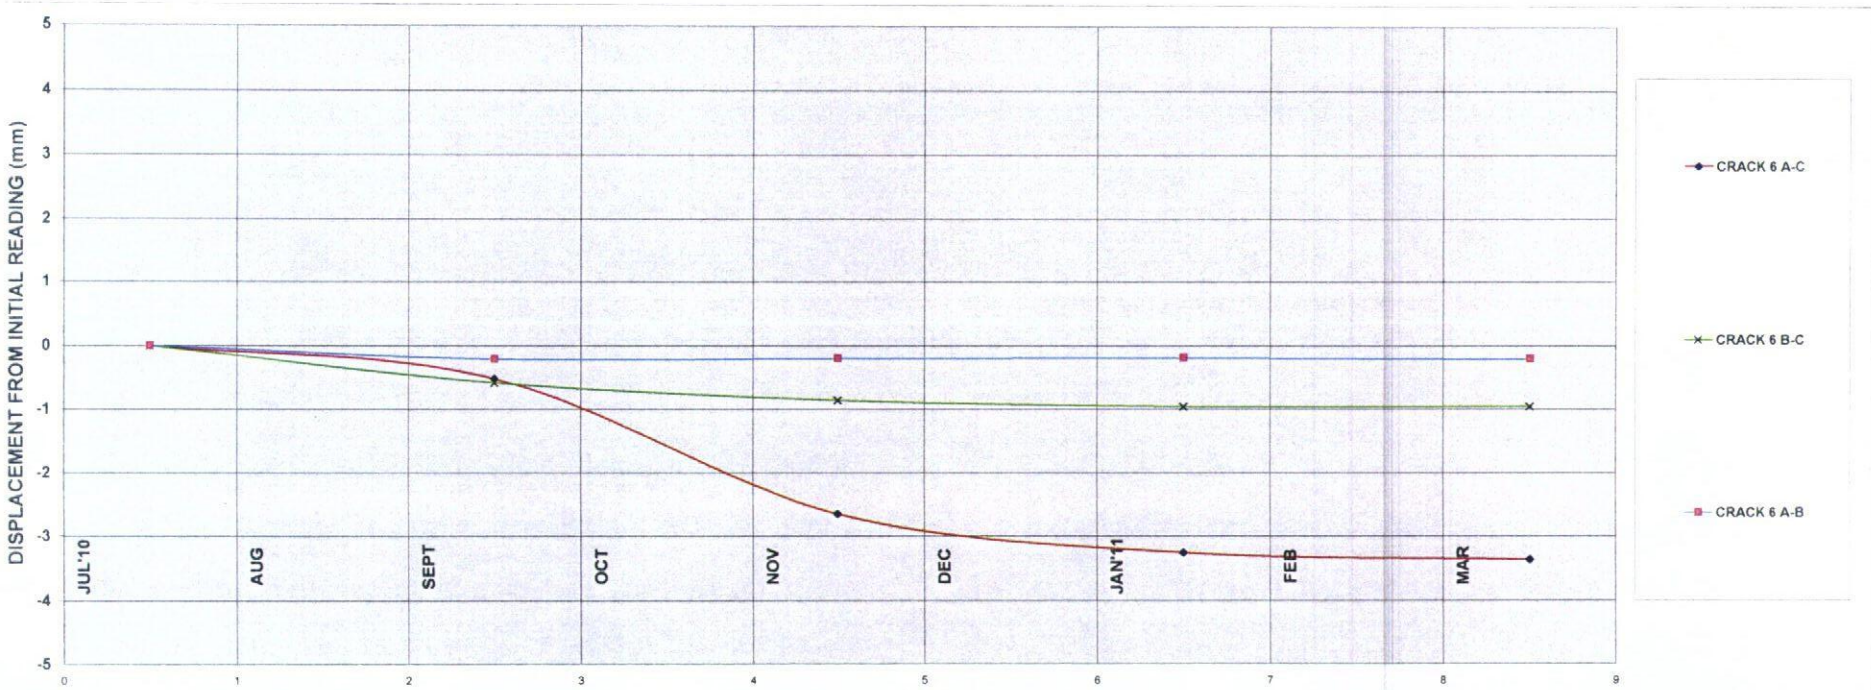
SHEET 1 OF 2

CRACK 1 / A-B	LOCATION : - SIDE OF REAR BAY - HIGH LEVEL	MAX-MIN (mm)=	3.21
CRACK 2 / A-B	LOCATION : - LHS OF REAR BAY - LOW LEVEL	MAX-MIN (mm)=	3.04
CRACK 3 / A-B	LOCATION : - REAR RH CORNER	MAX-MIN (mm)=	3.39
CRACK 4 / A-B	LOCATION : - REAR RH CORNER - LOW LEVEL - VERTICAL	MAX-MIN (mm)=	5.49
CRACK 4 / B-C	LOCATION : - HORIZONTAL	MAX-MIN (mm)=	5.93
CRACK 4 / A-C	LOCATION : - DIAGONAL	MAX-MIN (mm)=	0.7
CRACK 5 / A-C	LOCATION : - ABOVE WINDOW TO RH ELE - HORI	MAX-MIN (mm)=	2.53
CRACK 5 / B-C	LOCATION : - VERTICAL	MAX-MIN (mm)=	3.77
CRACK 5 / A-B	LOCATION : - DIAGONAL	MAX-MIN (mm)=	0.58
