HERITAGE STATEMENT IN CONNECTION WITH MODIFICATION AND REPAIRS TO THE EXISTING HOTEL 'STABLE BLOCK'

THE NEWTOWN HOUSE HOTEL, MANOR ROAD, HAYLING ISLAND, HAMPSHIRE PO11 0QR

15th March 2011

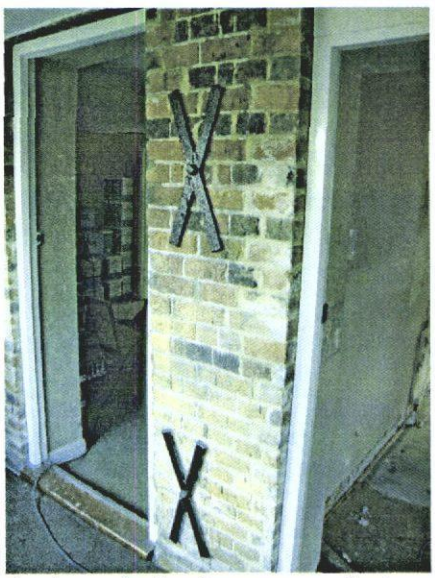
3.01 Restraint to existing walls due to distortion of structure and loss of integrity due to severing of existing wall restraints.

Steel restraint brackets appear to be decorative rather than functional

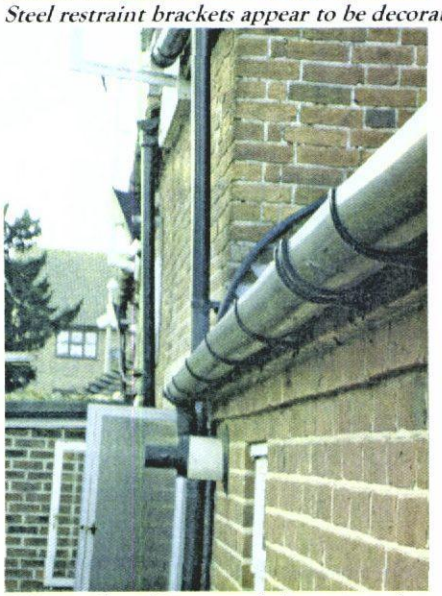
Thrust of roof has caused distortion of external wall and needs restraint

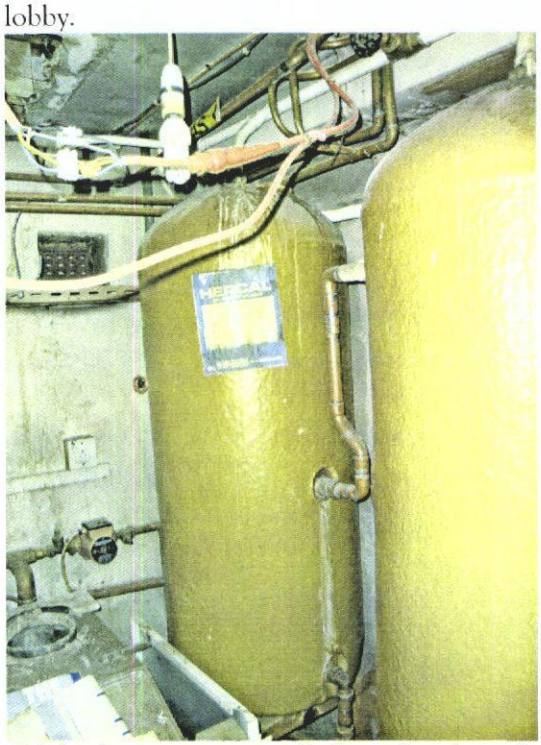
Existing hot water storage cylinders to be relocated within function suite.

3.04 Modification to layout of ground floor rooms to remove an existing boiler room and the creation of a disabled persons WC with a new access door from the adjoining lobby.

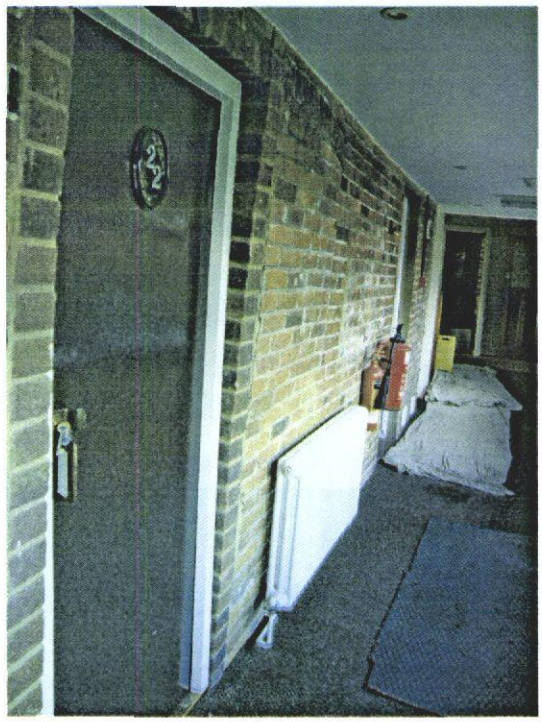
Pictures shows where inappropriate brickwork and bonding has been used to reduce openings The proposal is to reinstate original opening width. Photo also shows distortion of existing wall.

3.05 Enlargement of existing door openings to provide easier access for wheelchair users.

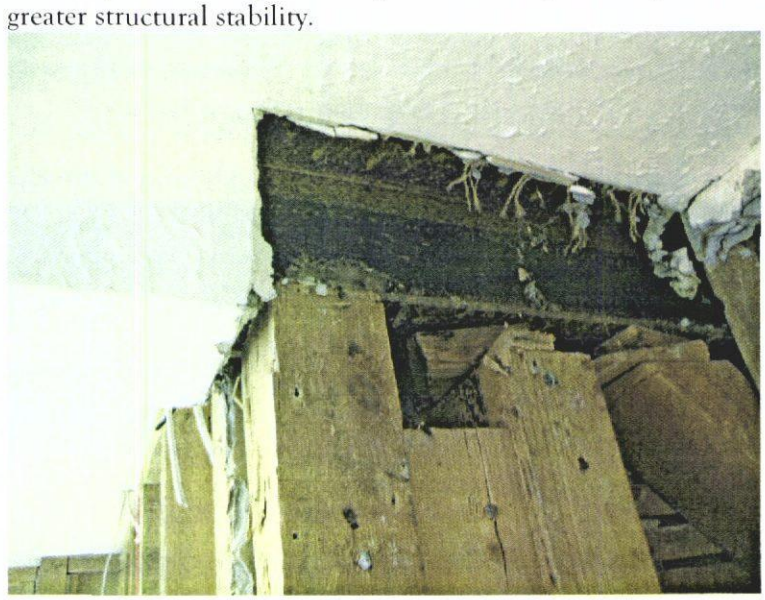
Existing RSJ is supported on first floor studwork that does not bear on a structural wall

3.06 Inspection and possible repair of existing steel RSJ over Room 223 to ensure greater structural stability.

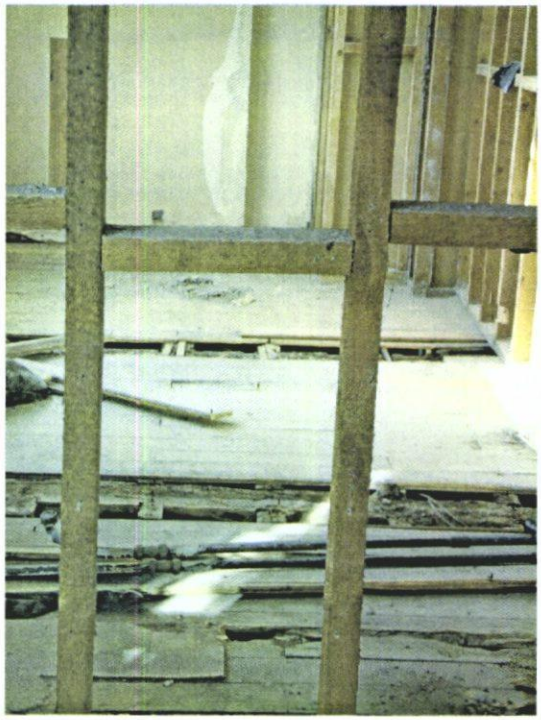
Existing studs after removal of plasterboard.

3.07 Modifications to room arrangement at first floor to create improved layout.

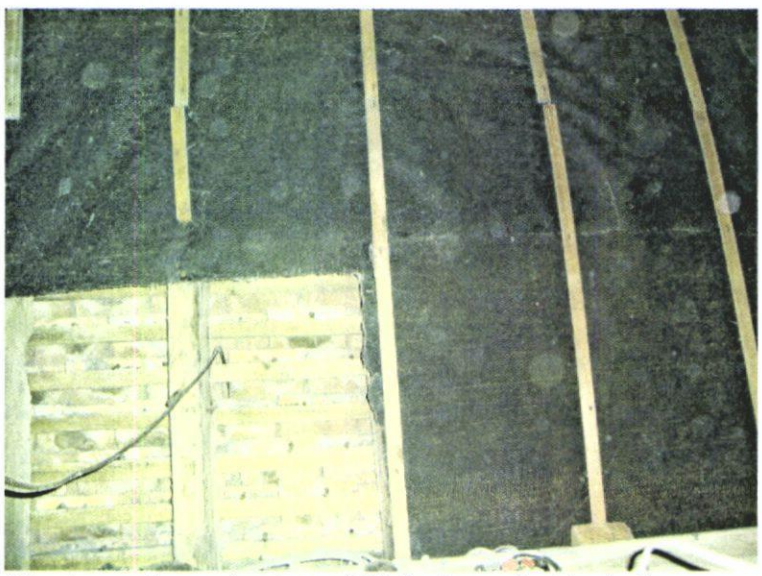
View into roof space showing roof felt fixed to underside of rafters

3.08 Repair to roof of building by removal of existing tiles, repairs to existing timber structure and replacement of damaged tiles on vapour permeable felt. Inspection has revealed that generally, the existing roof timbers are in a reasonable state of repair.

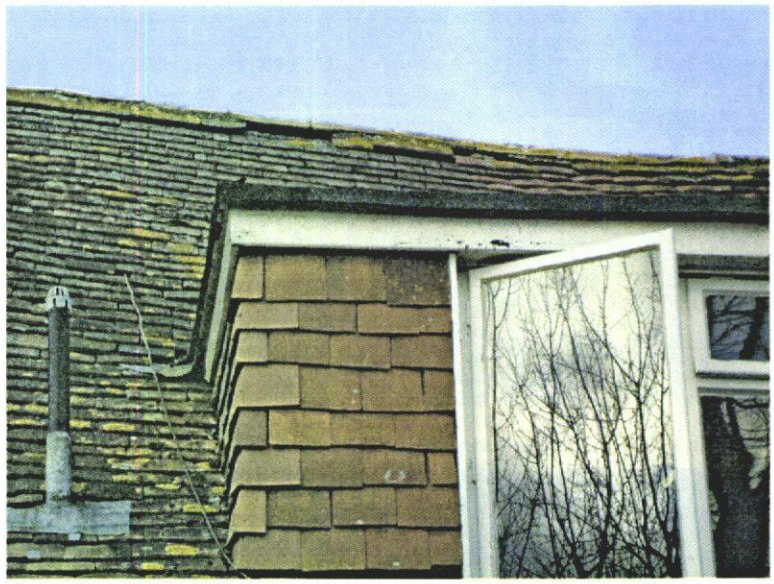
Roof showing lost tiles and distorted structure
