28 November 2022

Jack Porter  
Estates Coordinator  
SGN  
St Lawrence House  
Station Approach  
Horley, RH6 9HJ

EMSWORTH ABANDONED RESIDENTIAL PROPERTY: STRUCTURAL BUILDING ASSESSMENT

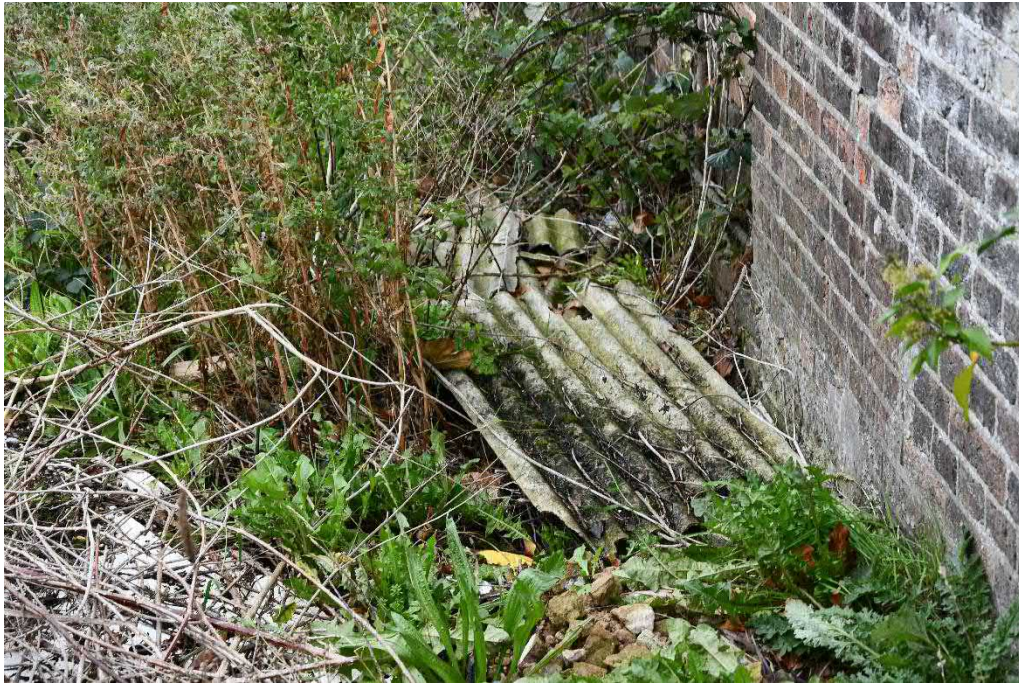
**PLATE 11:** Corrugated sheeting, possibly asbestos cement, on ground in front of western end of north elevation

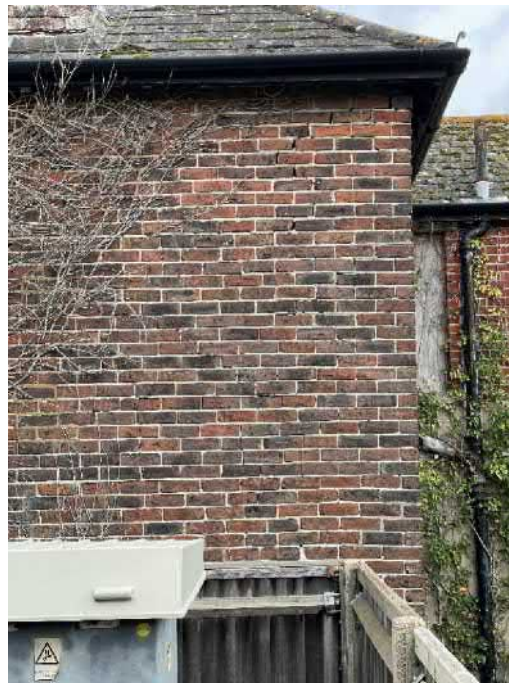
**PLATE 12:** Closer view of southern end of west elevation in (4) above

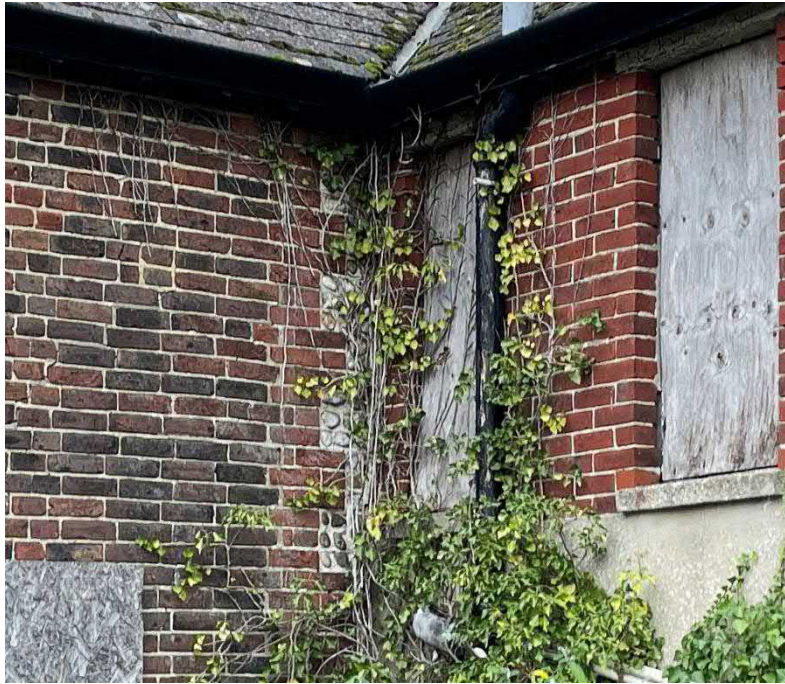
**PLATE 19:** Detailed view of corner return in (15) above – note change in colour of brickwork where rear extension inserted

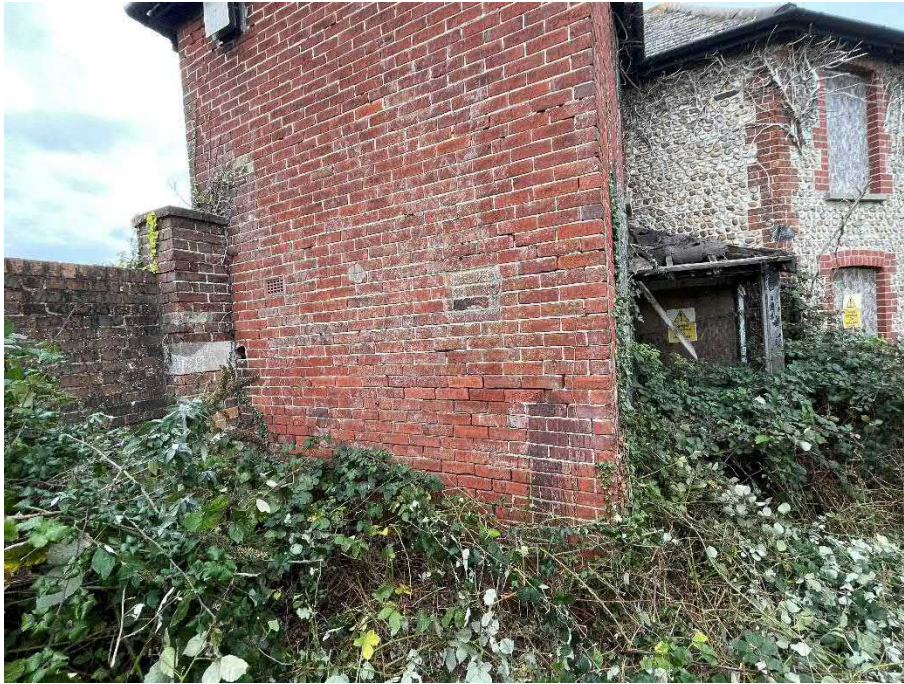
- 4.1.10. Loss of pointing at low level with stepped diagonal cracking above to south-east corner of rear “extension” (Plates 23-26).
- 4.1.11. Cracking and distortion of eastern wall to rear “extension” between window reveal and south-east corner (Plates 27 and 29).

**PLATE 23:** More detailed view of eastern corner of south elevation of rear “extension”

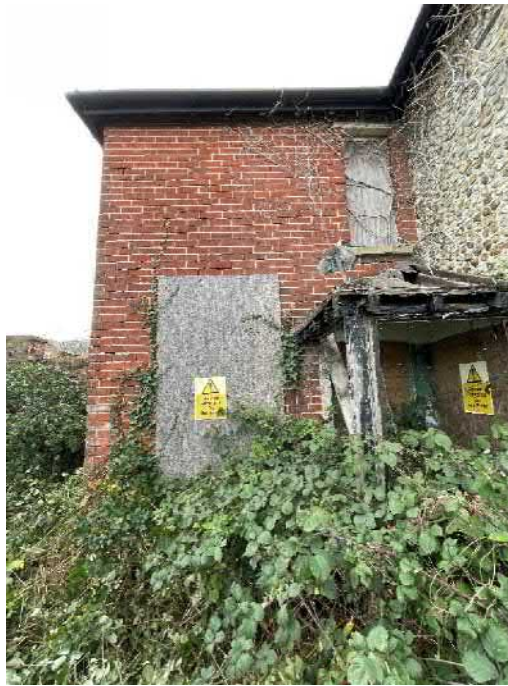
PLATE 27: Eastern elevation of rear "extension"

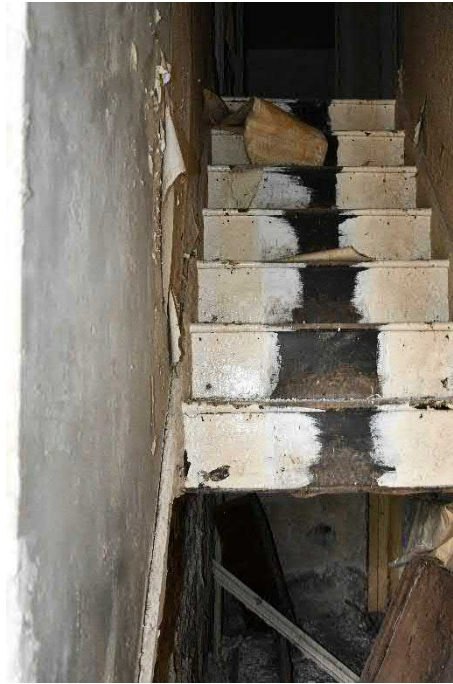
**PLATE 39:** Lower part of staircase removed preventing access to first floor

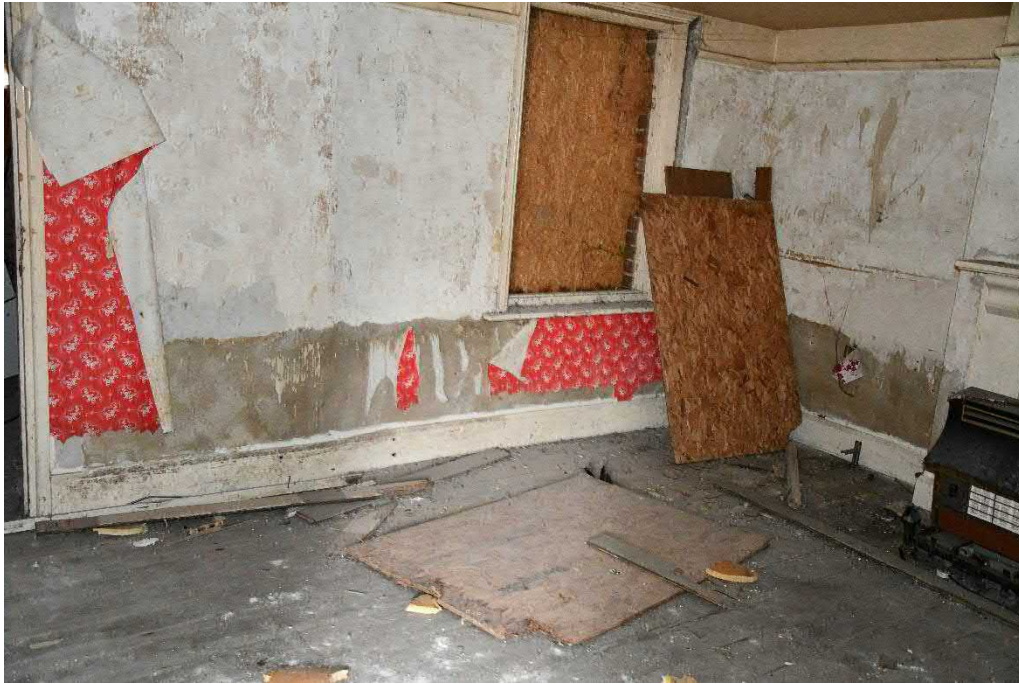
- 4.2.1. Extensive damage/theft/vandalism was noted within property (Plates 40, 41 and 44).
- 4.2.2. Two parallel full height vertical cracks to the eastern wall of the main house at ground floor level (Plate 43).
- 4.2.3. Evidence of water damage to walls generally to ground floor (Plates 42 and 43).
- 4.2.4. Diagonal cracking to the east side of the western ground floor window reveal to the rear wall of the main house in (Plates 45 and 46).

PLATE 45: View on south-west corner of house at ground floor level

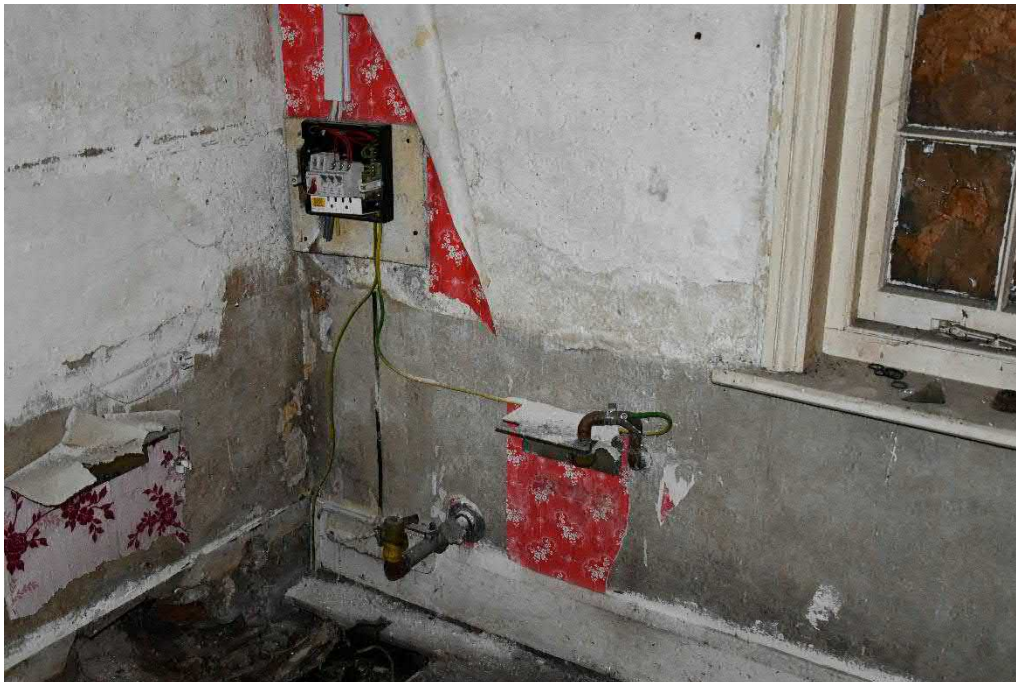
PLATE 48: Close-up on (47) above – gas and electricity meters removed

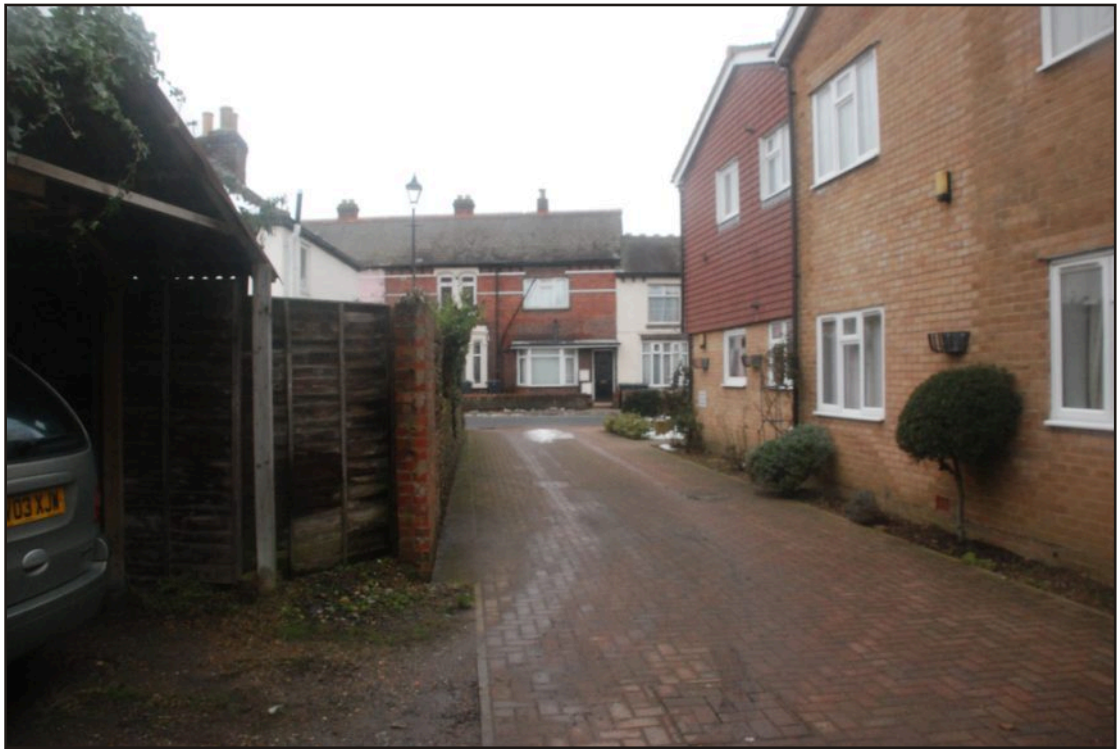
**Plate 20.** Seagull Court with private driveway to right of view.
