# Hutton + Rostron Environmental Investigations Limited

## Southleigh Park House: Joinery condition investigation

Site note A3 for 26 January 2021, job no. 152.09

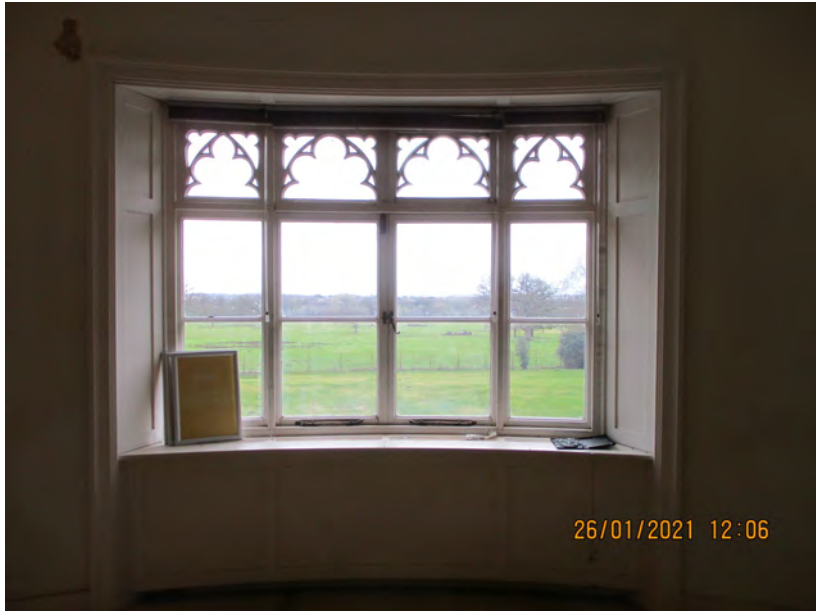
**Fig 1:**

First floor, F.12 Main Office; showing window wf.03 panelling constructed using MDF with only localised cosmetic damage

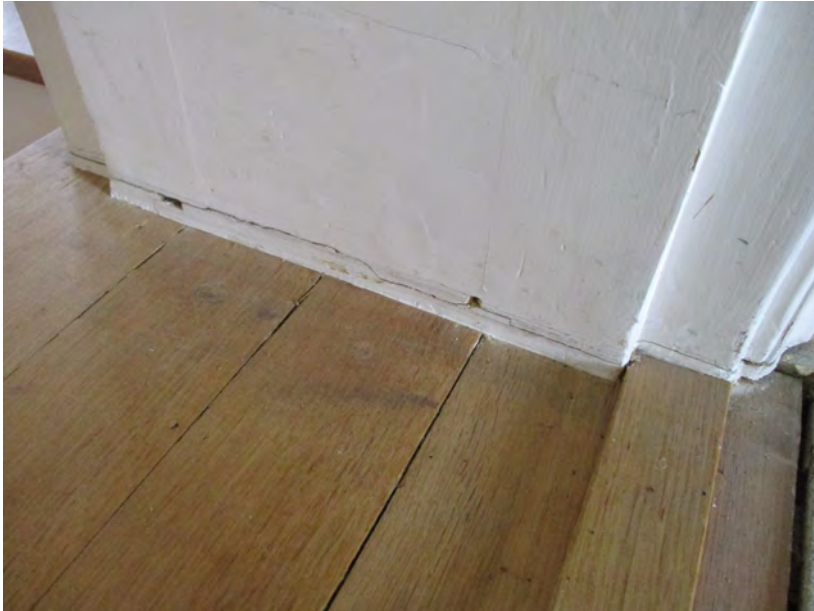
**Fig 3:**

First floor, F.12 Main Office; showing df.19 with MDF wedge suggesting previously altered floor levels

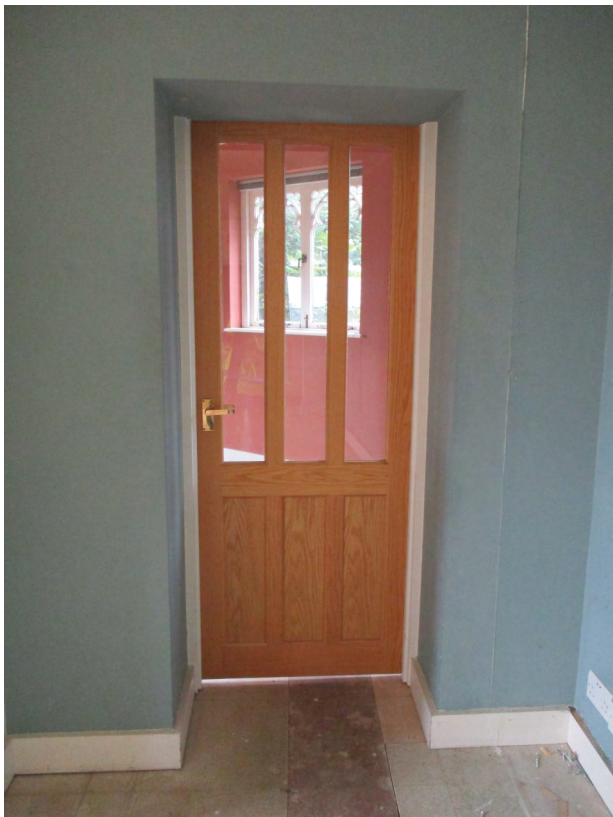
**Fig 10:**

First floor, F.13 Office; showing modern door

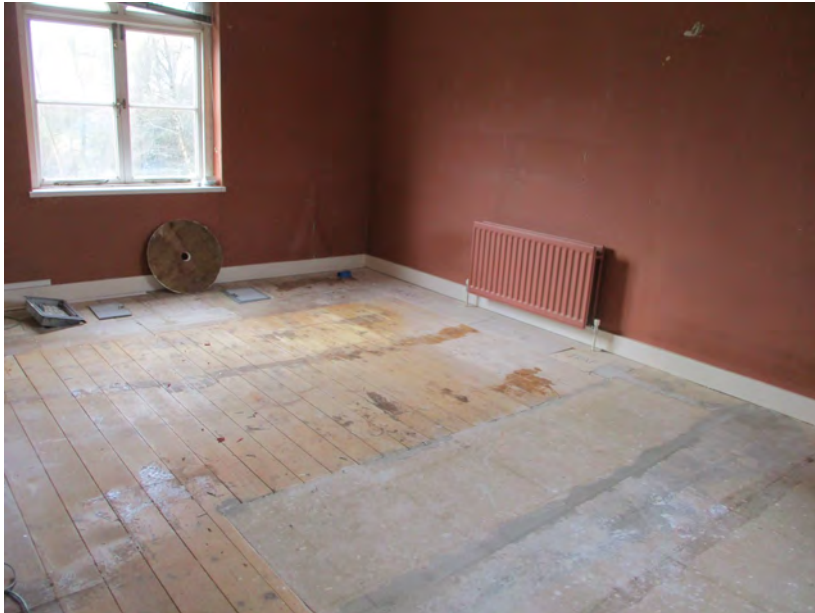
**Fig 11:**

First floor, F.13 Office; showing softwood timber skirting with very localised cosmetic damage

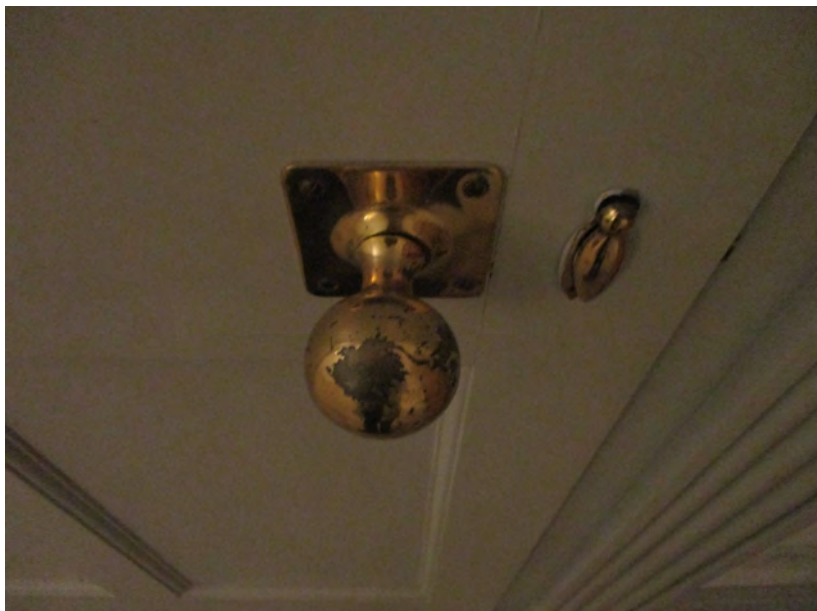
**Fig 13:**

First floor, F.14 R & D Office; showing  
df.05 general damage to door furniture

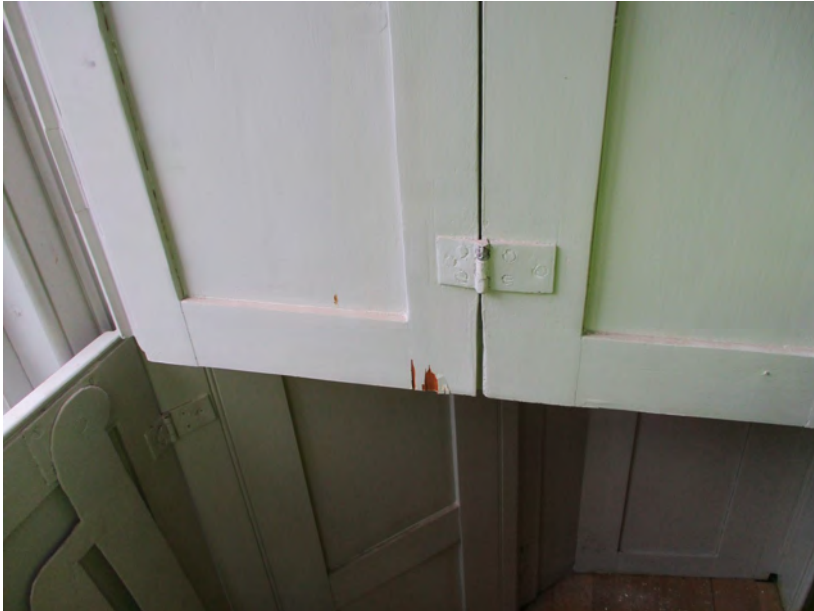
**Fig 19:**

First floor, F.14 R & D Office; showing df.06 with damage to timber surface

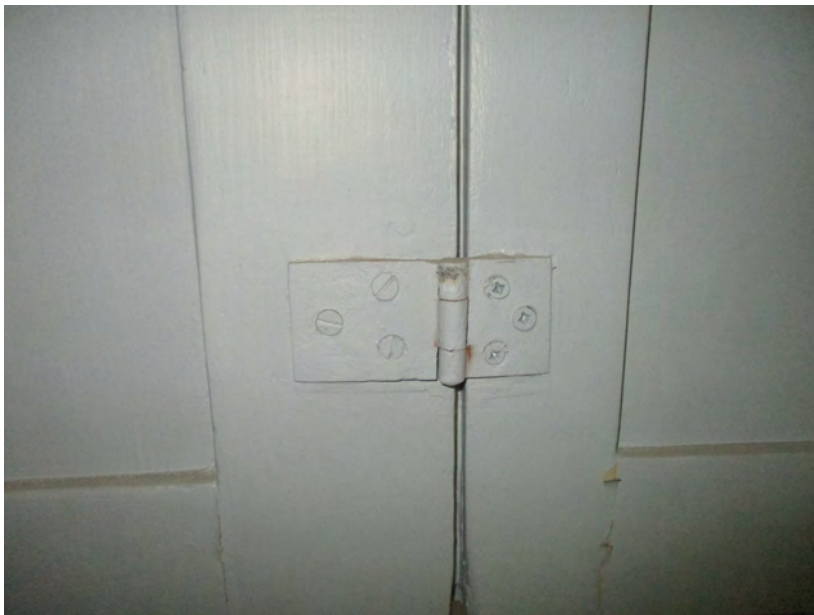
**Fig 20:**

First floor, F.14 R & D Office; showing df.06 hinges with both historic and modern screws

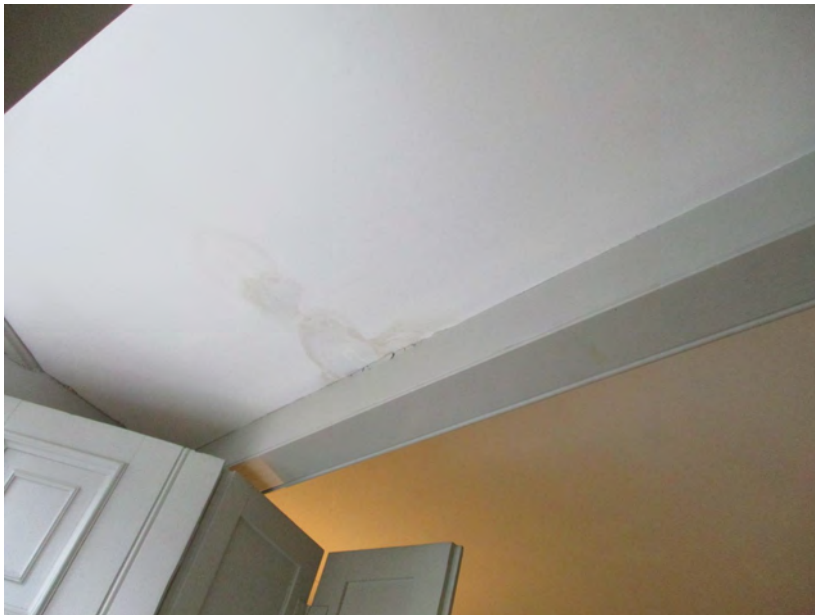
**Fig 22:**

First floor, F.14 R & D Office; showing ceiling above df.06 further investigation may be necessary

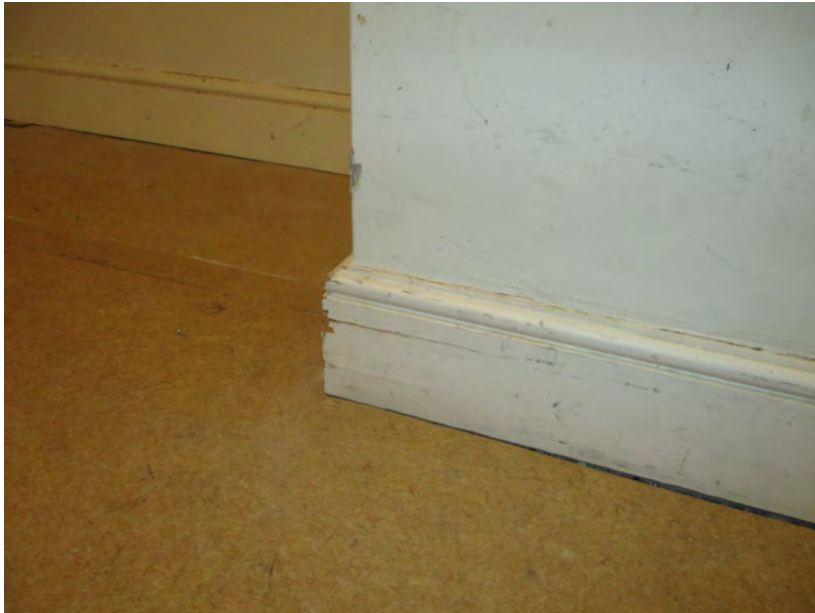
**Fig 27:**

First floor, F.05 R & D Lab 1; showing softwood timber skirtings with generally localised cosmetic damage to corners

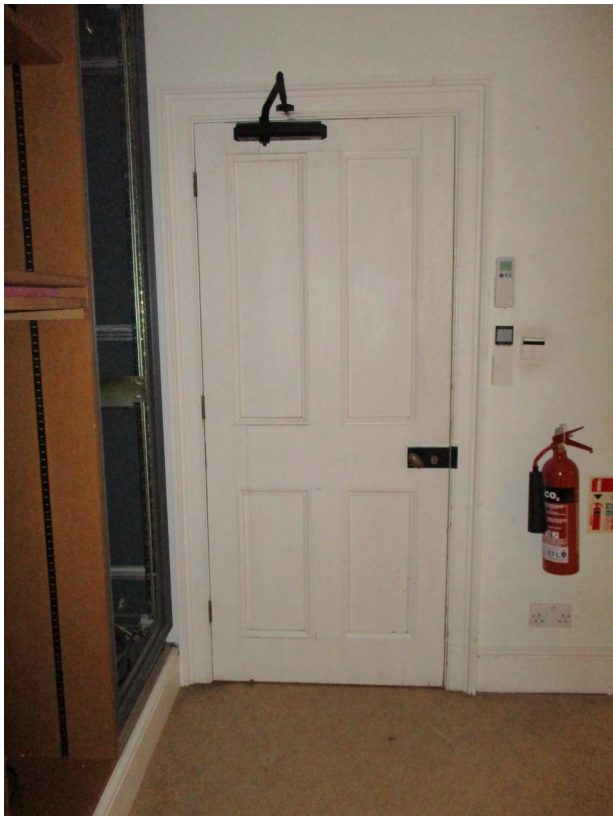
**Fig 28:**

First floor, F.07 R & D Lab 2; showing df.11 softwood timber with generally localised cosmetic damage

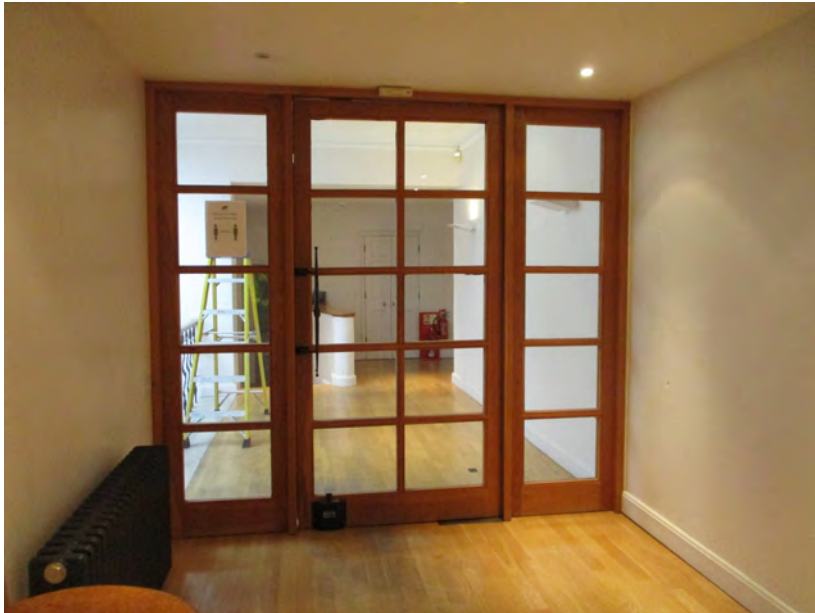
**Fig 31:**

First floor, F.09 Landing; showing df.13 modern timber glazed double doors with very localised cosmetic damage

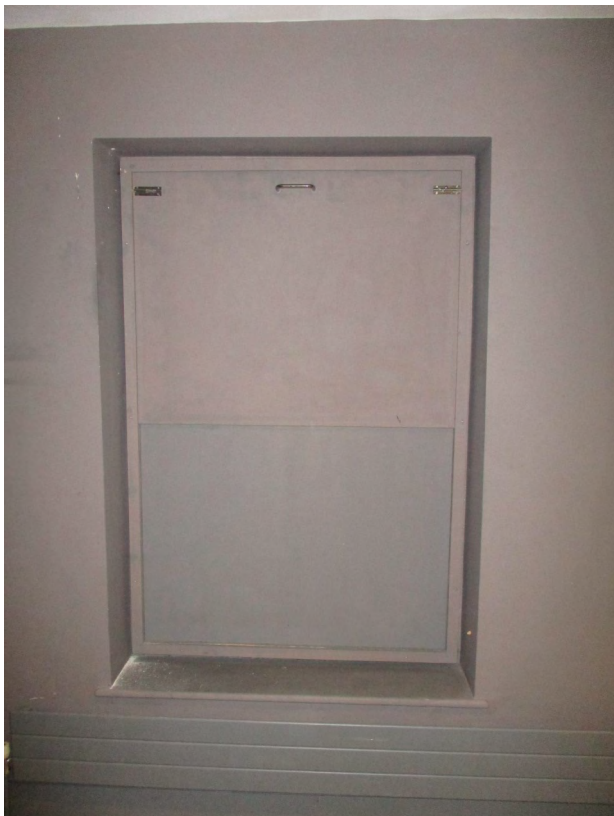
**Fig 34:**

First floor, F.10 Office; showing wf.35 MDF sheets in softwood timber frame with generally localised cosmetic damage, however, the left bolt lock was missing

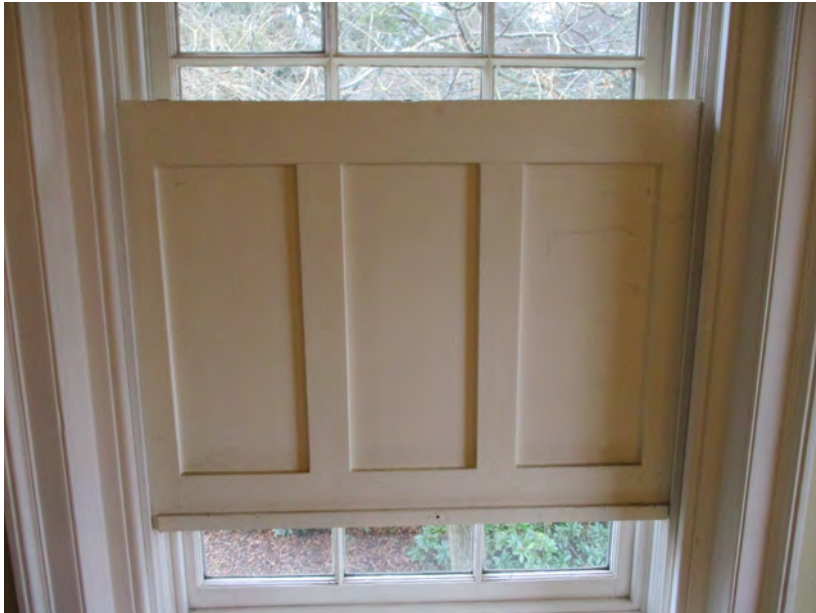
**Fig 39:**

First floor, F.11 Office; showing wf.37 softwood timber panelled shutters with generally localised cosmetic damage

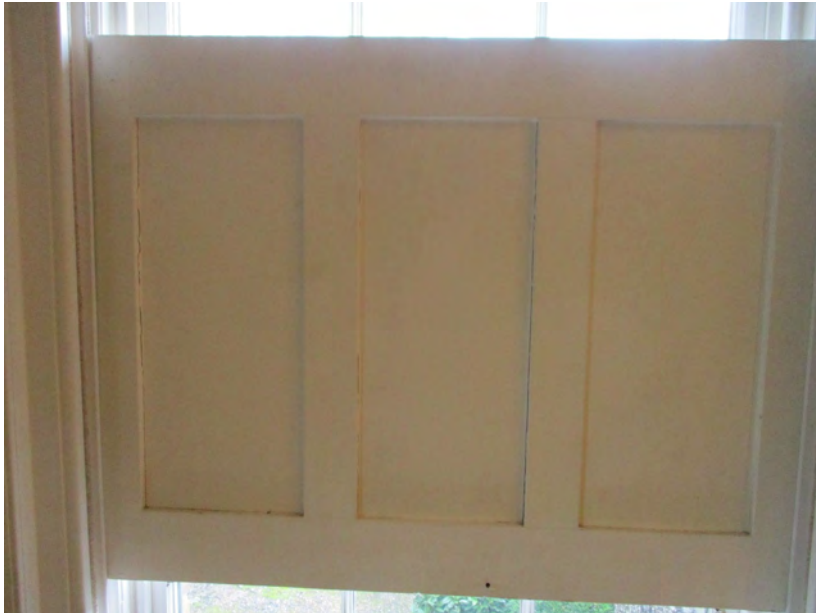
**Fig 41:**

First floor, F.11 Office; showing wf.38 softwood timber panelled shutters with generally localised cosmetic damage

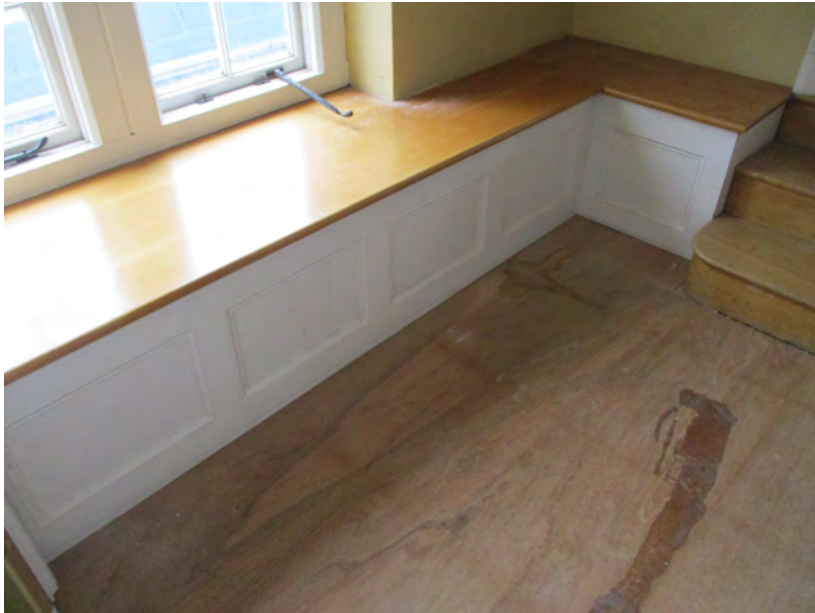
**Fig 43:**

First floor, F.11 Office; showing MDF and softwood timber frame panelled window box with generally localised cosmetic damage

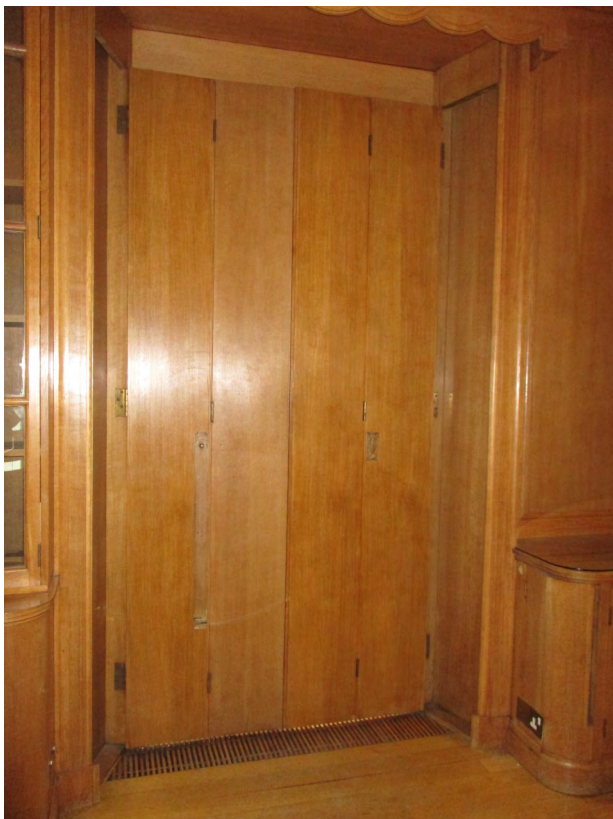
**Fig 48:**

Ground floor, G.13 Library; showing wg.01 oak veneered shutters and architrave. There were scratches to the internal face of the veneer surface from the shutter bar and corresponding damage to the shutter bar

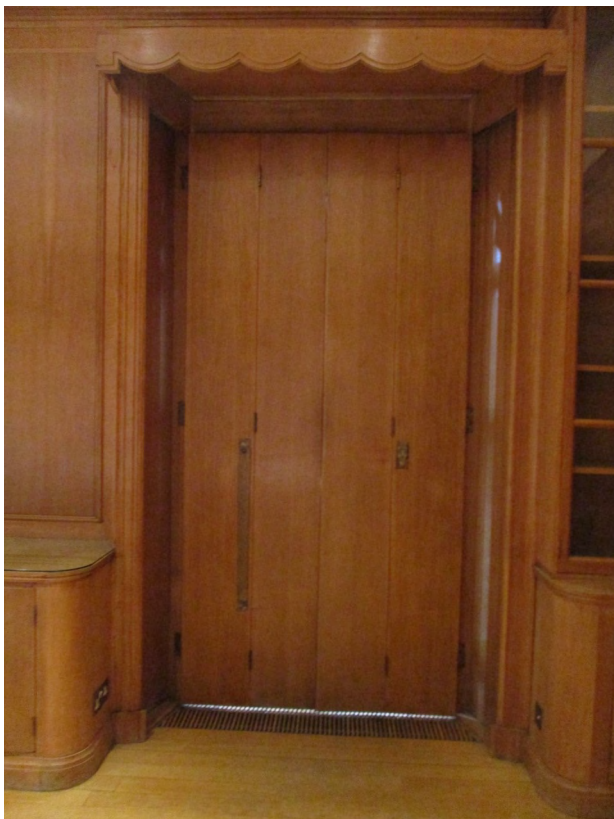
**Fig 50:**

Ground floor, G.13 Library; showing wg.02 oak veneered shutters and architrave. There were scratches to the internal face of the veneer surface from the shutter bar and corresponding damage to the shutter bar

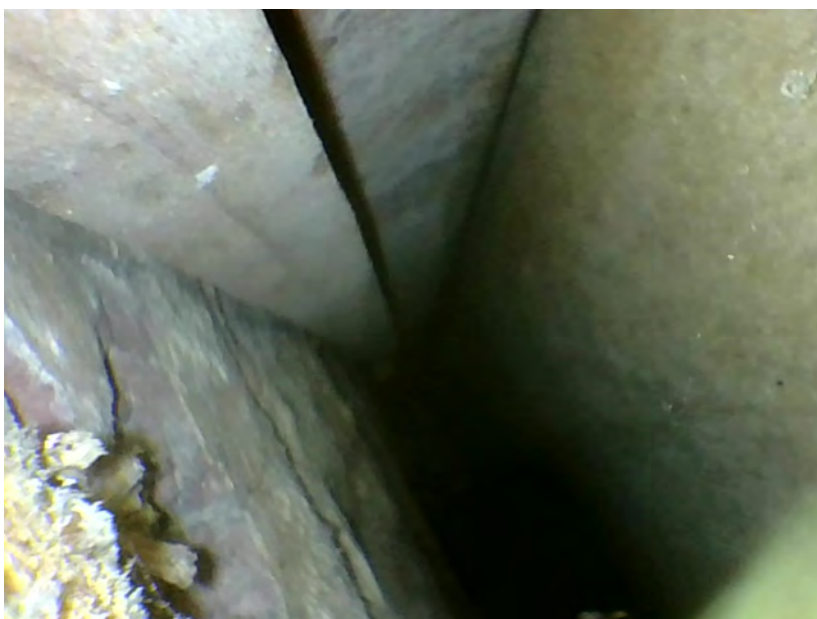
**Fig 52:**

Ground floor, G.13 Library; showing videoscope behind panelling showing structure supported by battens attached to the masonry

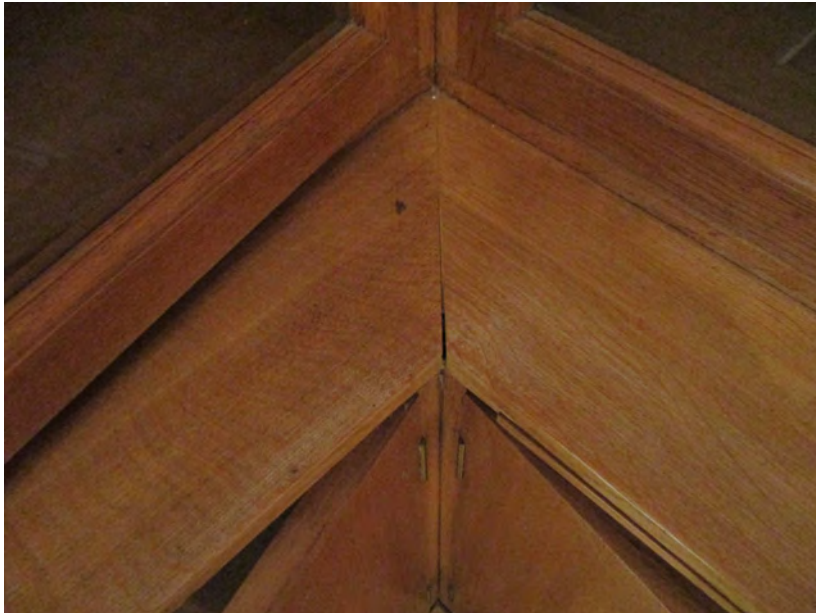
**Fig 53:**

Ground floor, G.13 Library; showing opening up of south-west corner joint of sill to built in cabinets

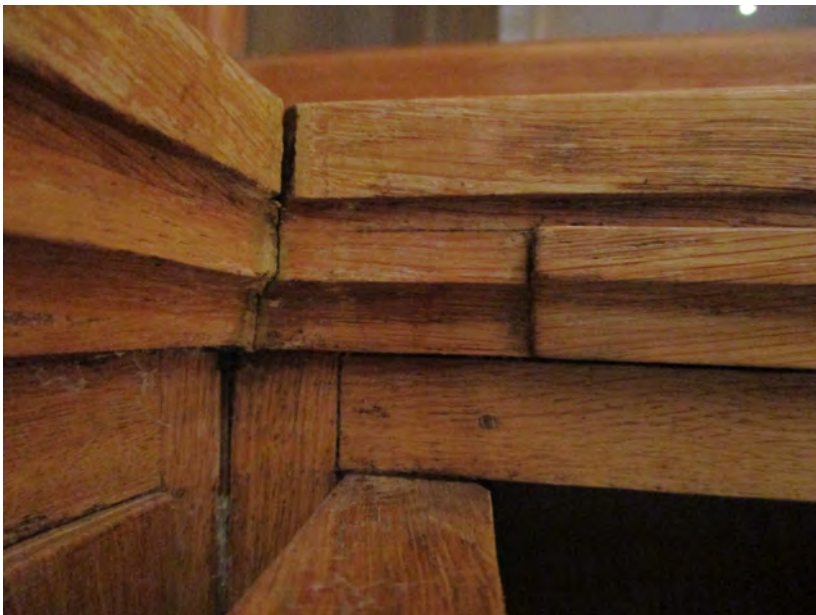
**Fig 54:**

Ground floor, G.13 Library; showing opening up of south-west corner joint of sill to built in cabinets from different view

Note evidence of previous repairs using wax and wood filler

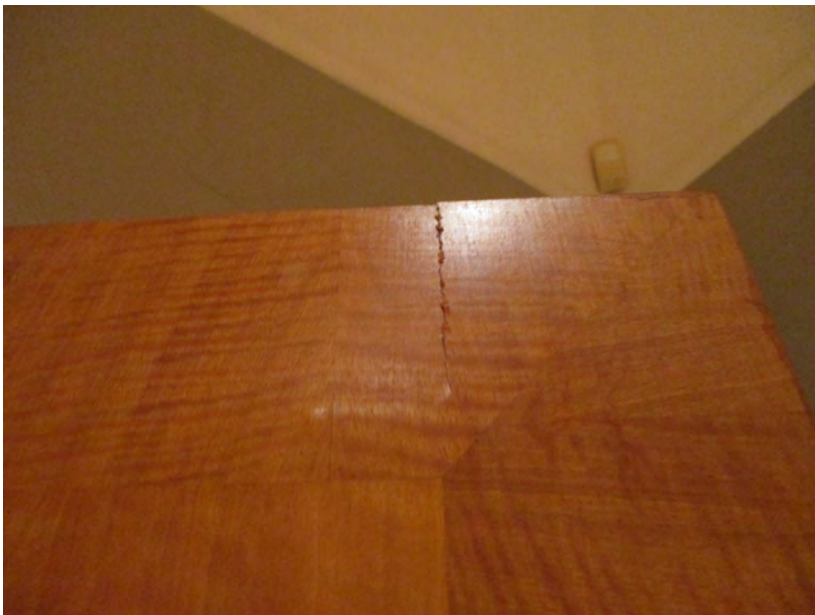
**Fig 56:**

Ground floor, G.14 Electronic Boardroom; showing dg.03 split in oak veneer

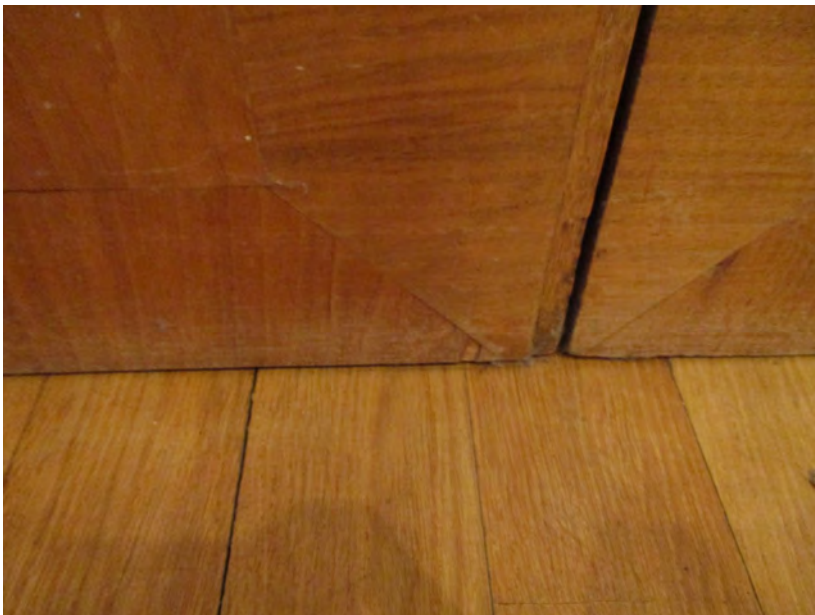
**Fig 58:**

Ground floor, G.14 Electronic Boardroom; showing east folding doors with localised missing veneer

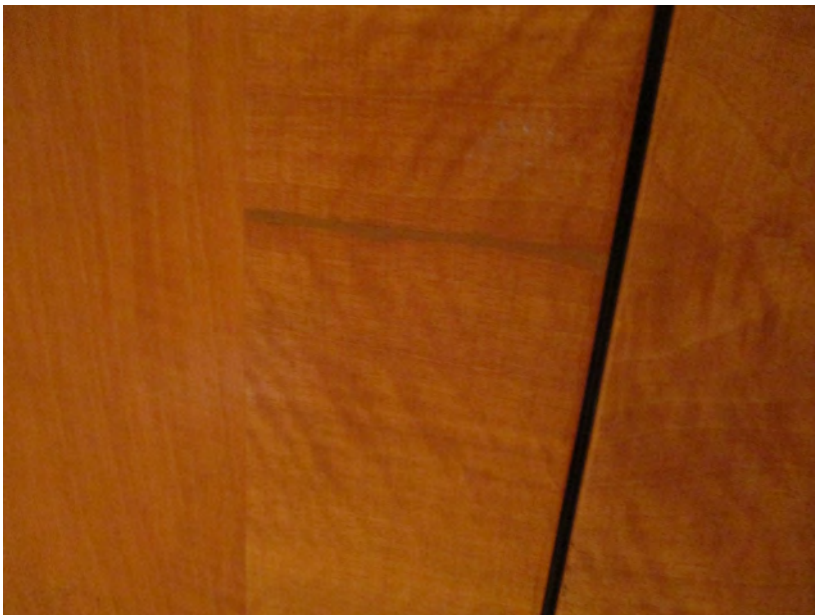
**Fig 60:**

Ground floor, G.14 Electronic Boardroom; showing west folding doors with poor previous repair/touch-up

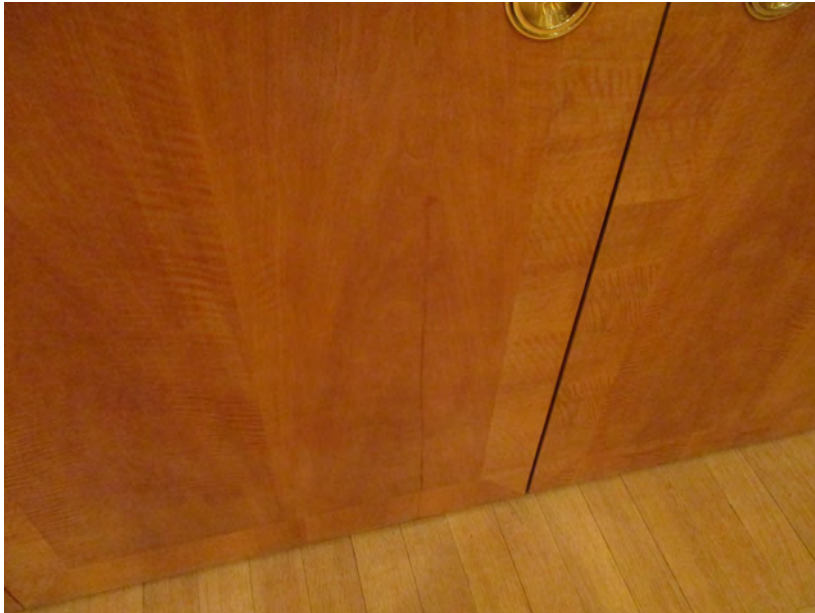
**Fig 61:**

Ground floor, G.14 Electronic Boardroom; showing west folding doors with staining to surface

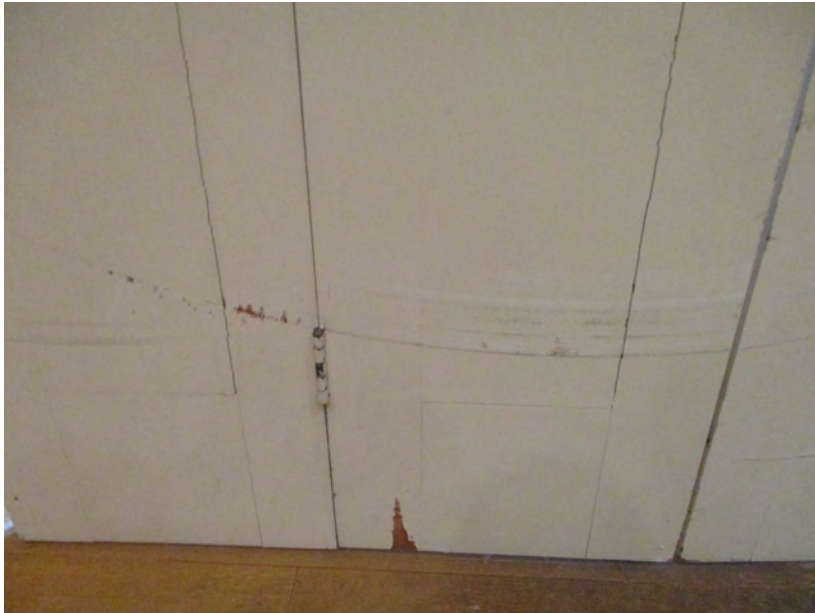
**Fig 63:**

Ground floor, G.14 Electronic Boardroom; showing wg.03 with damage to paintwork and localised damage towards base

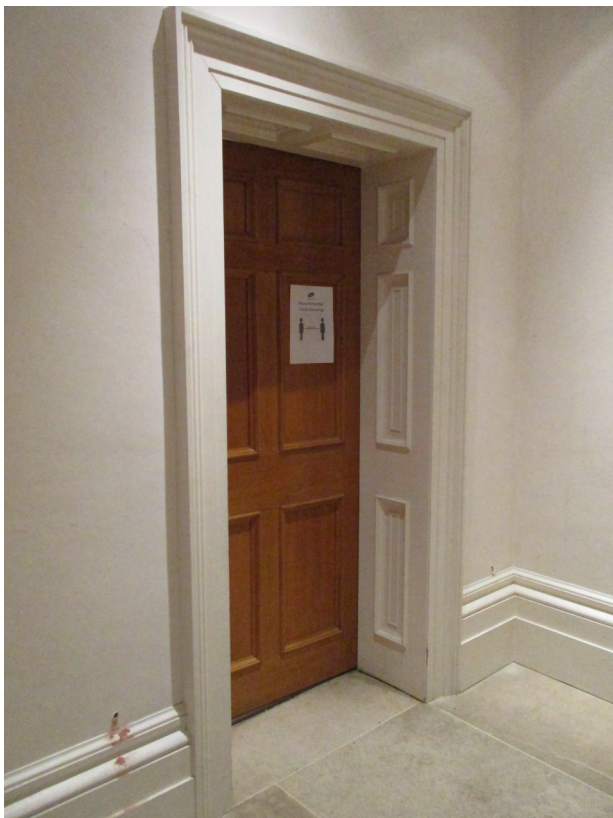
**Fig 64:**

Ground floor, G.14a Executive Office; showing dg.04 softwood timber architrave and deep panelled reveal with oak veneered door. Localised cosmetic damage to paintwork and opening up of panelling joints of oak door

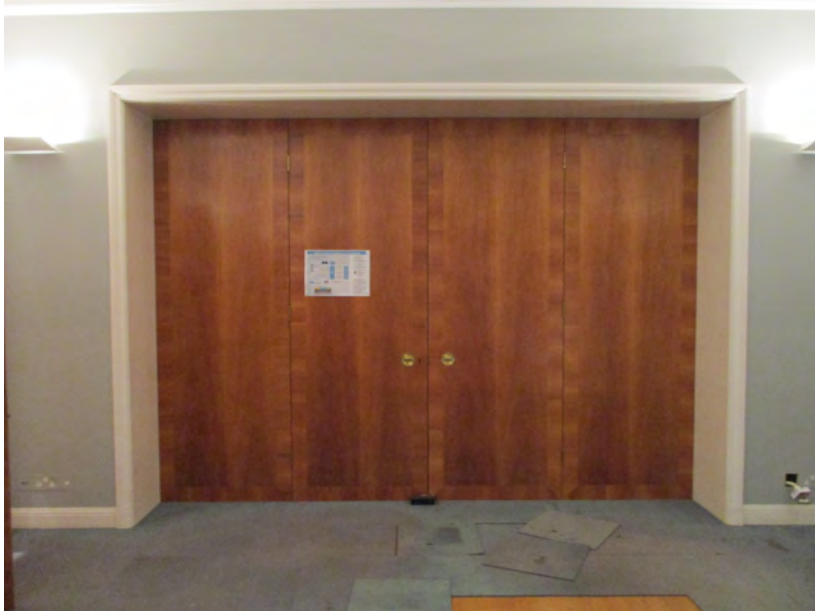
**Fig 65:**

Ground floor, G.14a Executive Office;  
showing general view of east folding  
doors with general wear

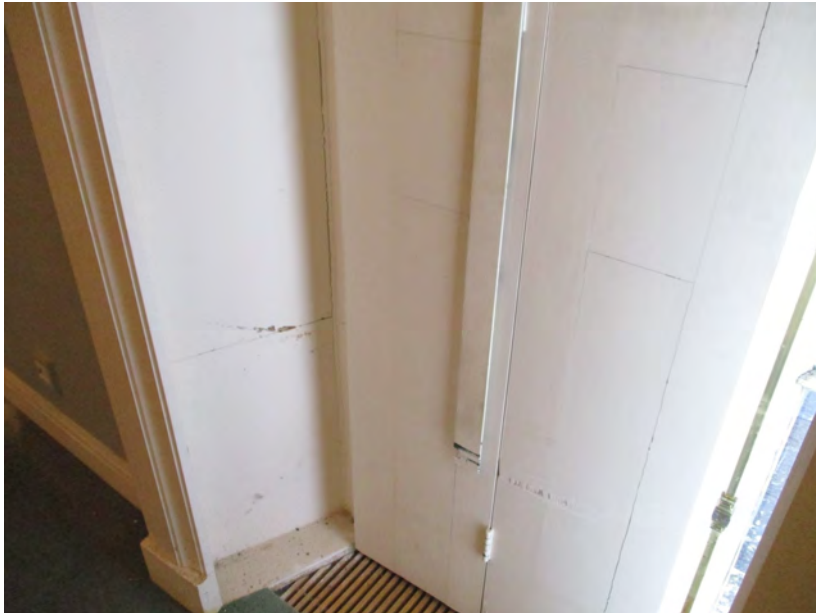
**Fig 67:**

Ground floor, G.14a Executive Office;  
showing wg.04 with damage to  
paintwork due to shutter bar and  
localised damage towards base

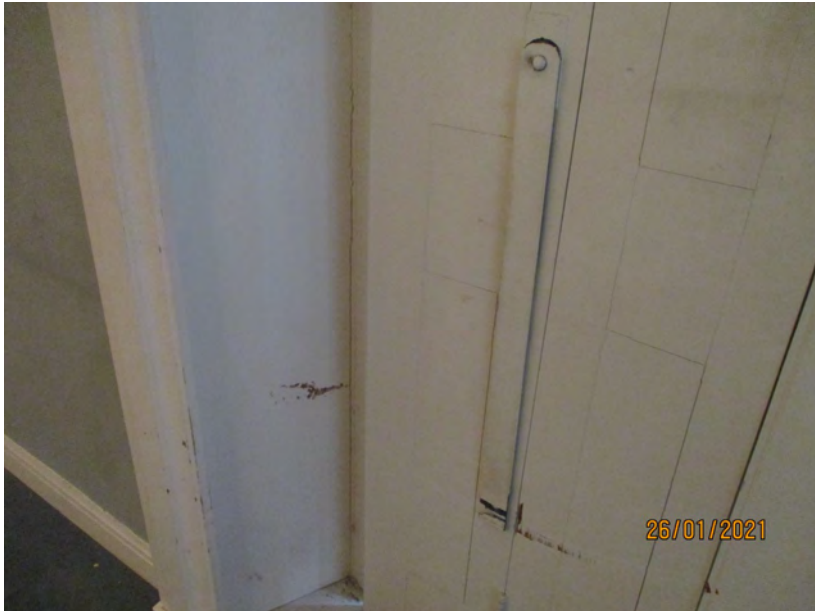
**Fig 69:**

Ground floor, G.14a Executive Office;  
showing wg.05 with damage to  
paintwork due to shutter bar and  
localised damage towards base

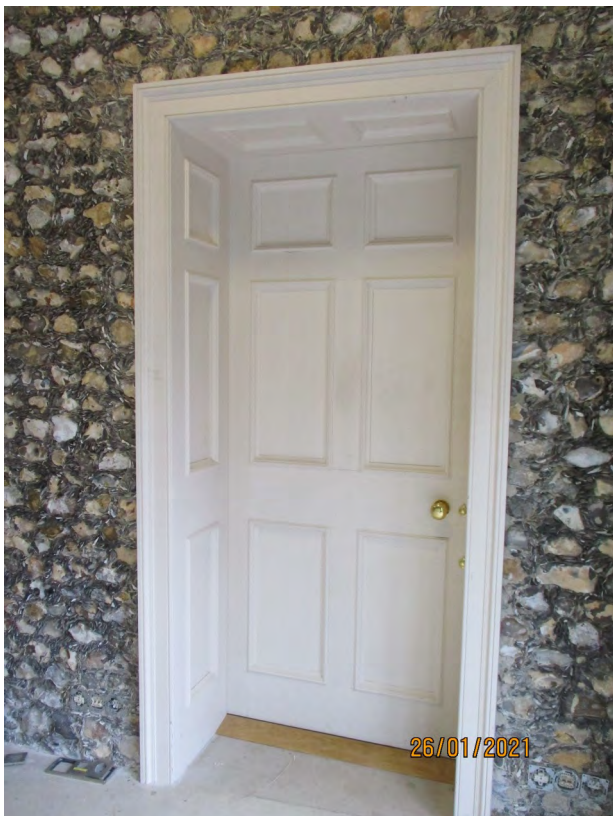
**Fig 70:**

Ground floor, G.15 Meeting Room;  
showing dg.05 softwood timber  
architrave and deep panelled reveal  
with painted timber door. Localised  
cosmetic damage to paintwork and  
opening up of panelling joints

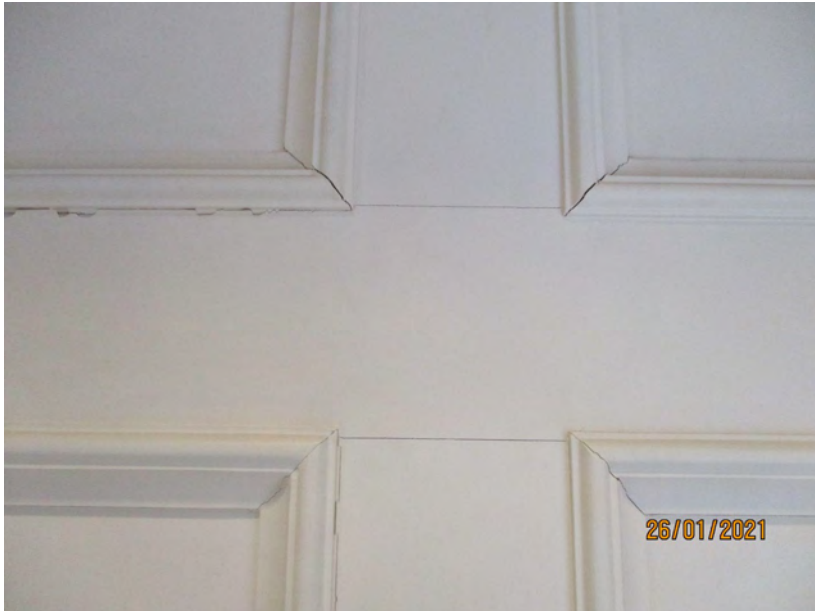
**Fig 71:**

Ground floor, G.15 Meeting Room;  
showing dg.05 opening up of joints in  
panelling

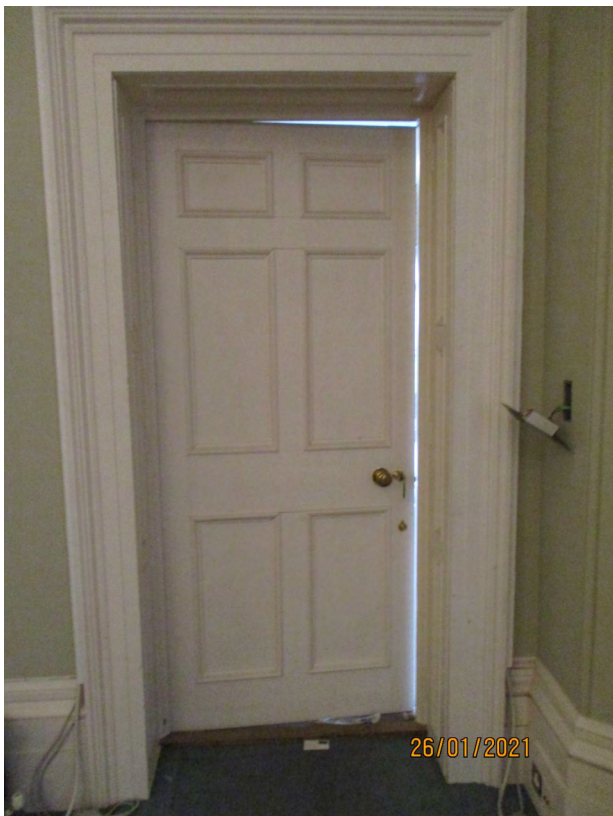
**Fig 72:**

Ground floor, G.15 Meeting Room;  
showing dg.07 softwood timber  
architrave and deep panelled reveal  
with painted timber door. Localised  
cosmetic damage to paintwork and  
opening up of panelling joints

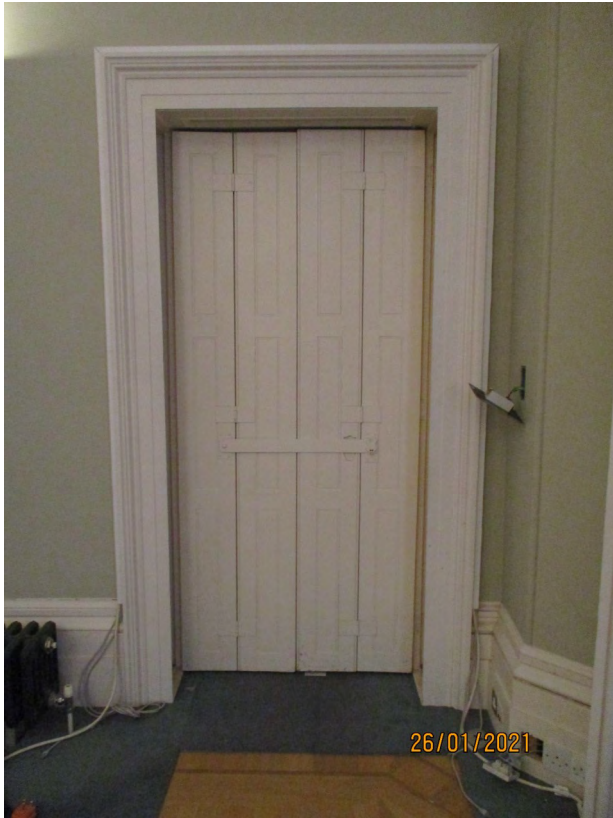
**Fig 73:**

Ground floor, G.15 Meeting Room;  
showing dg.07 softwood timber  
shutters with localised cosmetic  
damage to paintwork

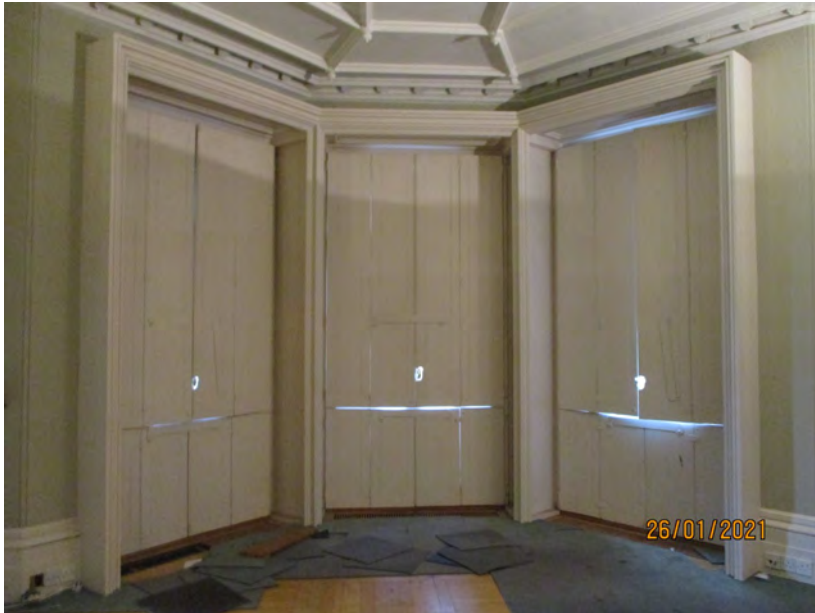
**Fig 75:**

Ground floor, G.16 Boardroom;  
showing wg.09, wg.10, wg.11 softwood  
timber shutters with localised cosmetic  
damage to paintwork

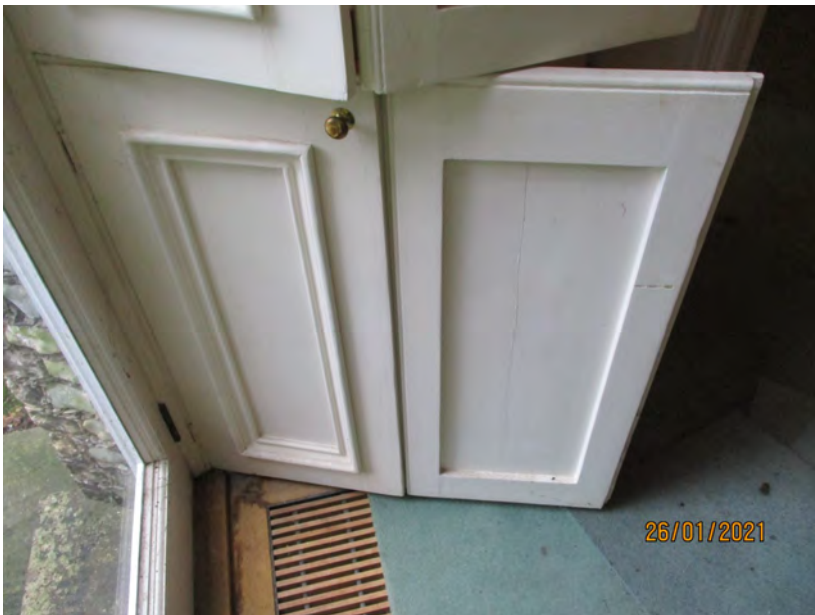
**Fig 76:**

Ground floor, G.16 Boardroom;  
showing wg.10, with split to outer panel

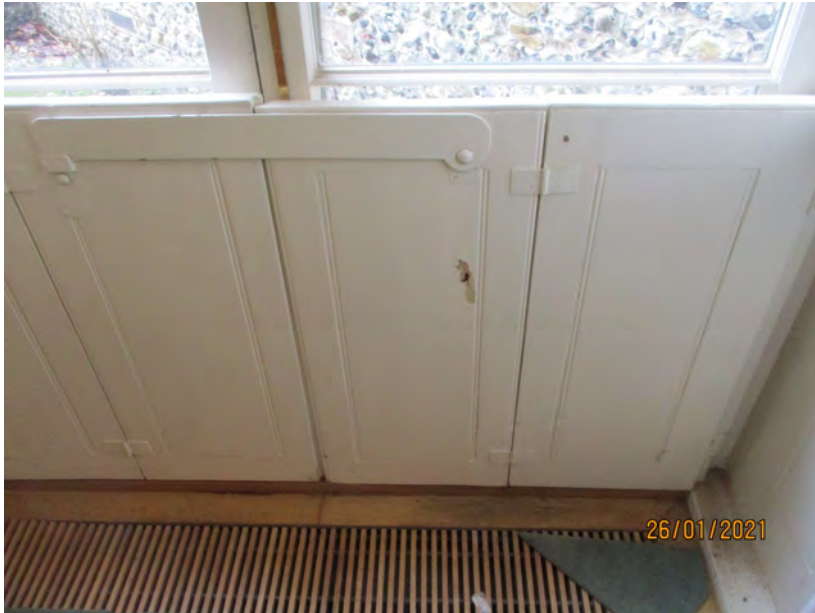
**Fig 77:**

Ground floor, G.16 Boardroom;  
showing wg 11 with damage to  
paintwork

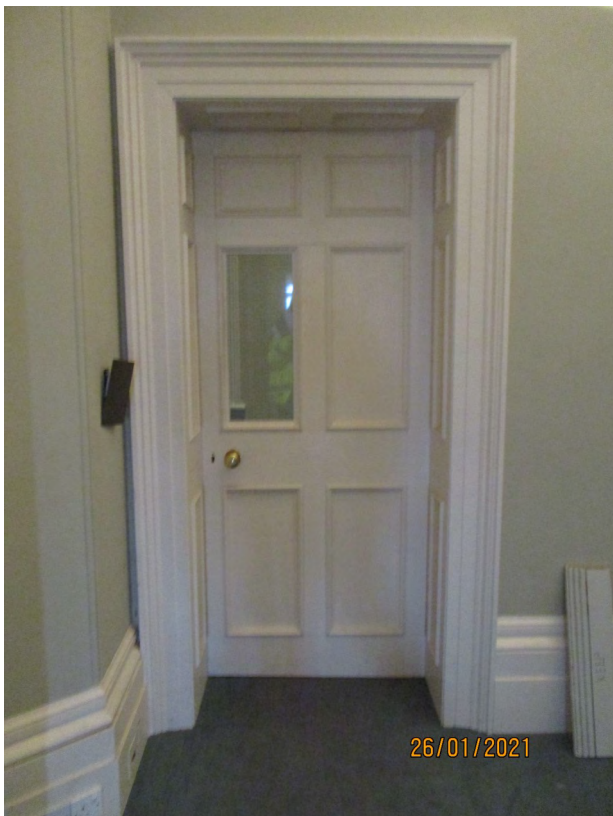
**Fig 78:**

Ground floor, G.16 Boardroom;  
showing dg.08 softwood timber  
architrave and deep panelled reveal,  
painted timber door with reinforced  
glazing pane. Localised cosmetic  
damage to paintwork and opening up  
of panelling joints of door

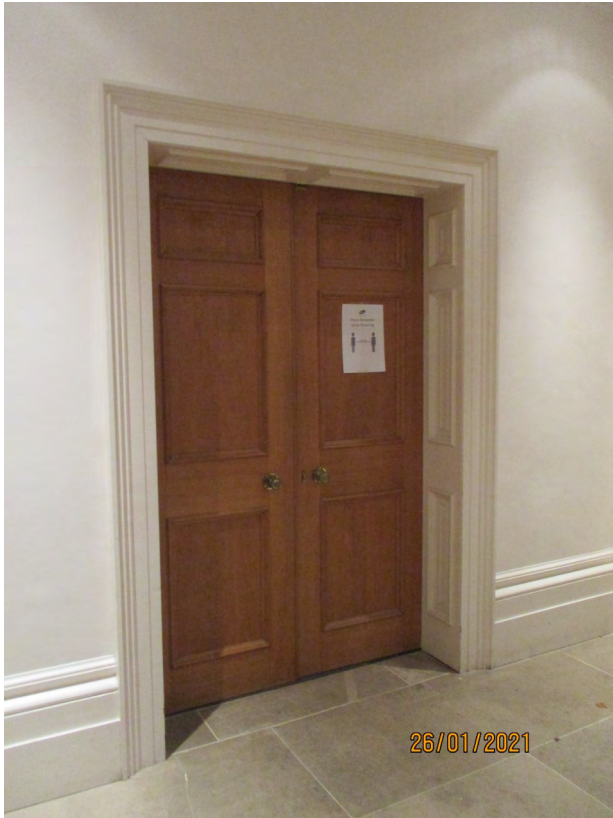
**Fig 79:**

Ground floor, G.16 Boardroom;  
showing dg.06 painted softwood timber  
architrave and deep panelled reveal  
with oak door. Localised cosmetic  
damage to paintwork

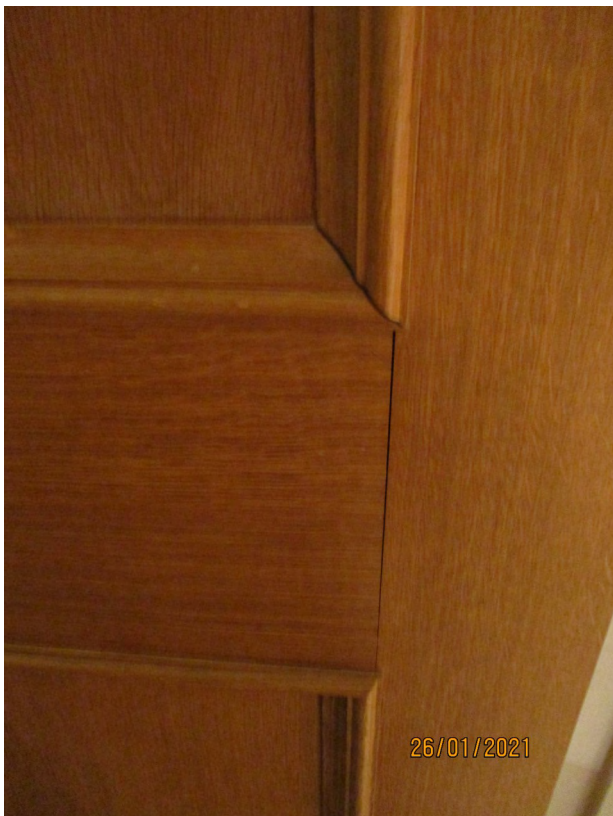
**Fig 80:**

Ground floor, G.16 Boardroom;  
showing dg.06 with joints opening up

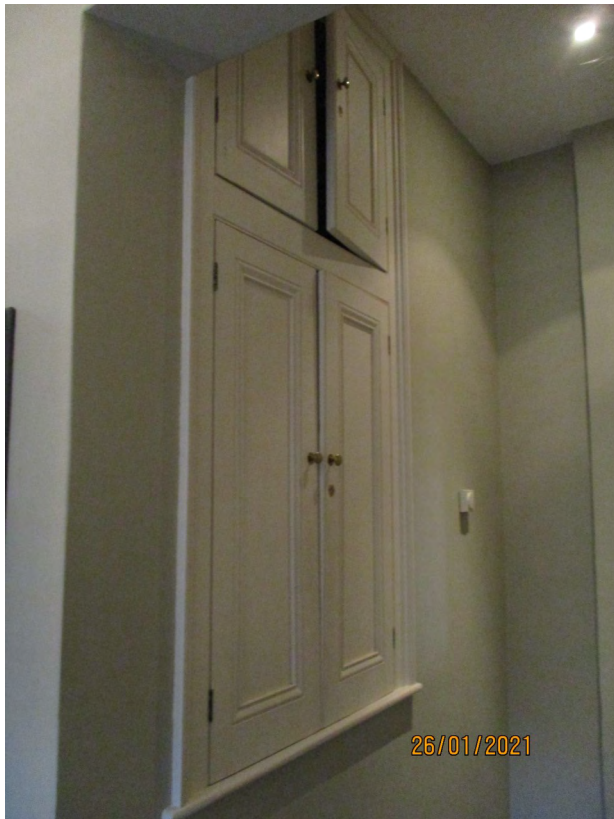
**Fig 81:**

Ground floor, G.18 Office; showing softwood timber cupboard with split to one panel and evidence of previous repair

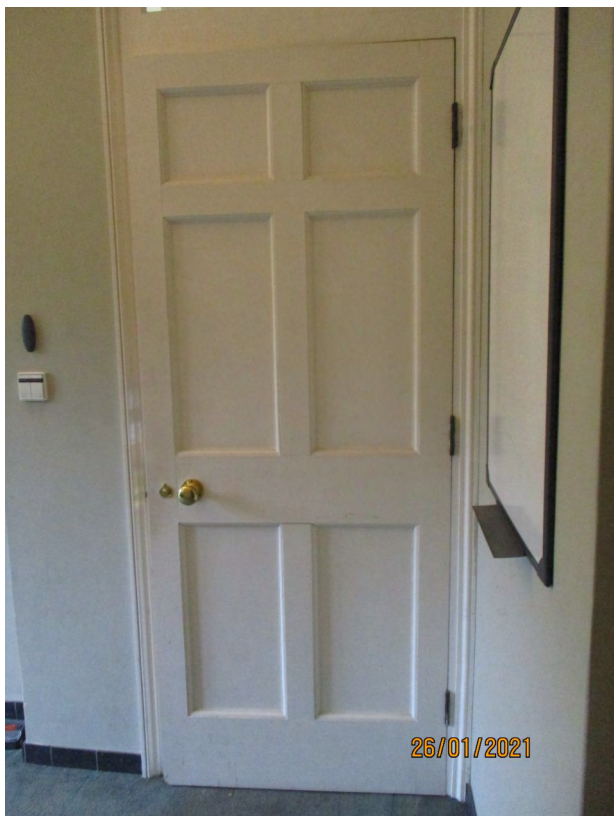
**Fig 82:**

Ground floor, G.18 Office; showing dg.09 softwood timber architrave. Localised cosmetic damage to paintwork at low level

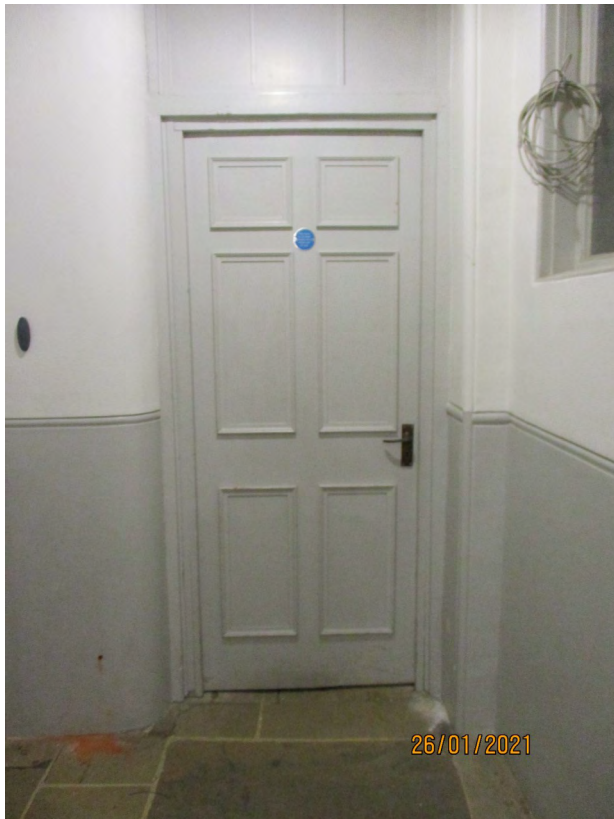
**Fig 83:**

Ground floor, G.04 Back Corridor;  
showing dg.32 softwood timber  
architrave. Localised cosmetic damage  
to paintwork at low level

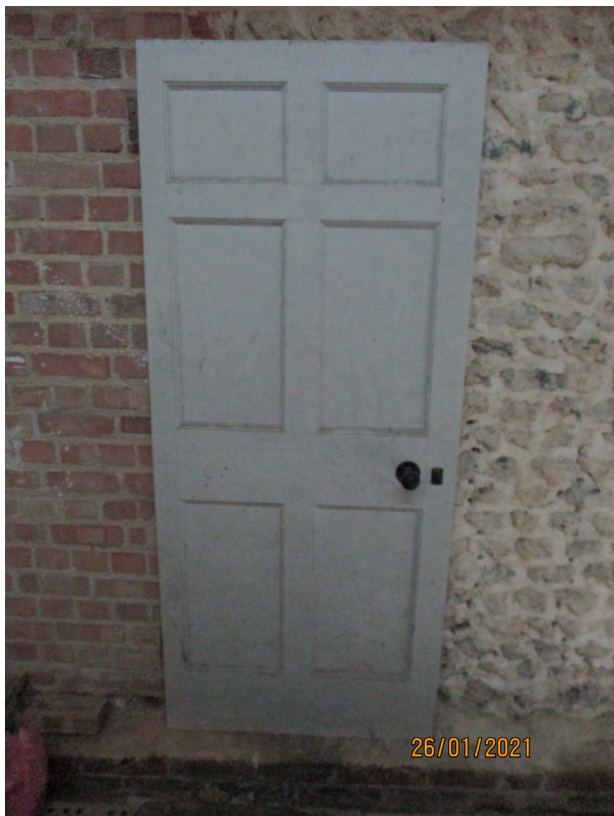
**Fig 84:**

Ground floor, softwood timber door.  
Localised cosmetic damage to  
paintwork at low level
