# Hutton + Rostron Environmental Investigations Limited

## Southleigh Park House: Joinery condition investigation

Site note A3 for 26 January 2021, job no. 152.09

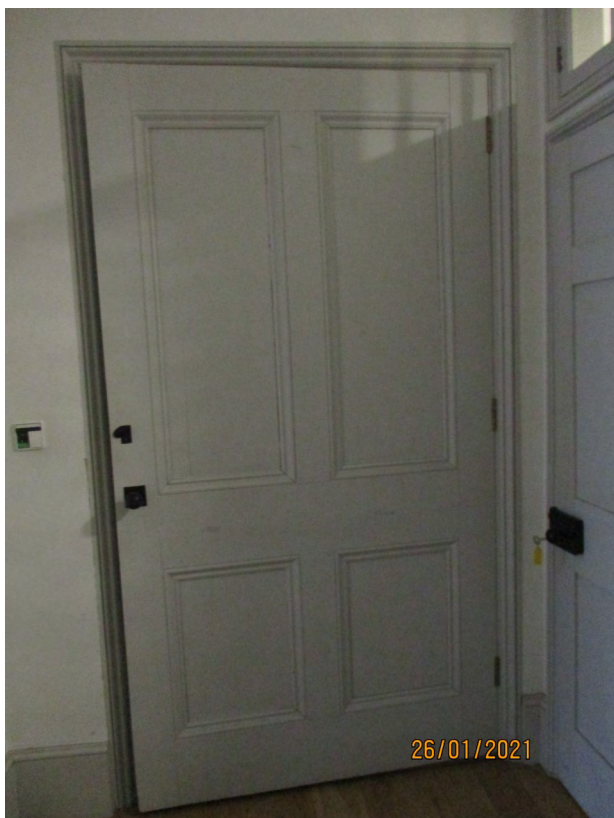
**Fig 86:**

Ground floor, G.05 R&D Lab; showing former silver safe softwood timber door and architrave. Localised cosmetic damage to paintwork at low level

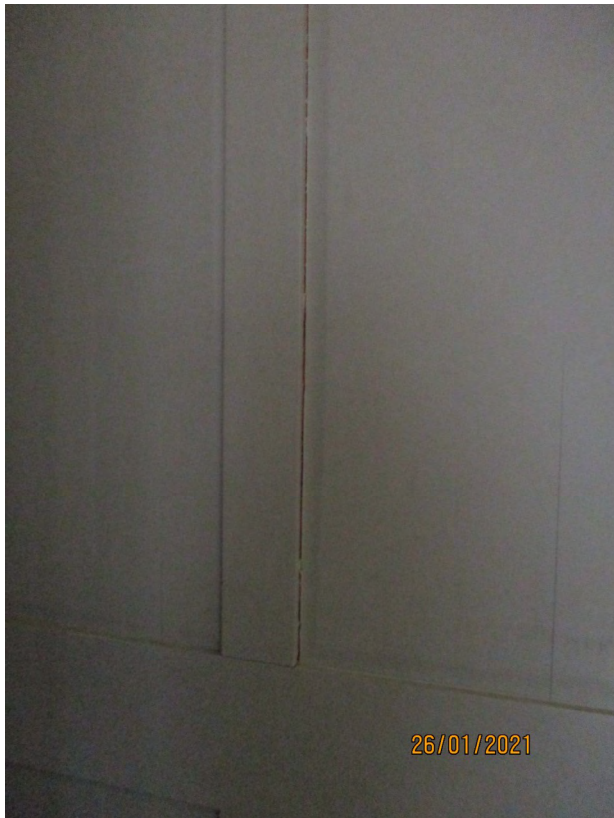
**Fig 87:**

Ground floor, G.05 R&D Lab; showing former silver safe softwood painted timber door and architrave. There was opening up of panelling joints

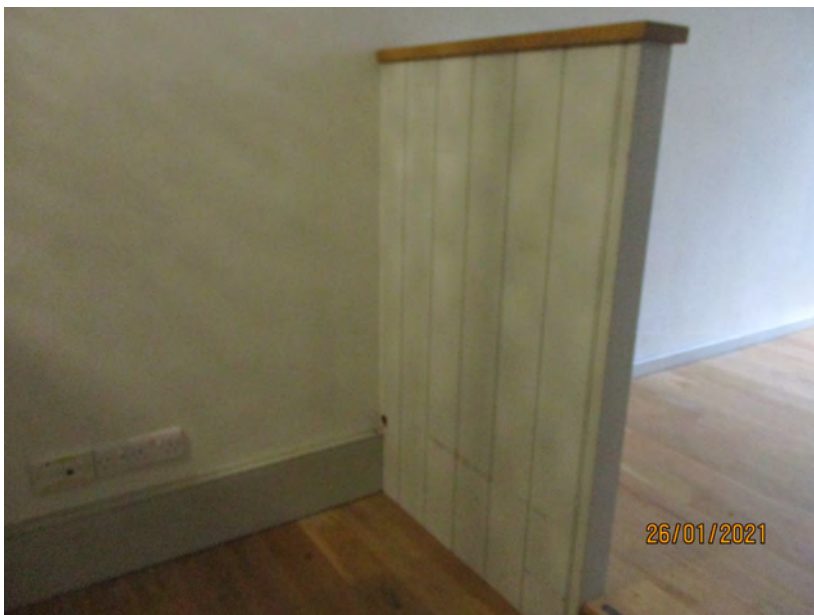
**Fig 88:**

Ground floor, G.05 R&D Lab; showing panelled half wall section. Minimal damage to paintwork and a small hole had been drilled at skirting level for services

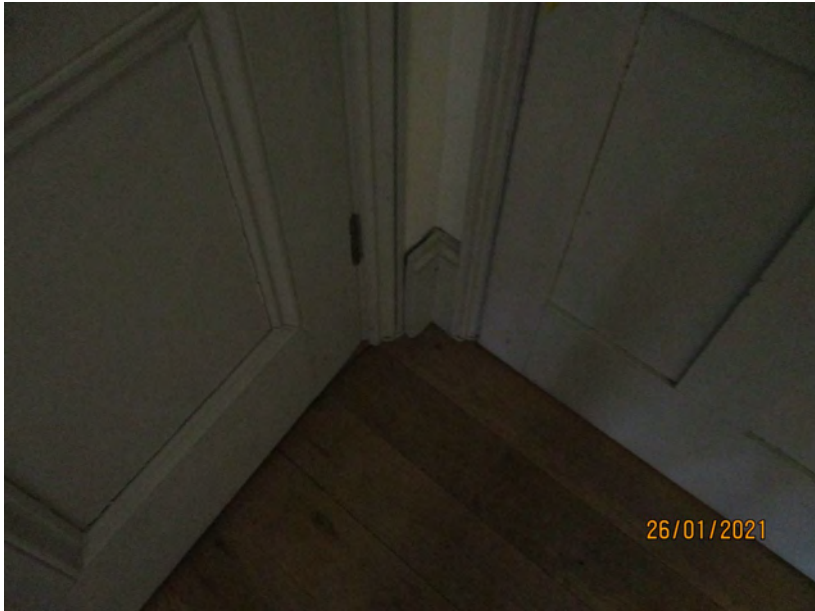
**Fig 89:**

Ground floor, G.05 R&D Lab; showing detachment of skirting around corners

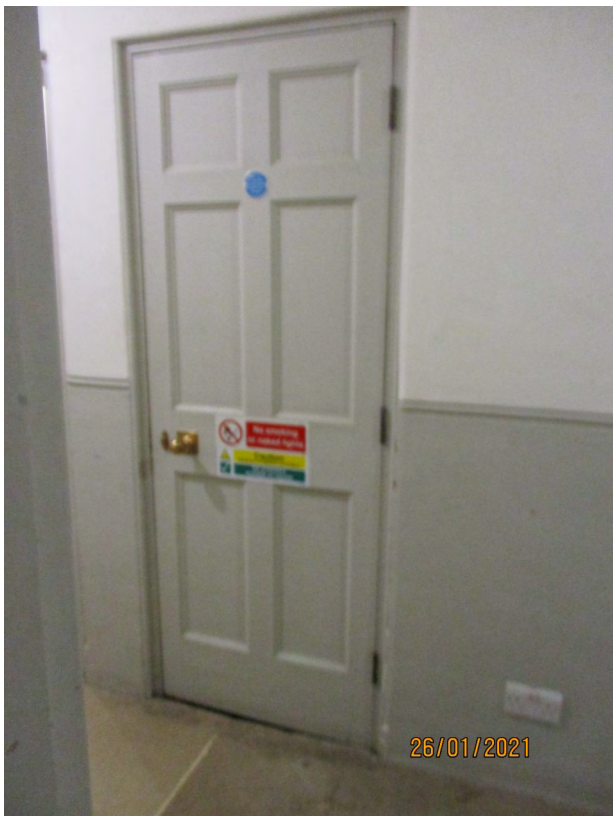
**Fig 90:**

Ground floor, G.04 Back Corridor; showing dg.10 softwood timber and architrave. Very localised damage to low level paintwork

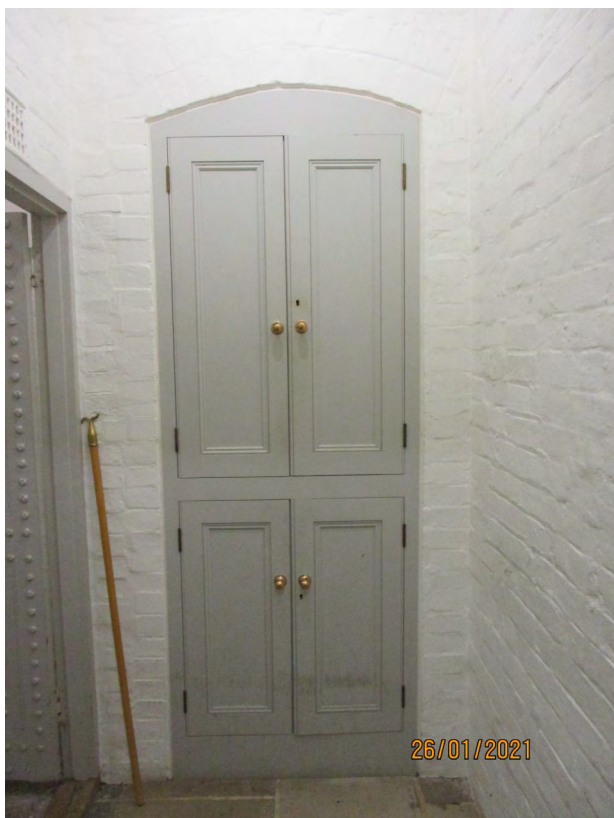
**Fig 92:**

Ground floor, G.17 former Wine Store;  
showing softwood timber cupboard and  
architrave. Very localised damage to  
paintwork at low level and around  
handles

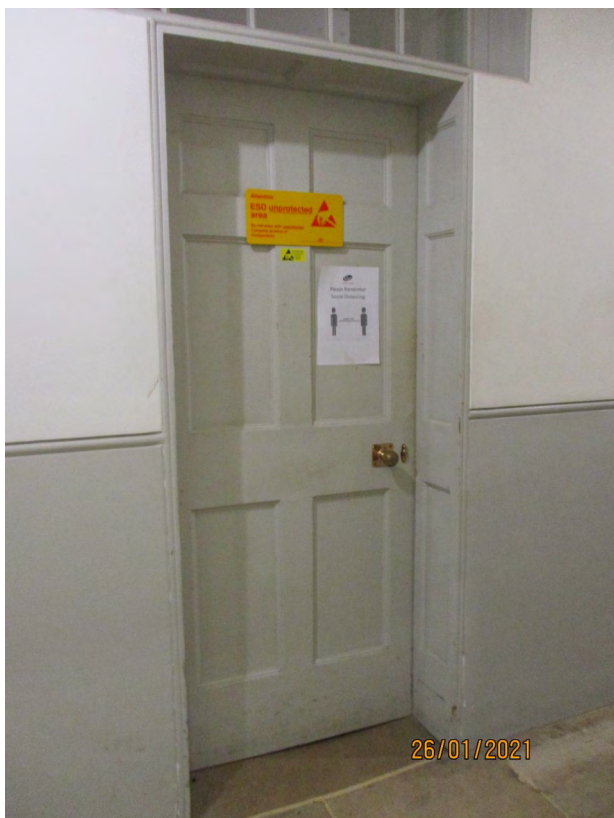
**Fig 94:**

Ground floor, G.06 IT Workshop;  
showing dg.13 softwood timber  
architrave . Very localised damage to  
paintwork at low level from general use  
and a crack to the middle panel near  
the door handle

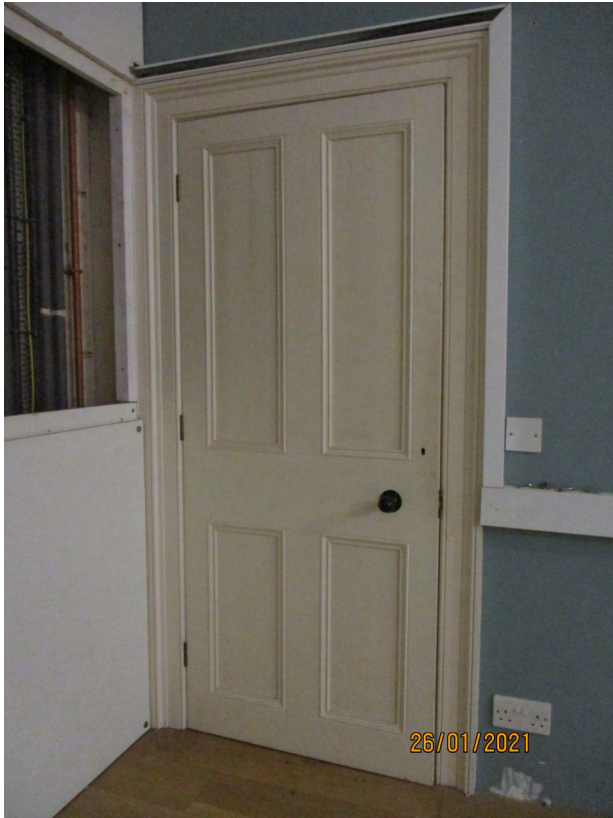
**Fig 95:**

Ground floor, G.06 IT Workshop;  
showing dg.31 softwood timber  
architrave . Very localised damage to  
paintwork at low level from general use  
and a crack to the top left panel near  
the hinges

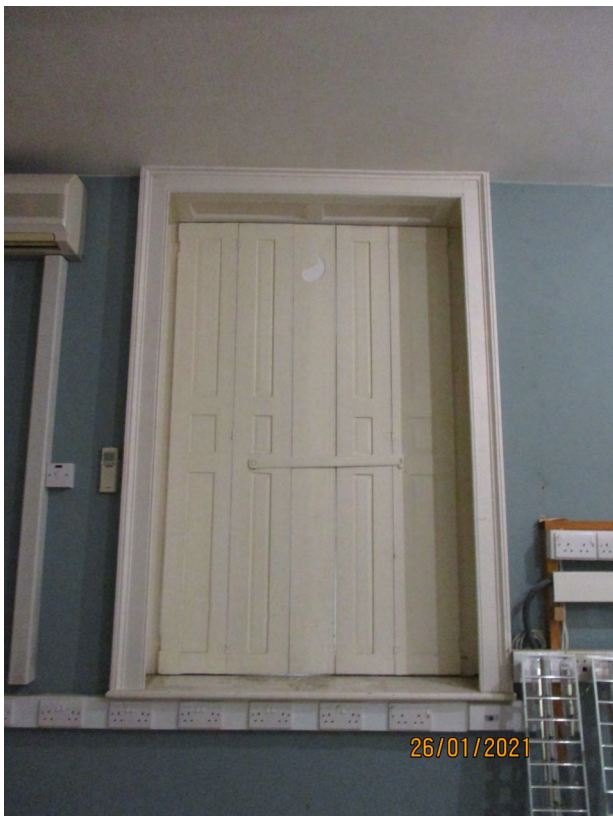
**Fig 96:**

Ground floor, G.06 IT Workshop;  
showing wg.27 softwood timber  
shutters and architrave . Very localised  
damage to paintwork from general use

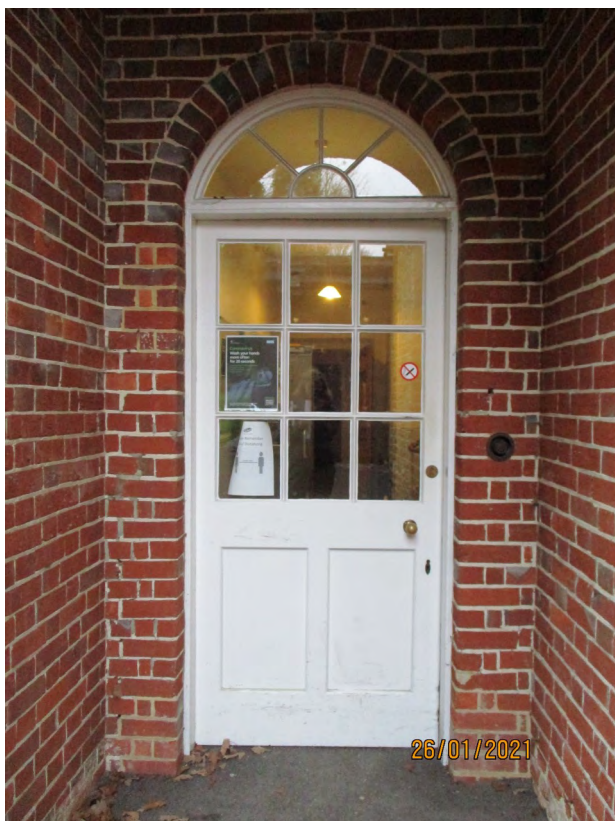
**Fig 98:**

Ground floor, G.04 Back Corridor;  
showing xd.08 softwood timber door  
with glazing and architrave. Localised  
damage to paintwork at low level from  
general use

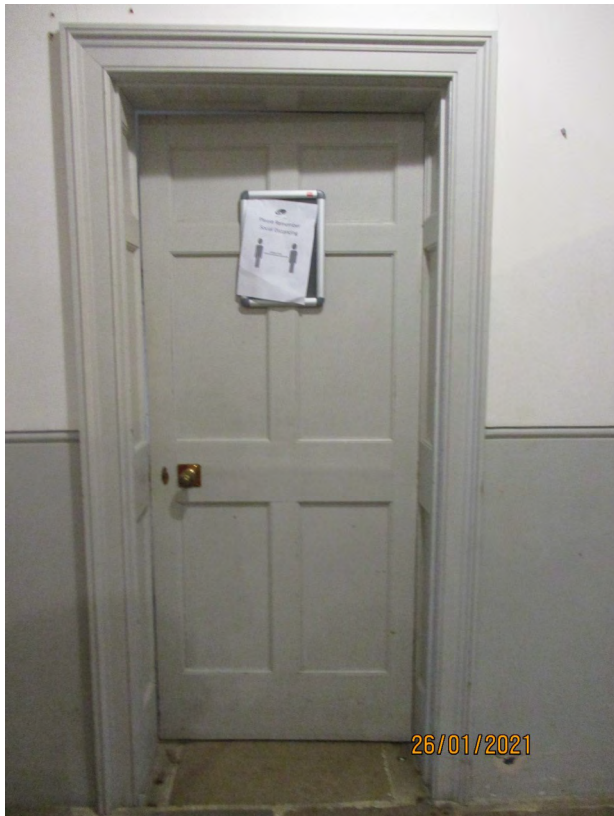
**Fig 99:**

Ground floor, G.07 IT Office; showing dg.15 softwood timber door and architrave . Very localised damage to paintwork at low level from general use

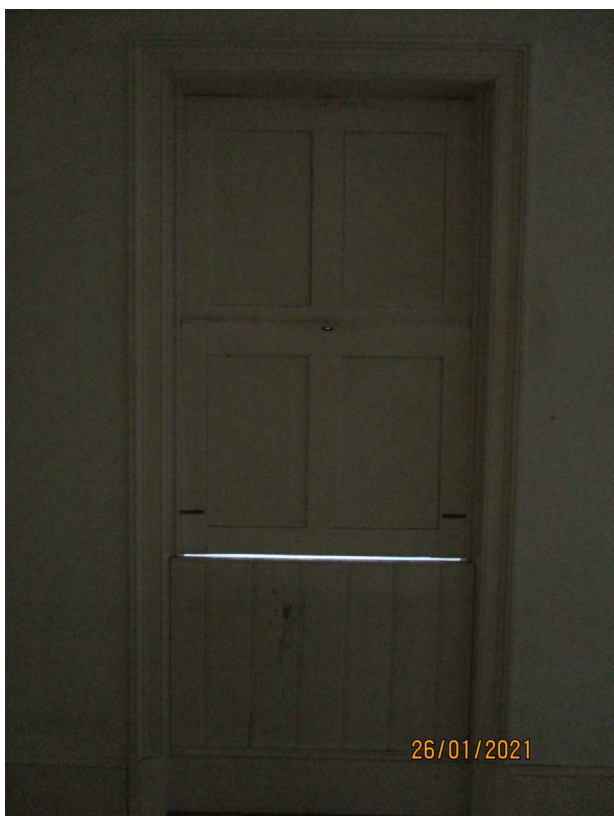
**Fig 100:**

Ground floor, G.07 IT Office; showing wg.29 softwood timber panelled vertical sliding shutters and architrave. There was general wear and tear damage to the paint work to all elements and some cracking to the paintwork around joints in the panelling. Localised damage to paintwork on the edges of the architrave

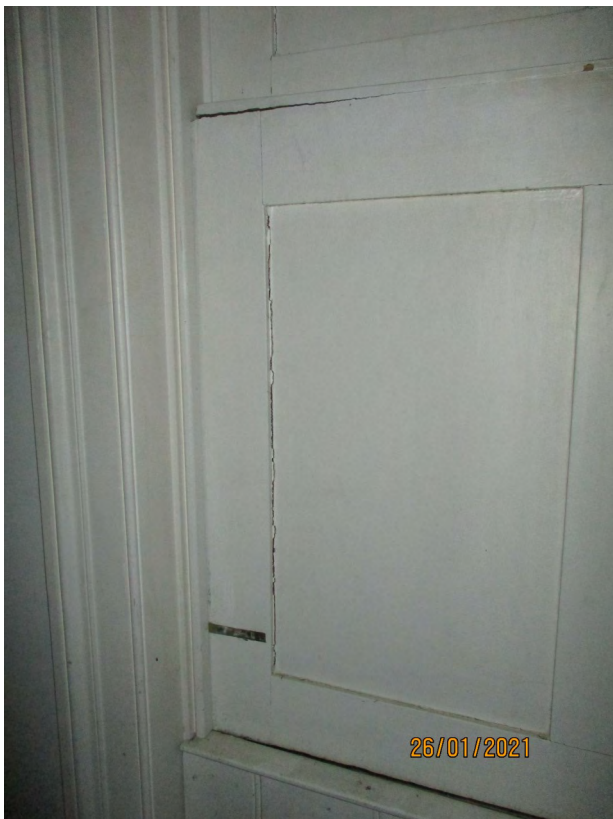
**Fig 102:**

Ground floor, G.07 IT Office; showing wg.30 with cracking to the paintwork around joints in the panelling

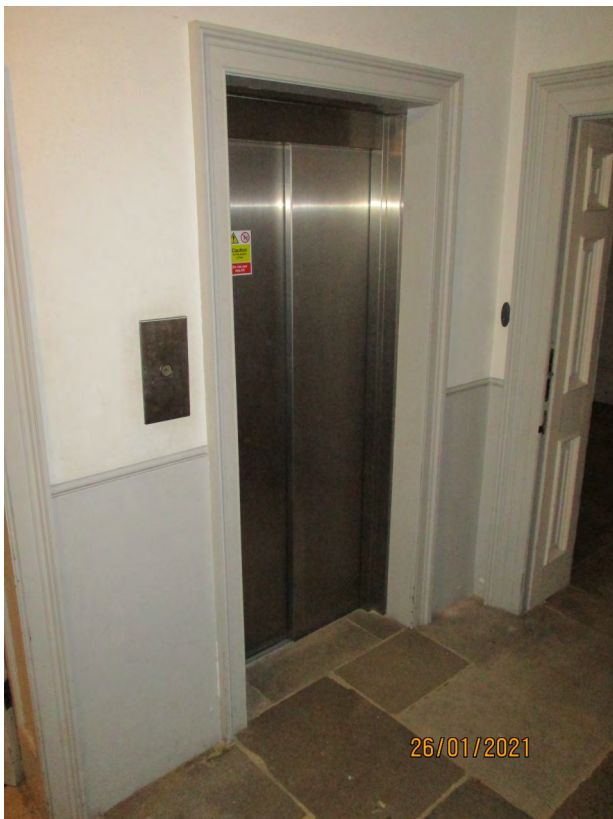
**Fig 104:**

Ground floor, G.04 Back Corridor;  
showing softwood timber architrave to  
lift. There was general wear and tear  
damage to the paintwork

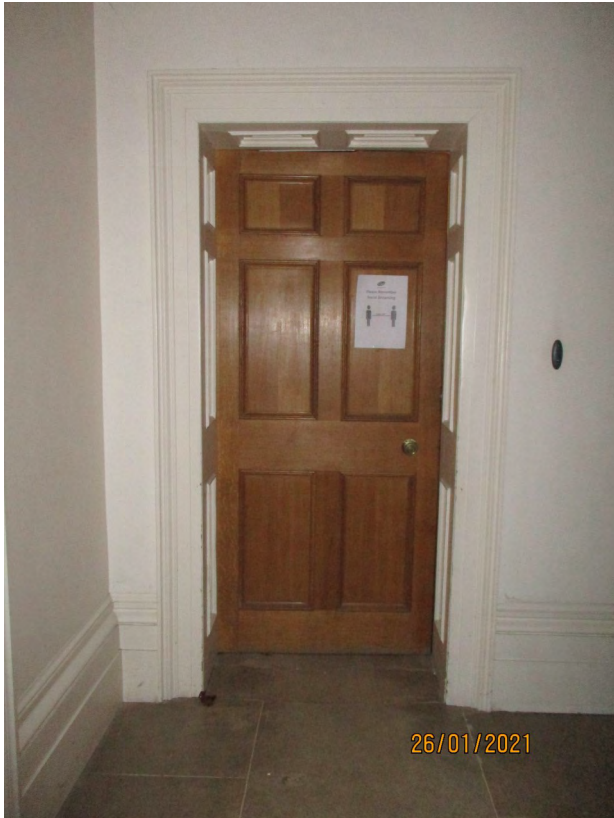
**Fig 105:**

Ground floor, G.09 Main Hall; showing dg.18 oak panelled door with deep panelled painted door reveal. There was general wear and tear damage to the elements at low level

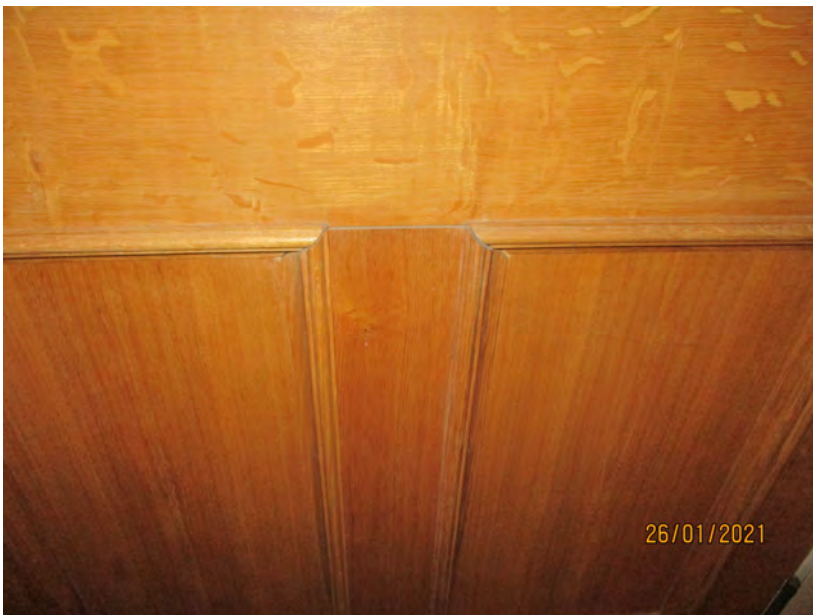
**Fig 106:**

Ground floor, G.09 Main Hall; showing dg.18 oak panelled door. There was opening up of joints of the panelling

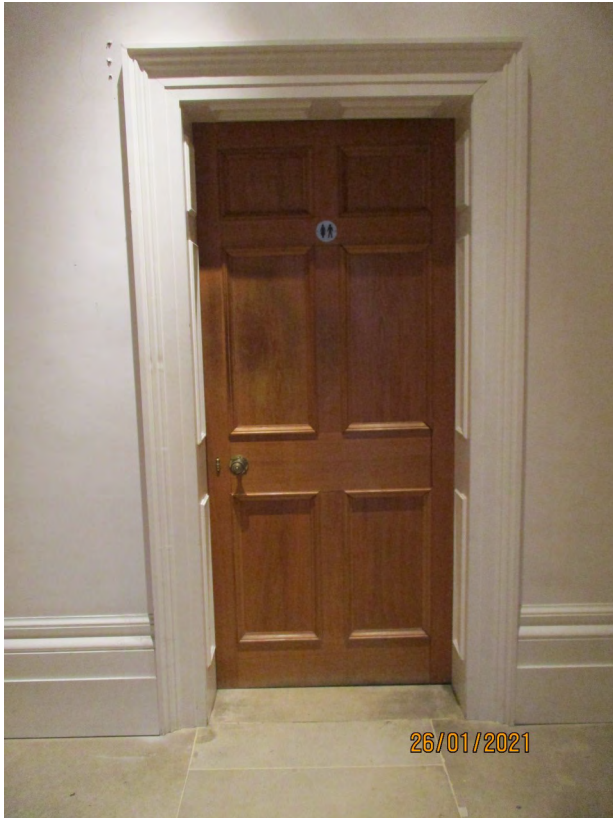
**Fig 107:**

Ground floor, G.10 Toilets; showing dg.19 oak panelled door with deep panelled painted door reveal. There was general wear and tear damage to the elements at low level

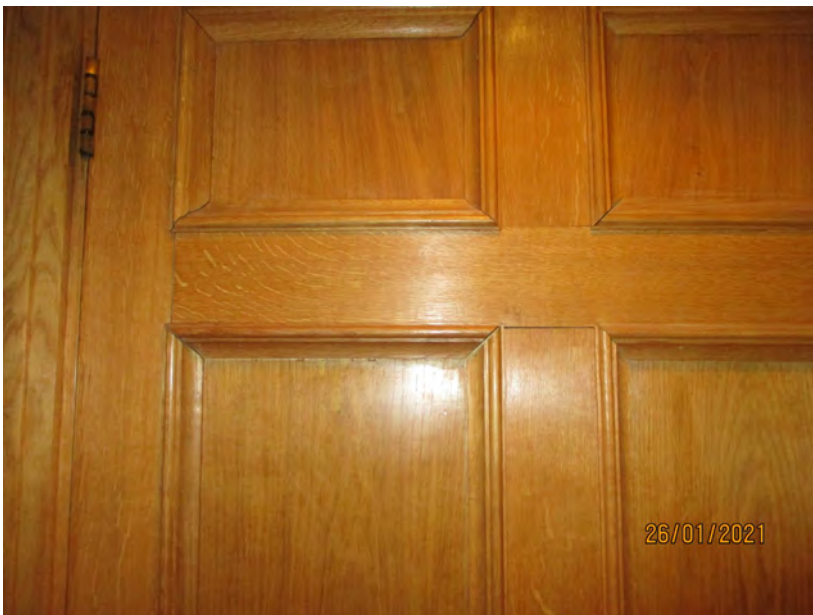
**Fig 108:**

Ground floor, G.10 Toilets; showing dg.19 oak panelled door. There was opening up of the joints of the panelling

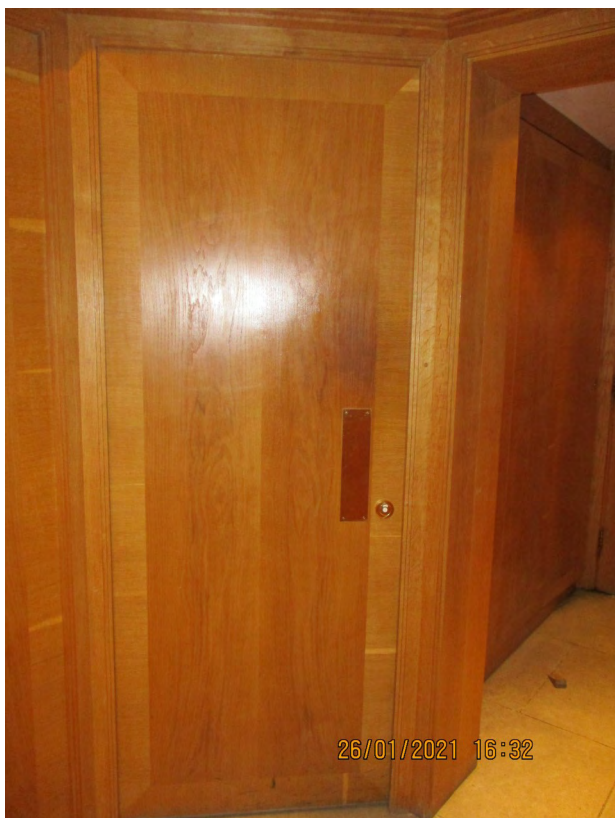
**Fig 110**

Ground floor, G.10 Toilets; showing general view of doors and panels. There was very localised wear above finger plates

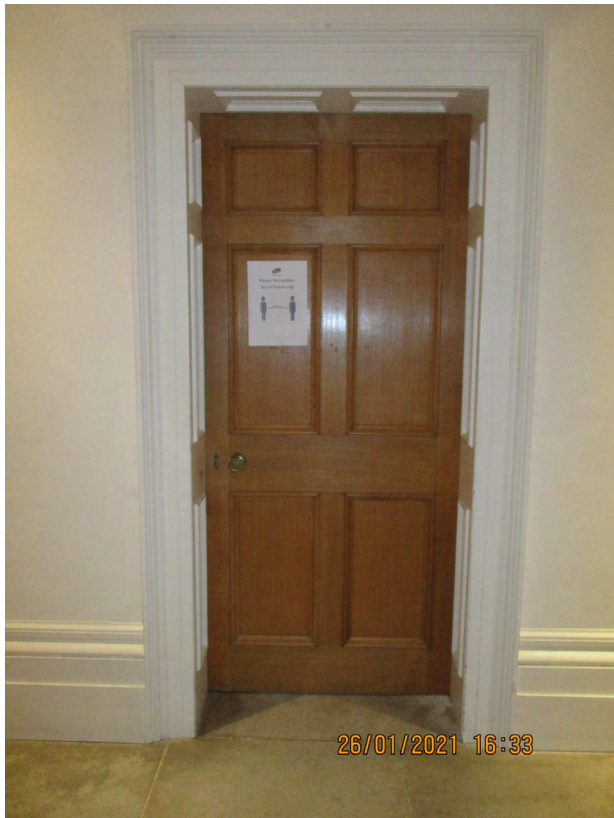
**Fig 111:**

Ground floor, G.11 Office (former morning room; showing dg.24 oak panelled door with deep panelled painted door reveal. There was general wear and tear damage to the elements at low level

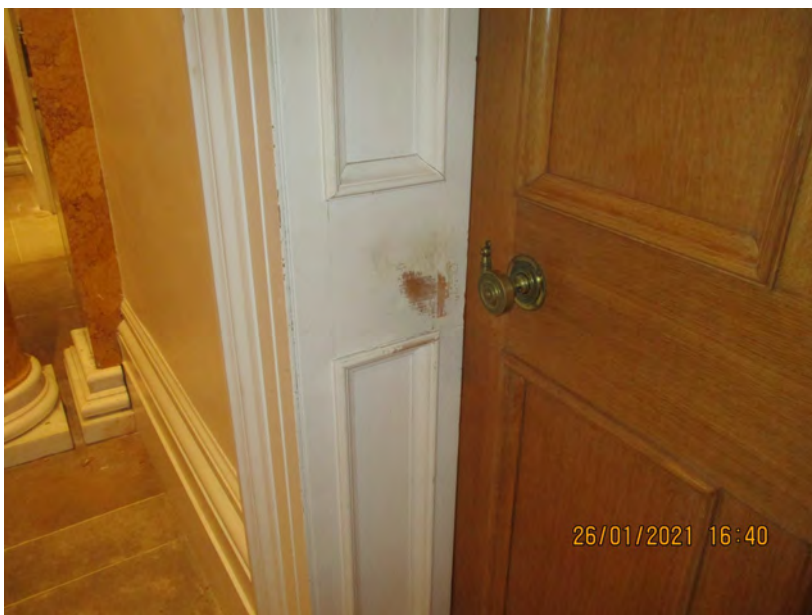
**Fig 112:**

Ground floor, G.11 Office (former morning room; showing dg.24 deep panelled painted door reveal. There was damage to the paintwork around the door handle

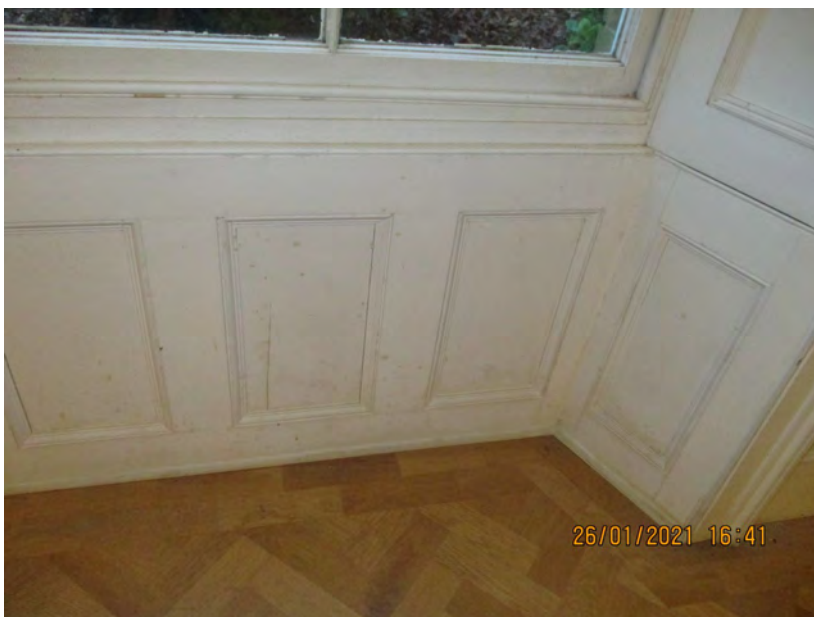
**Fig 114:**

Ground floor, G.011 Office (former morning room); showing wg.33 solid softwood timber panels. Evidence of cracking to the central right panel and loosening to joints between panels and stiles

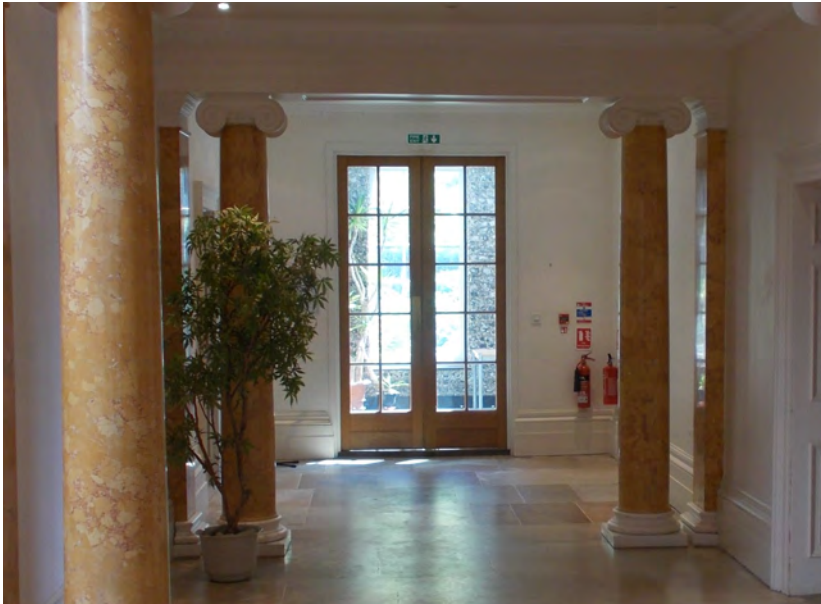
**Fig 115:**

Ground floor, G.09 Main Hall; showing dg.01 timber double doors with 10no. glazing panes to each door. There was general wear and tear damage to the elements at low level

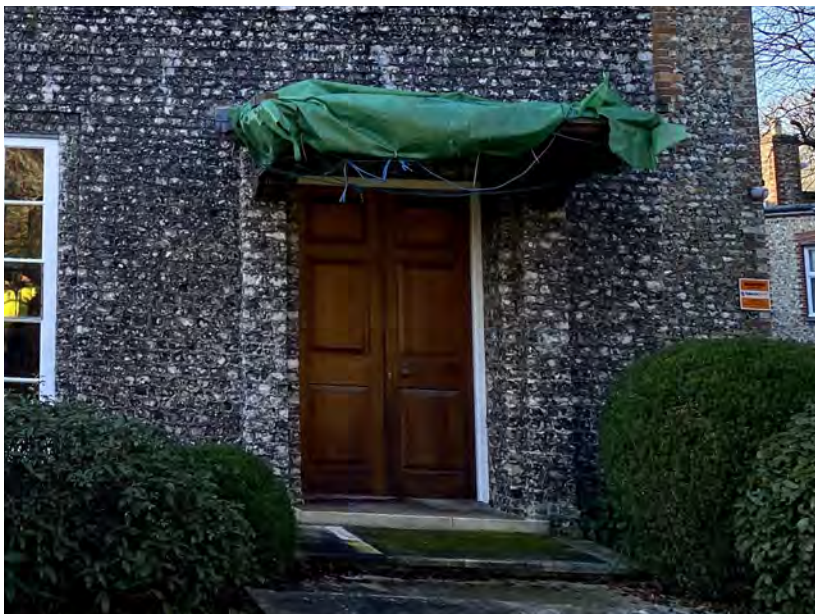
**Fig 116:**

Ground floor, G.12 Reception; showing xd.09 oak panelled double doors. Localised cosmetic damage generally towards the bottom half of the door
