# Hutton + Rostron Environmental Investigations Limited

## Southleigh Park, Mansion House: Masonry damp and damp-proof course investigation

Site note A6 for 18 January 2021, job No. 152.09

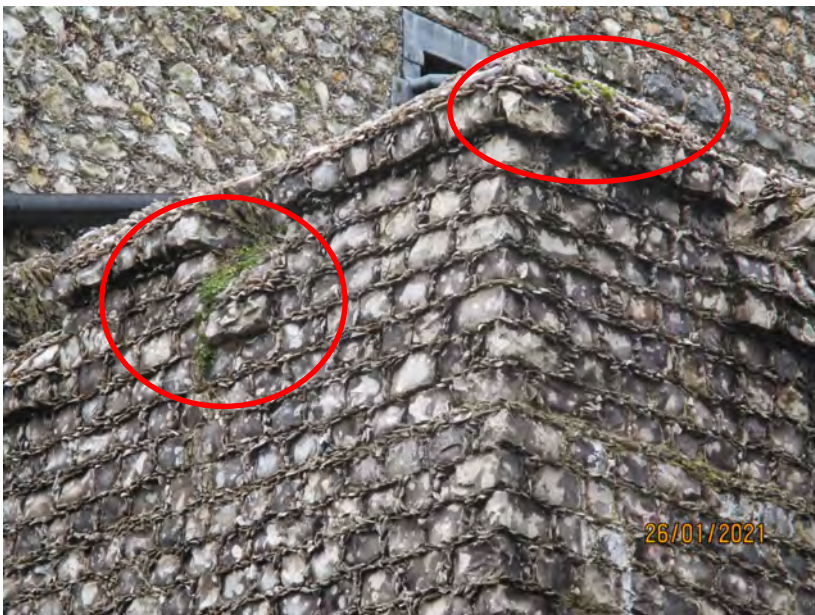
**Fig 21:**

1.2.2, central area; showing biological growth affecting masonry at high level, indicating raised exposure to weathering and possible intermittent failure of the provision for roof drainage on the reverse of the parapet wall

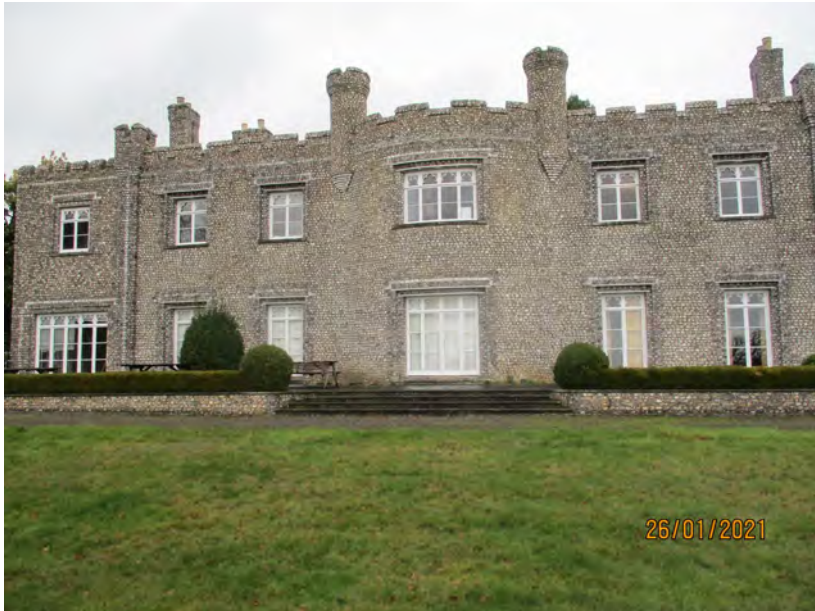
**Fig 23:**

1.3.1; showing general view of principal south elevation

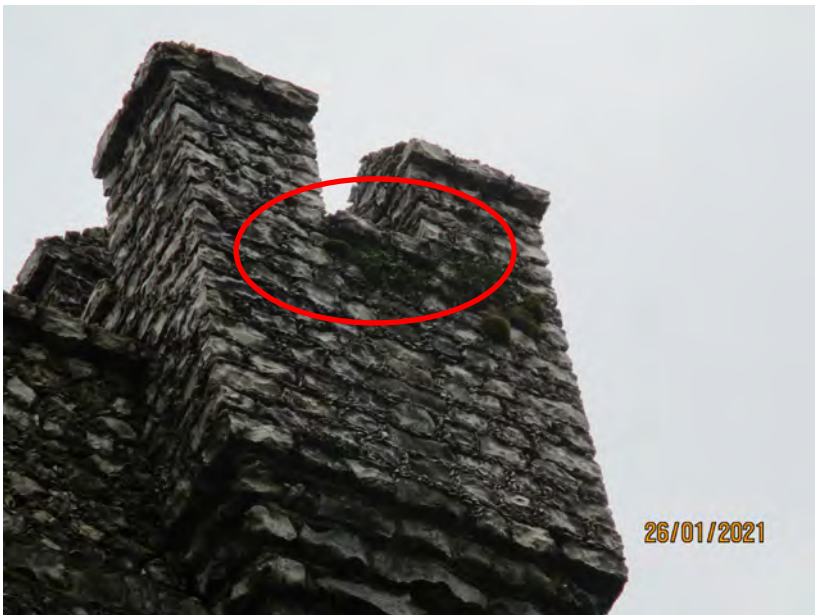
**Fig 24:**

1.3.1, south-west corner of structure; showing plant growth affecting parapet masonry at high level

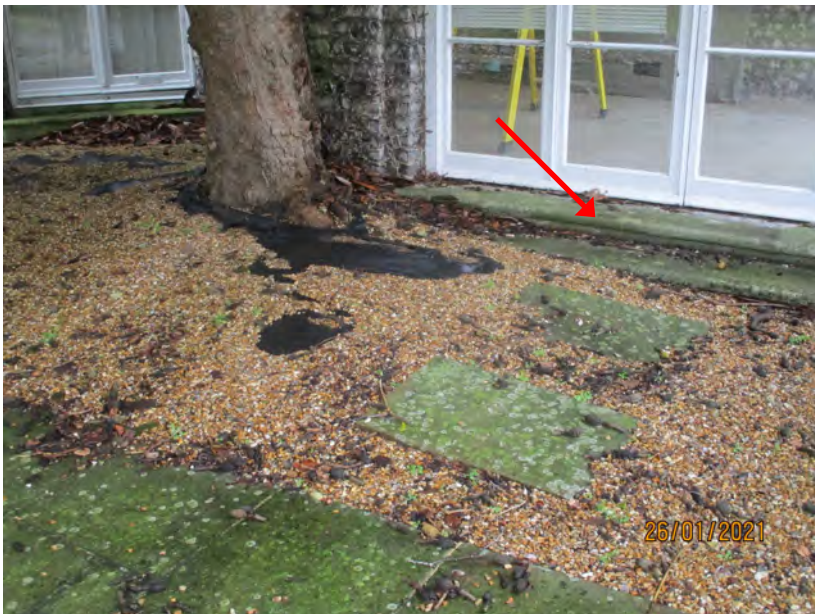
**Fig 26:**

1.4.1, base of mature tree on west side  
of south-west bay; showing ground  
levels raised close to finished floor  
level on the interior and biological  
growth affecting sheltered masonry  
features

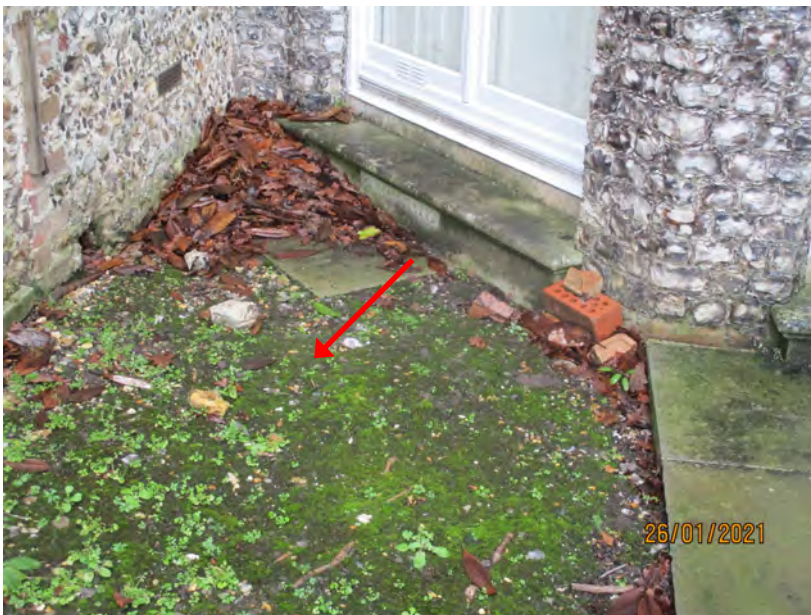
**Fig 28:**

1.4.2, north side; showing saturated ground in contact with the façade, with ground levels around 250mm below finished floor level on the interior

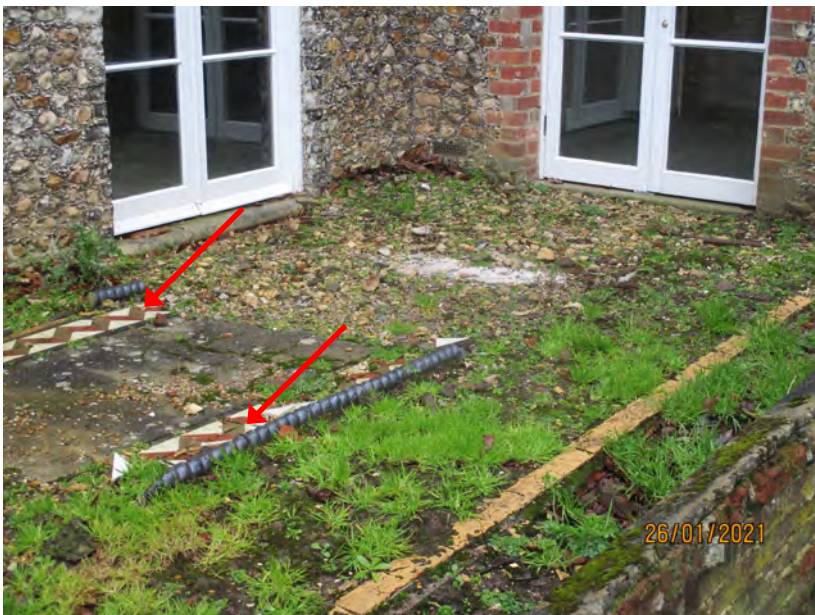
**Fig 30:**

1.3.2, base of façade at return corner; showing residual encaustic tiles and concrete paving and low retaining wall, possibly where an orangery or greenhouse had been constructed and subsequently demolished. Note ground levels equivalent to finished floor level on the interior, increasing the risk of water penetration to the base of the structure

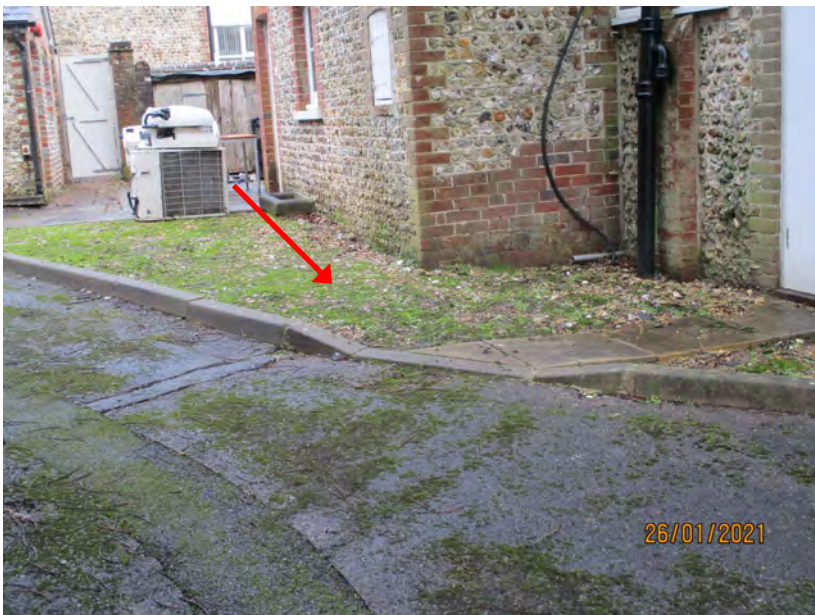
**Fig 36:**

1.4.3, view from south-west; showing soil in contact with the façade vulnerable to saturation, where surrounded by hard landscaped areas and kerbs

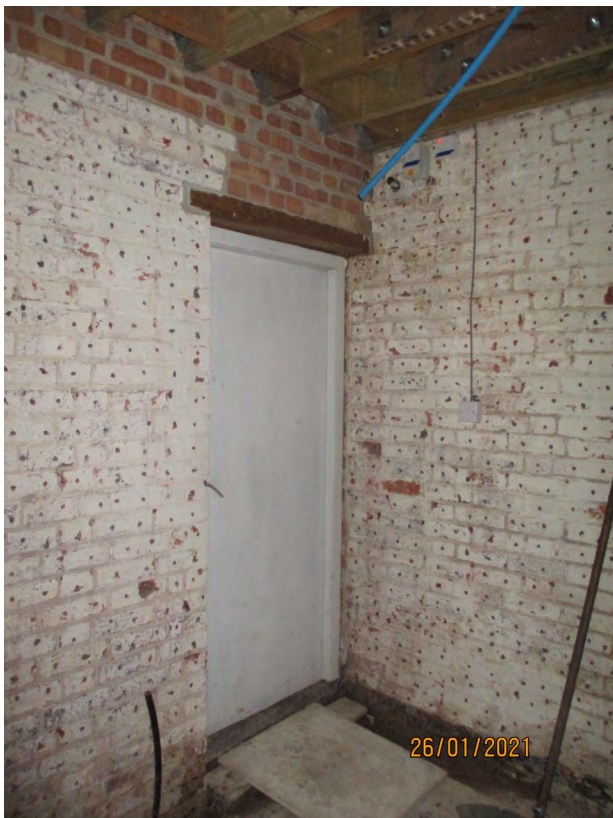
**Fig 38:**

West wing, north-west corner; showing holes drilled in external wall brickwork, consistent with fungicidal wall irrigation on a previous refurbishment

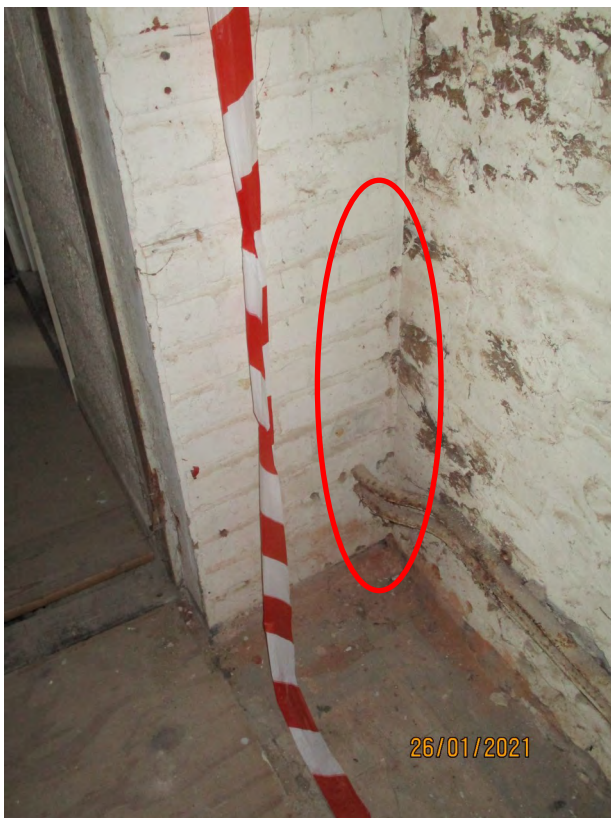
**Fig 40:**

West wing, north side; showing holes drilled in masonry consistent with installation of a chemical injected vertical dpc on a previous refurbishment

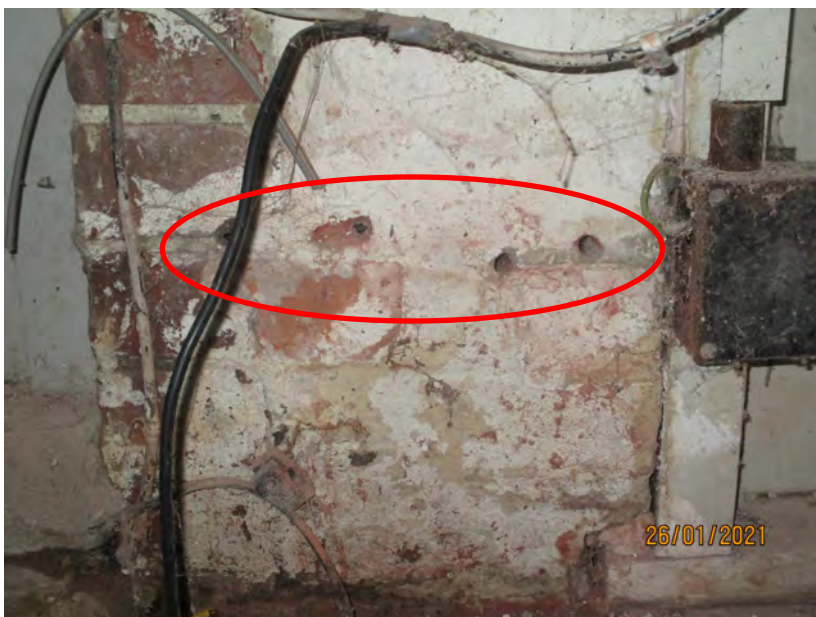
**Fig 42:**

West wing, electrical inlet room on north side; showing rows of horizontal holes drilled in external wall masonry, consistent with the installation of a chemical injected dpc on a previous refurbishment

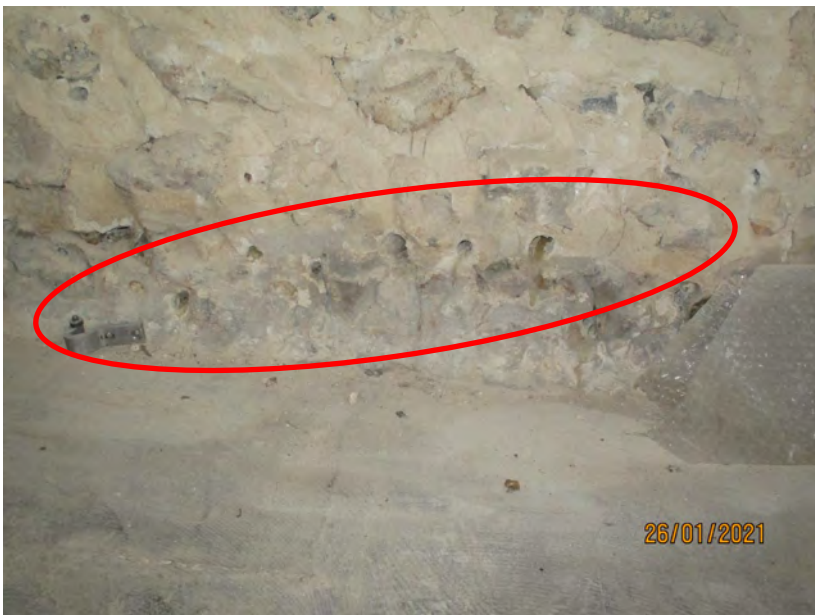
**Fig 46:**

West wing, internal wall on east side; showing horizontal row of holes at base of wall consistent with the installation of a chemical injected damp-proof course on a previous refurbishment

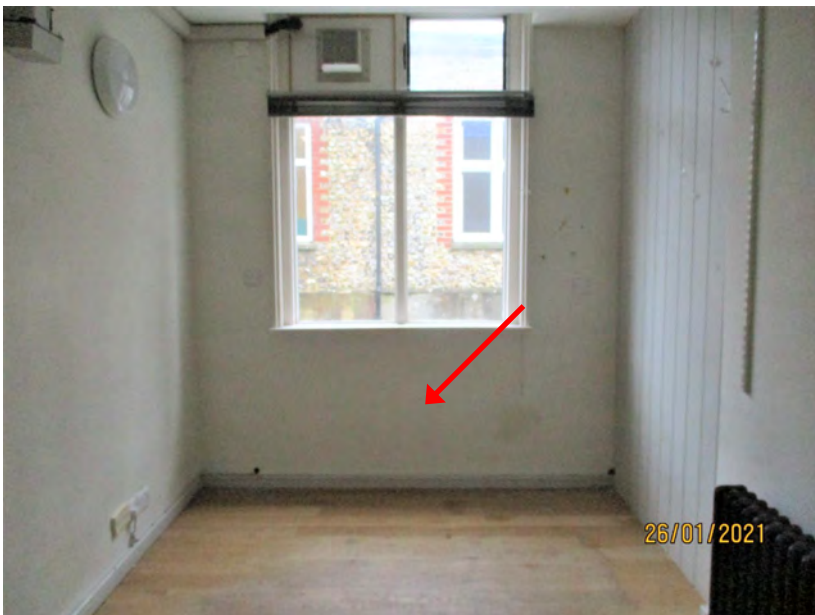
**Fig 48:**

Main house, north side, typical room to west of main entrance; showing north external wall dry lined to full height

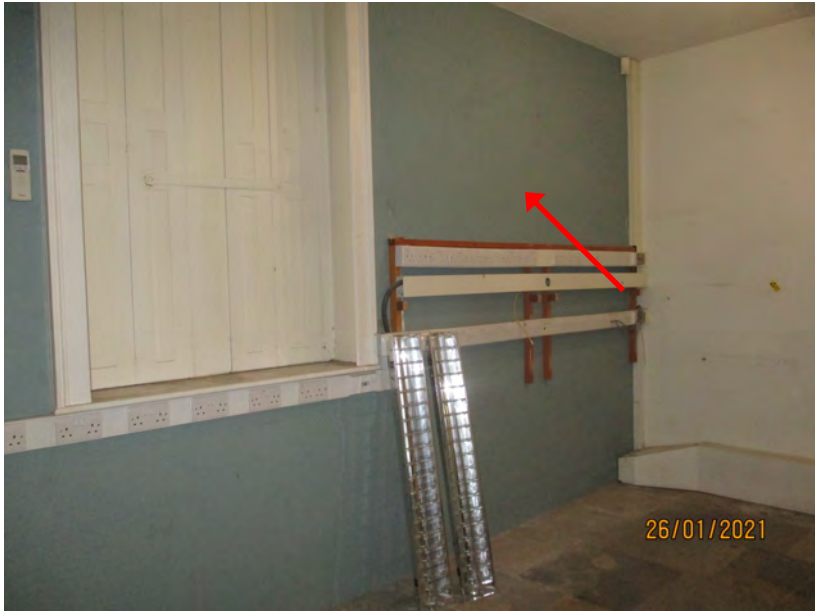
**Fig 49:**

Main house, north side, room to west of main entrance; showing north external wall dry lined to full height

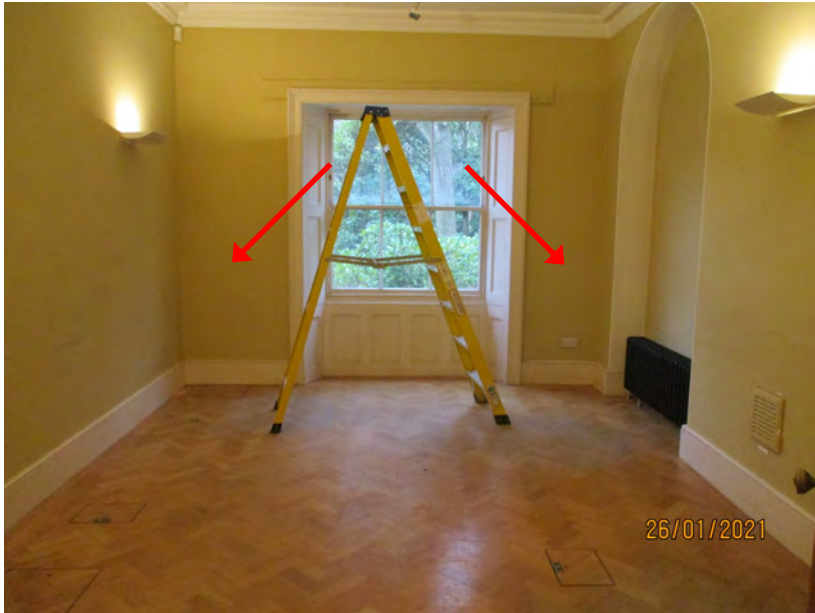
**Fig 51:**

Main house, north-east room at ground floor level; showing north external wall dry lined to full height

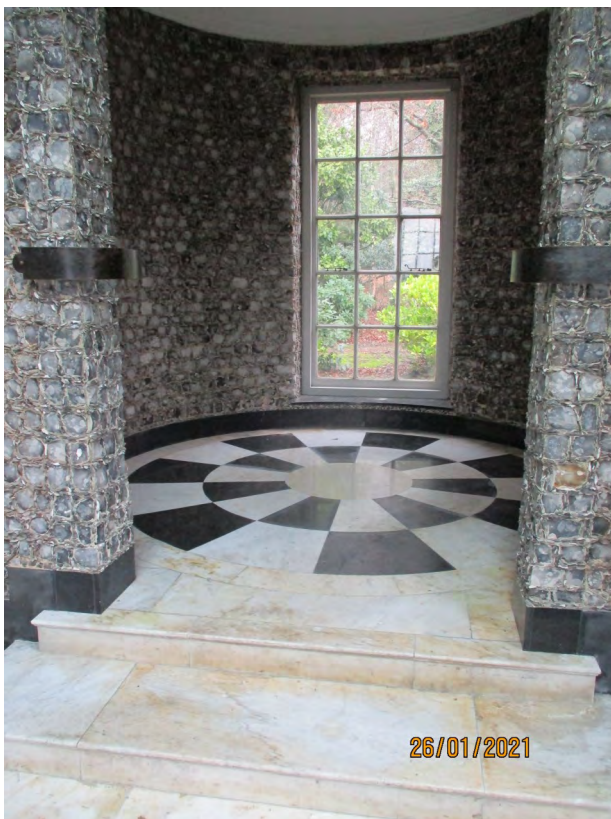
**Fig 52:**

North-east conservatory, north end; showing general arrangement of knapped flint and galetted internal wall finishes, marble floors and full height glazing

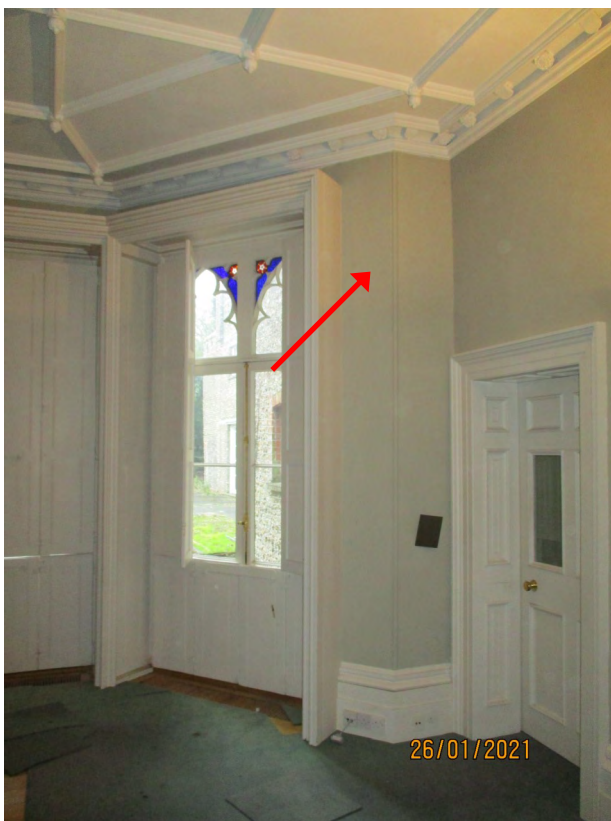
**Fig 54:**

Main house, south-west room, west side; showing structures around full height glazed doors to the exterior dry lined to full height

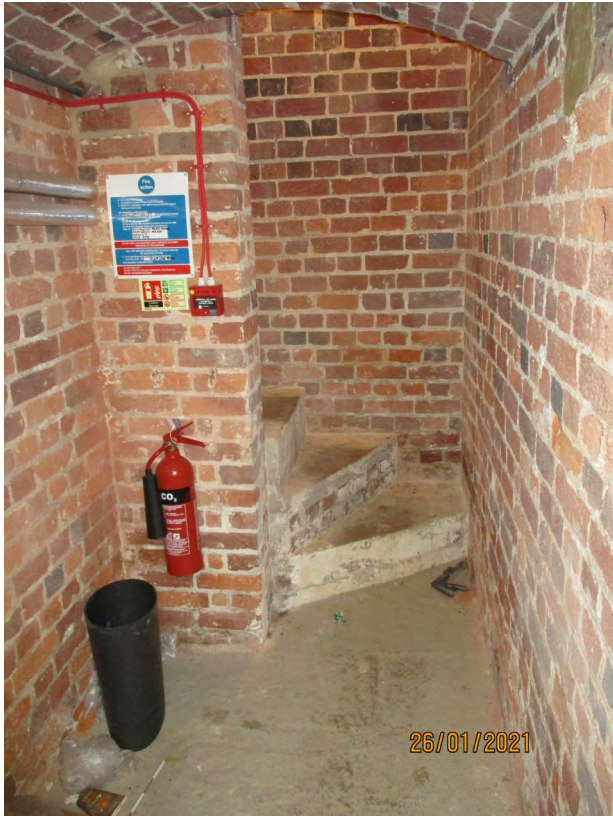
**Fig 55:**

Cellar, south side; showing generally good condition of exposed brick wall and soffit surfaces

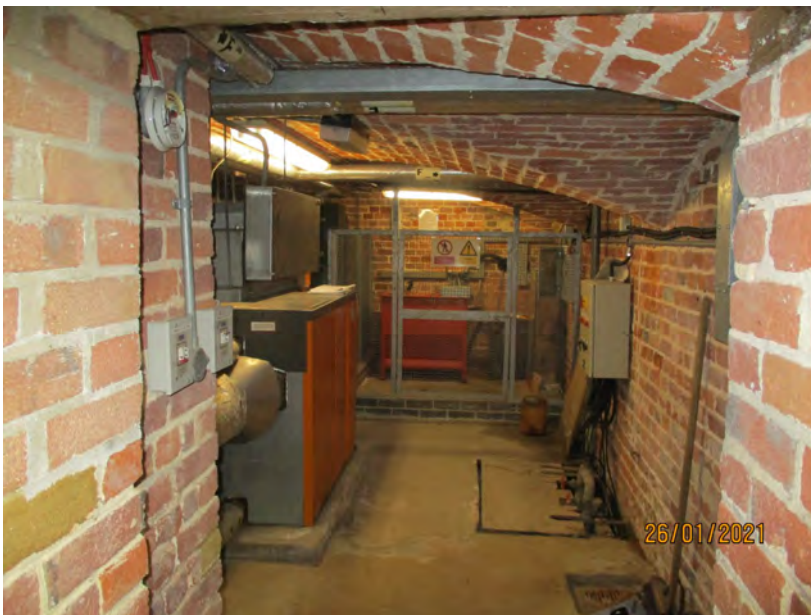
**Fig 56:**

Cellar, south side; showing generally good condition of exposed brick wall and soffit surfaces

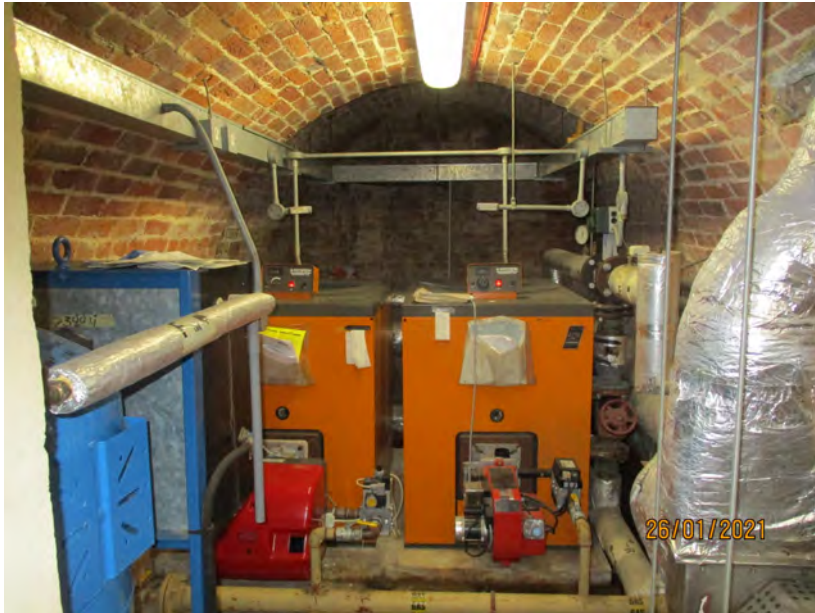
**Fig 57:**

Cellar, north side; showing generally good condition of vaulted brick structures and arrangement of water heating plant

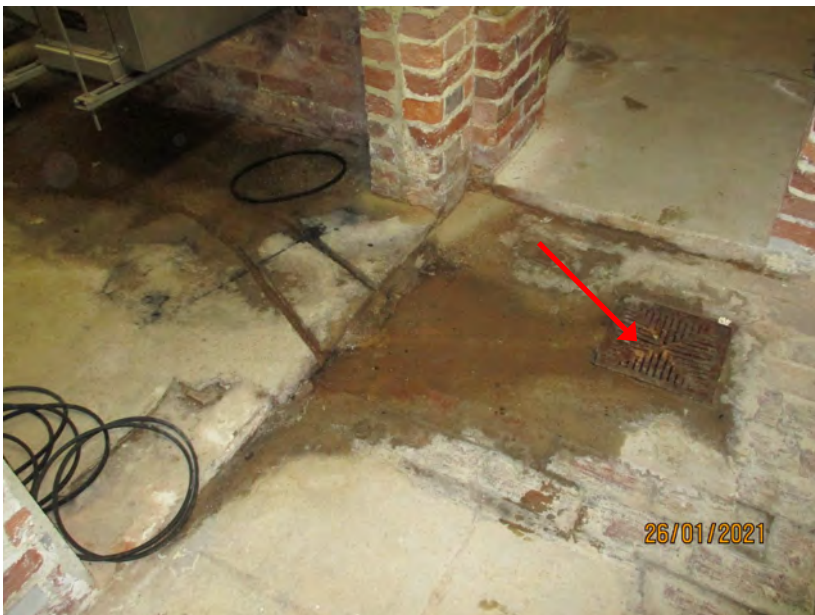
**Fig 58:**

Cellar, west end of corridor; showing floor drain receiving condensate water from heating plant

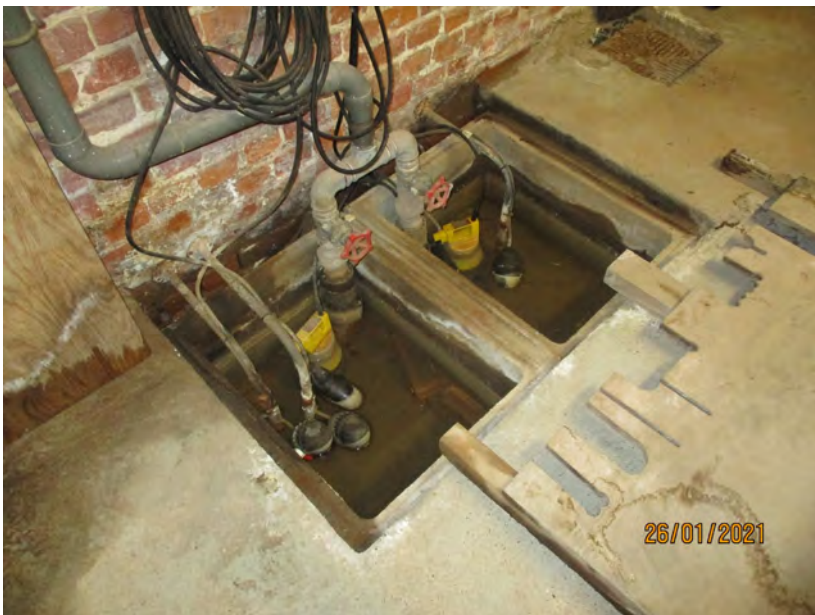
**Fig 60:**

Cellar, south side; showing twin sumps, with pumps controlled by flotation switches, receiving water from below the floor screeds, including a sub-floor channel at the north wall/floor junction. Sumps may also have been receiving water from surface drains, as shown in fig.58 above
