# Havant Thicket Reservoir Project

## **Environmental Statement Volume 4 - Appendices**

#### **A9.14 Arboricultural Impact Assessment**

Portsmouth Water Ltd.

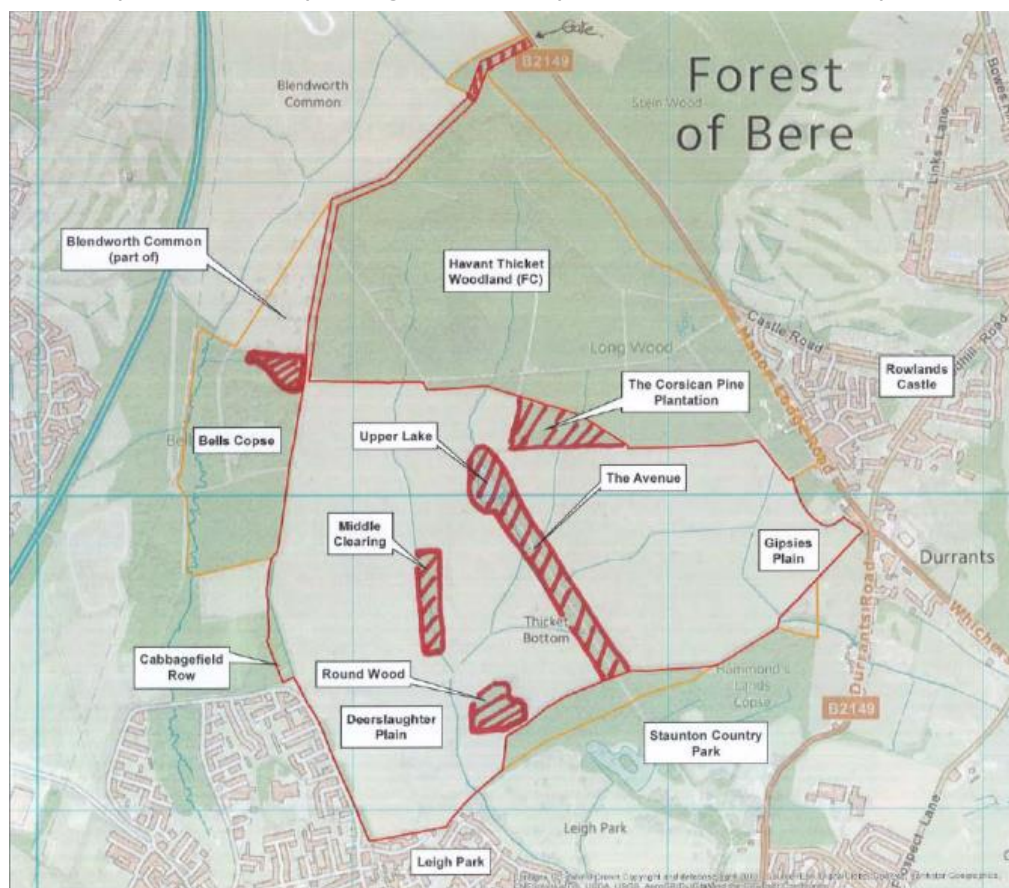
**Figure 3-1 - woodlands within and adjacent to reservoir site. [Source Portsmouth Water Ltd and Cross and Sanderson, 2020]**

- 3.3. The reservoir site and its northern access lie within or adjacent to woodland areas shown on Figure 3-1 below. The two red hatched plots with no label are known as the 'Blendworth Fragment' for the thin northern strip, and 'Bells Copse fragment' for the plot to the north of Bells Copse.

- 3.4. The red hatched woodland areas are all designated Ancient Woodland, namely; The Avenue; Round Wood; Middle Clearing; Bells Copse fragment; The Corsican Pine Plantation; and, the Blendworth Fragment. Whilst these designations have been challenged, Natural England still maintain their Ancient woodland status. The different woodlands are discussed in more detail below.

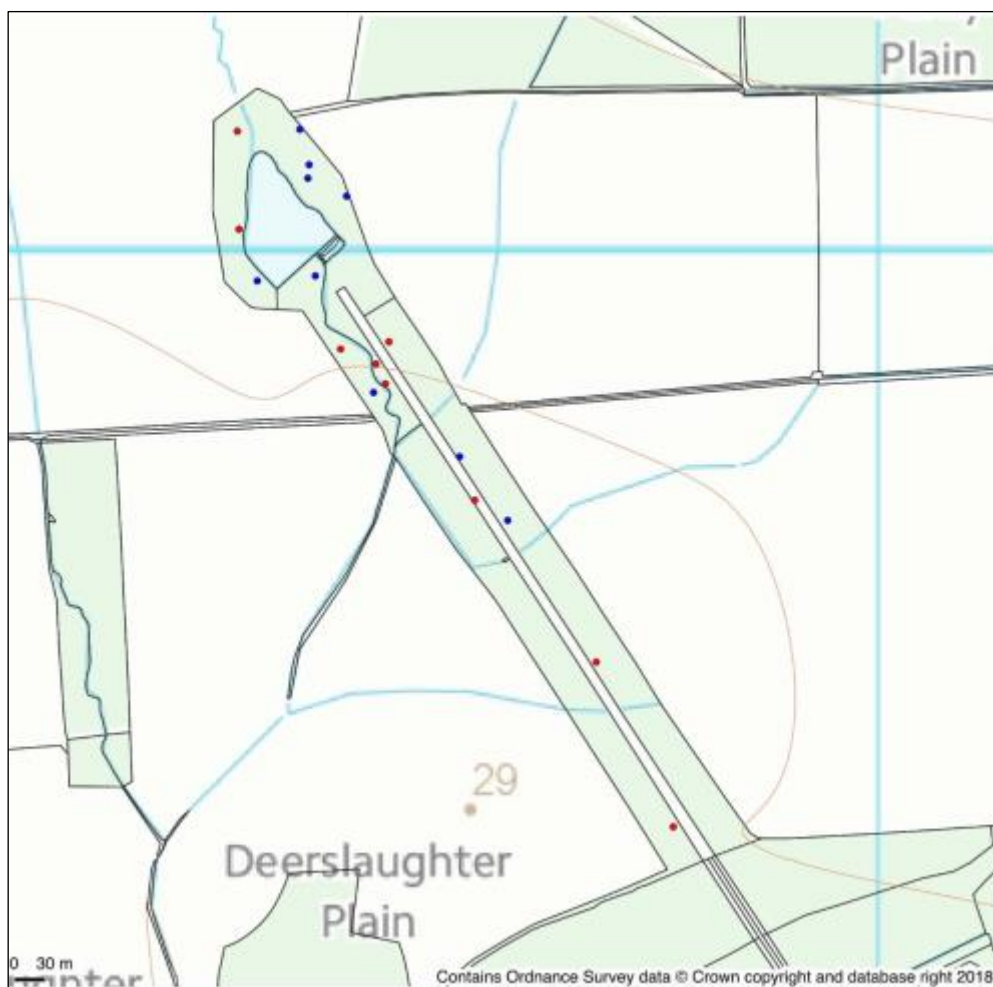
**Figure 3-5 - location of veteran trees in The Avenue. Red dots are for trees with lichen interest, and blue dots are for trees without lichen interest [Source: Cross and Sanderson, 2020]**

- 3.21. Cross and Sanderson (2020) have identified a total of 18no. veteran trees as part of their assessments in The Avenue and considered to be part of the pre-enclosure trees in this locality.
- 3.22. The trees contain various decay features that provide saproxylic habitat value, but in their reporting, it was confirmed that these were few in number. Only one of these trees has been recorded individually as part of this report, and that is believed to be the southern red dot and referenced as tree W127V in this report. It was noted within the Cross and Sanderson report that their locations are open to discrepancy based on the limitations of their recording equipment.
- 3.23. The locations of the trees are shown on Figure 3-5 below and have been incorporated into the TPPs.

- 3.24. Those individual trees that have been classified as veteran specimens as part of this report are referenced as 'V' within the life stage classification column of the survey schedule and shaded gold on the TPPs. A total of 8 veteran trees were identified as part of this assessment. All these trees are growing within or adjacent to the pipeline corridor. See Table 3-1 below for those trees recorded as veteran specimens.

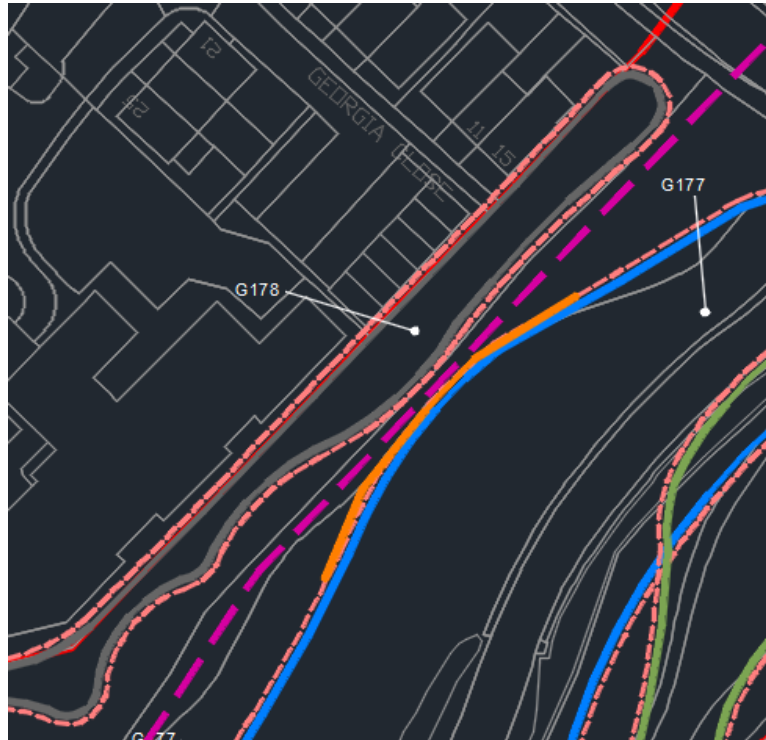
**Figure 4-1 - extract from Atkins TPP. Pink dashed line forming pipeline corridor.**

- 4.22. These trees are currently either located within the footprint of the pipeline corridor or within easement areas required to facilitate the installation of the pipeline and accommodate plant movement and other construction activity. A 10m wide easement for areas of land outside of a road corridor where the red line is restricted in Staunton Country Park has been used to inform this assessment.
- 4.23. Where the red line has been extended the limitations of construction vehicle movement and soil storage is reduced and as such the arboriculturists have in areas along Hermitage Stream reduced tree removals to a minimum. Based on the assumption that the trench for the pipeline could be excavated on opposing sides of pinch points in between trees. As illustrated on Figure 4-1 below.

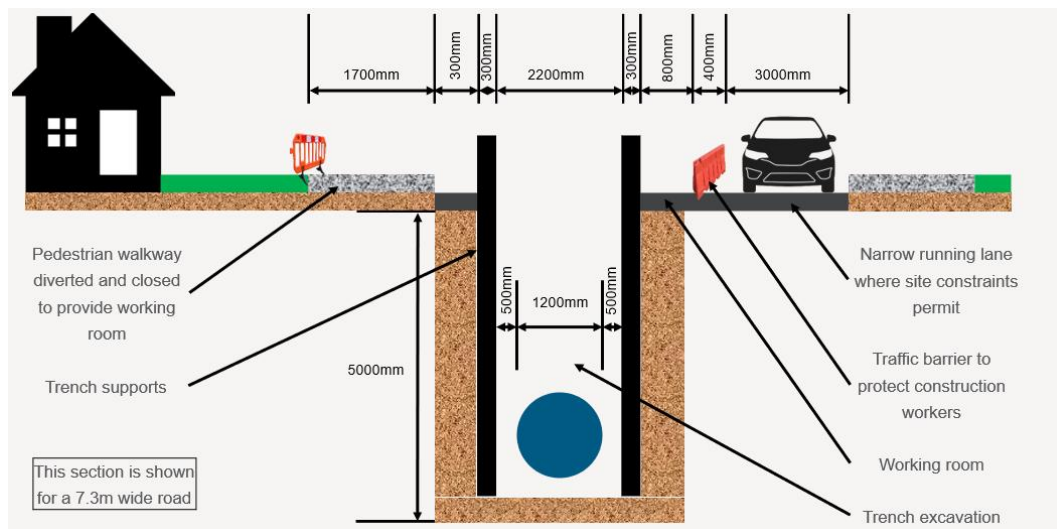
**Figure 4-2 - typical cross section for 7.3m wide road [Source: 200414-Havant Reservoir draft Construction Sequence V0.7 WIP]**

- 4.25. The impacts of these works are reduced for trees based on the existing disturbed ground conditions, including potential historic root severance from utility installations. Whilst its reduced, such works would not be negligible in terms of potential impacts on tree roots. As such any areas adjacent to trees and within their RPAs would require specific mitigation measures and defined within an AMS. Specific mitigation measures could include localised trenchless solutions or vacuum excavations of revealed sub-soils under arboricultural supervision.
