SHEET 6  
Photographic Record / Inventory:  
Ground Floor: G6, 7, 8, 9, 10

January 2020

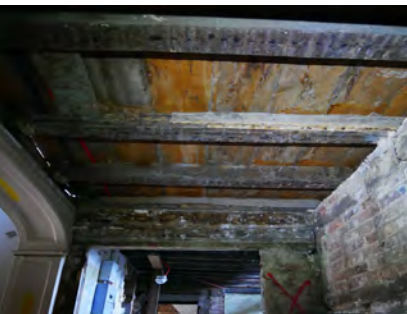
19. G6 - Inner hallway - baffle entry from west. The nib was added to narrow the doorway. A narrow timber has been added below the cross beam. Ceiling was intended to be concealed.
