Before: Dining Room

Current (2018/19):

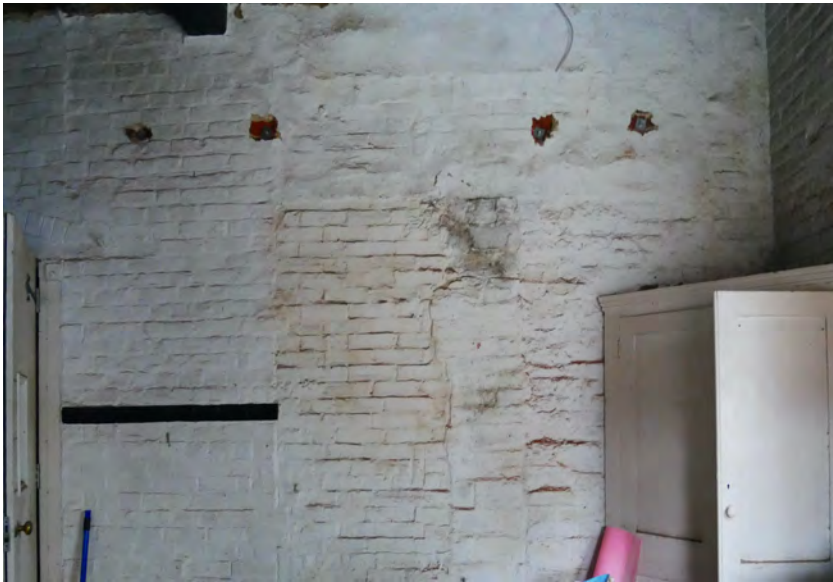
32. Inner face of south wall reveals a former door opening to G12 and a cambered arch to the door to G13. Bolts for new Floor to G11/12 noted.
