**Tree Report**  
**200 Seafront, Hayling Island**

**1.1 Test date:** 21st April 2020 by Mr. Kim Gifford, undertaken in the area of test and at the time of inspection.

**1.6 Holm Oak (Quercus ilex) front garden 200 Seafront, Hayling.**  
**Test undertaken in fine weather conditions.**

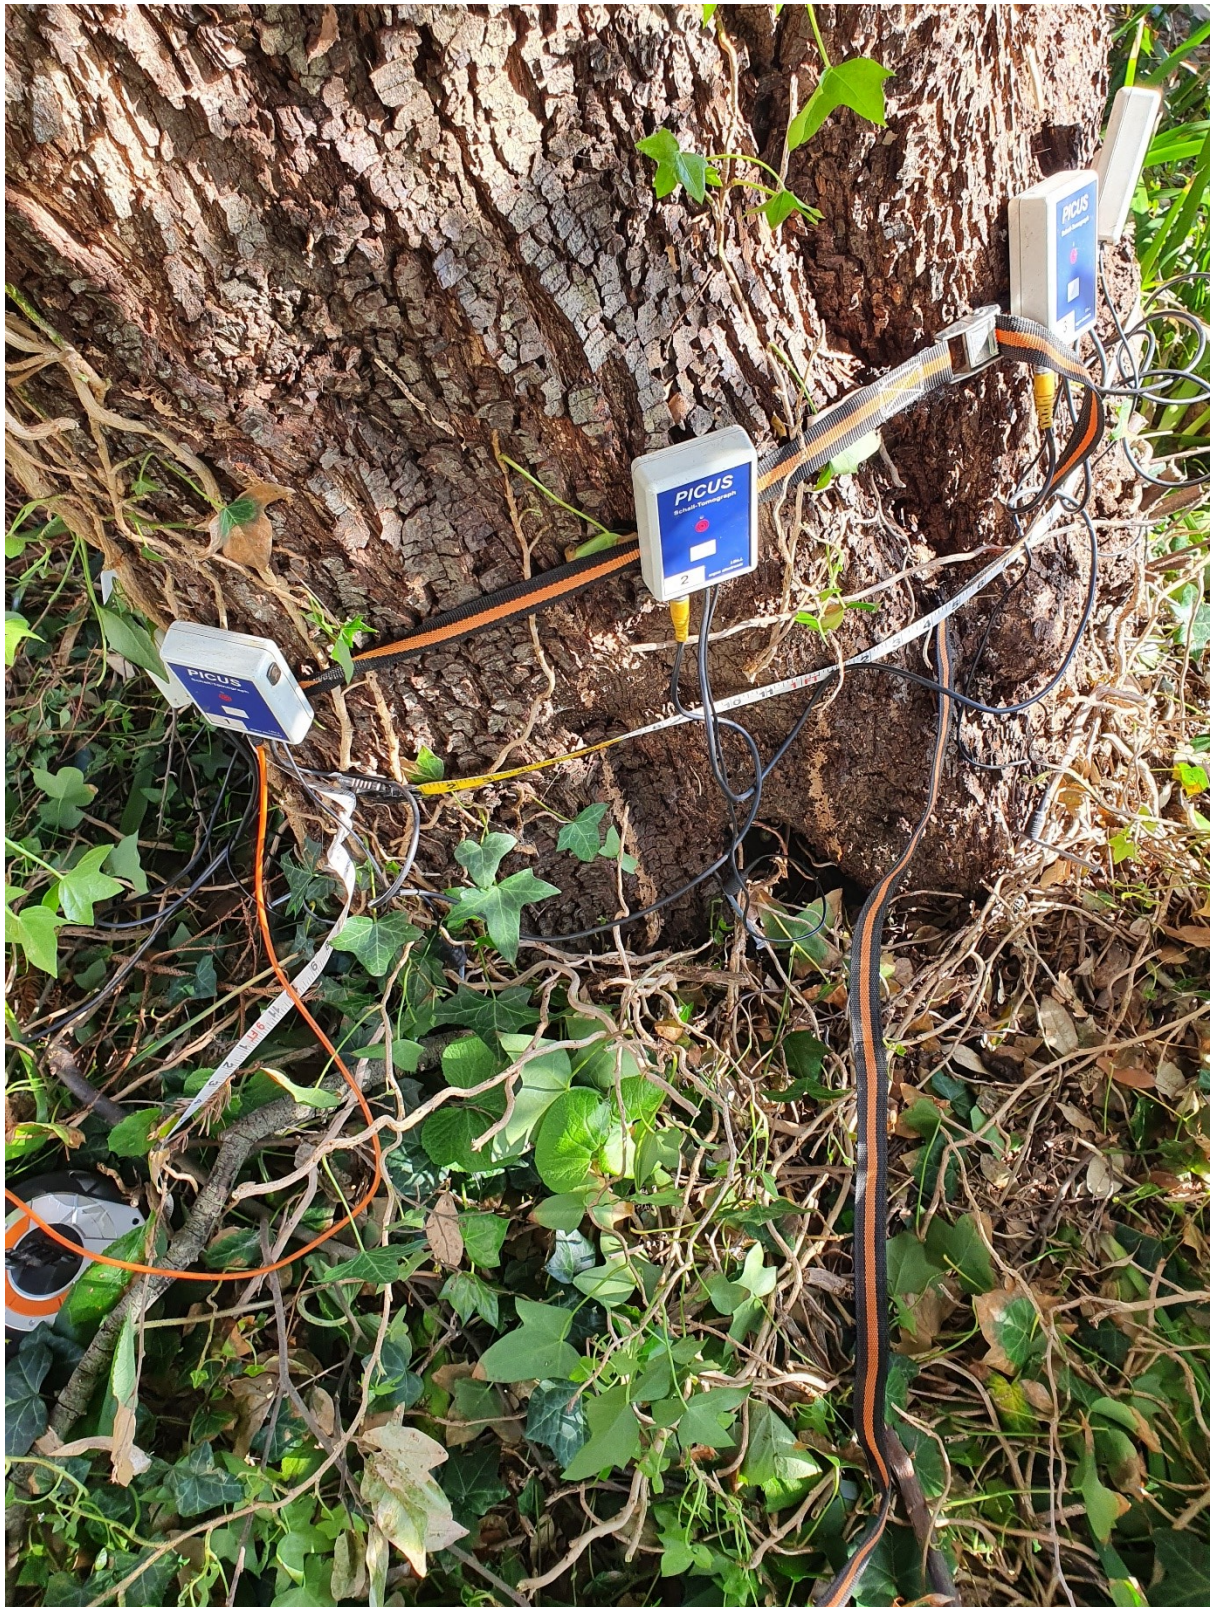
The measuring point readings give evidence of medium sound velocities overall in the area of test representation showing as altered timber. The tomographic image shown above has a percentage amount of altered/ decayed timber (detailed on the top graph bar of the image). With reference to the 'colour chart see figure 2', the slower sonic speed of sound is represented by three bands of data representation blue/violet/white being the slowest altered/decayed timber, green being faster not altered timber, brown being fast sonic-speeds solid timber.

The yellow lines are indicators of possible internal cracking or splitting timber in the area of test.

*Figure Picus testing*

**It is appropriate to recommend that the Holm Oak is removed entirely and mitigated with a new semimature transplant. I would recommend a Fastigate Oak (Quercus robur Fastigate).**
