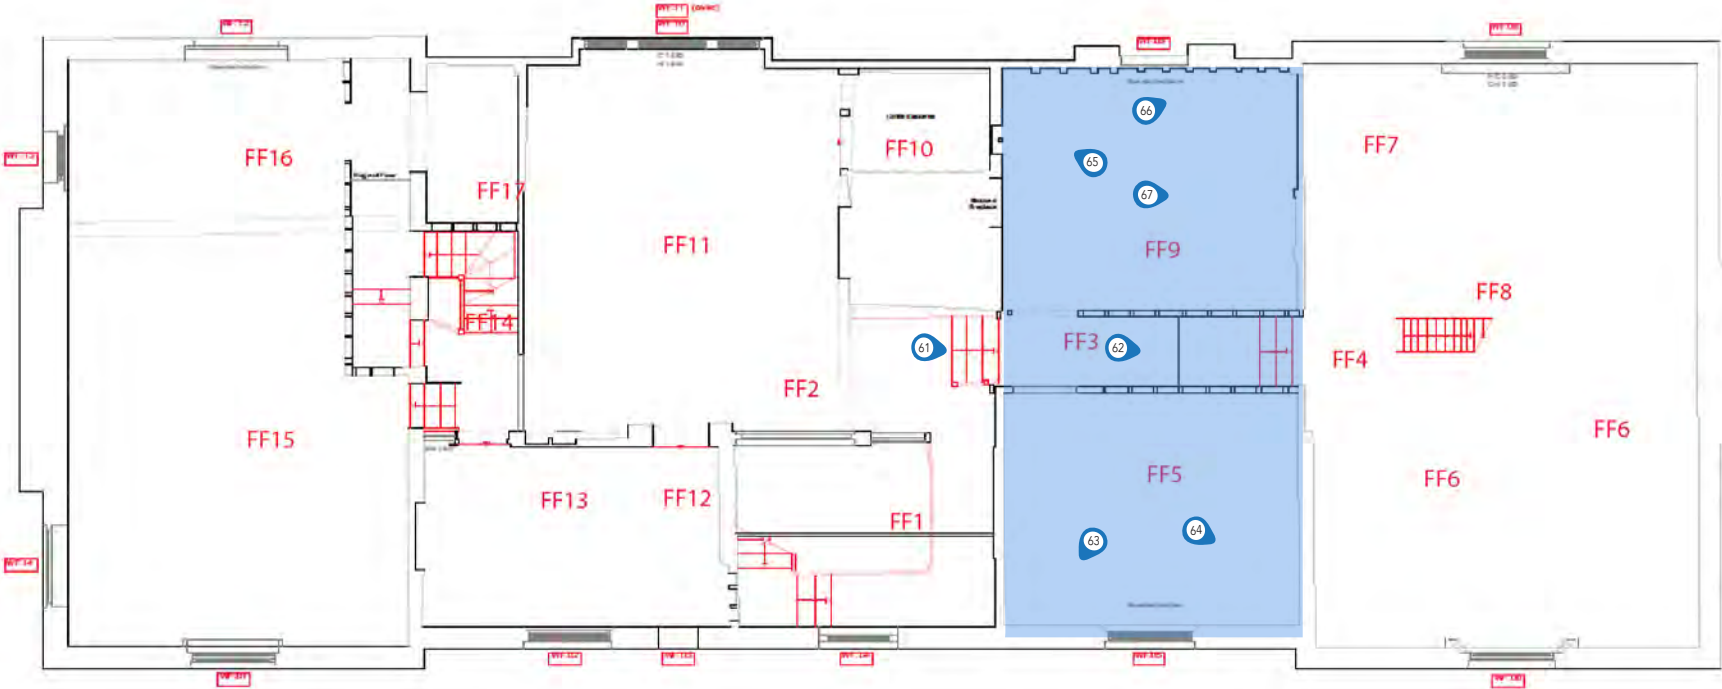
Notes:  
Refer to Dwg MHB-03A, 05A for notes and O7A. Reference should also be made to The Green Oak Carpentry Co details for repairs. FF5 pre-dates the insertion of hall / stair bay. Both FF5 and FF9 were altered during the time that the southern cross wing was added and including raising floor, ceiling.
