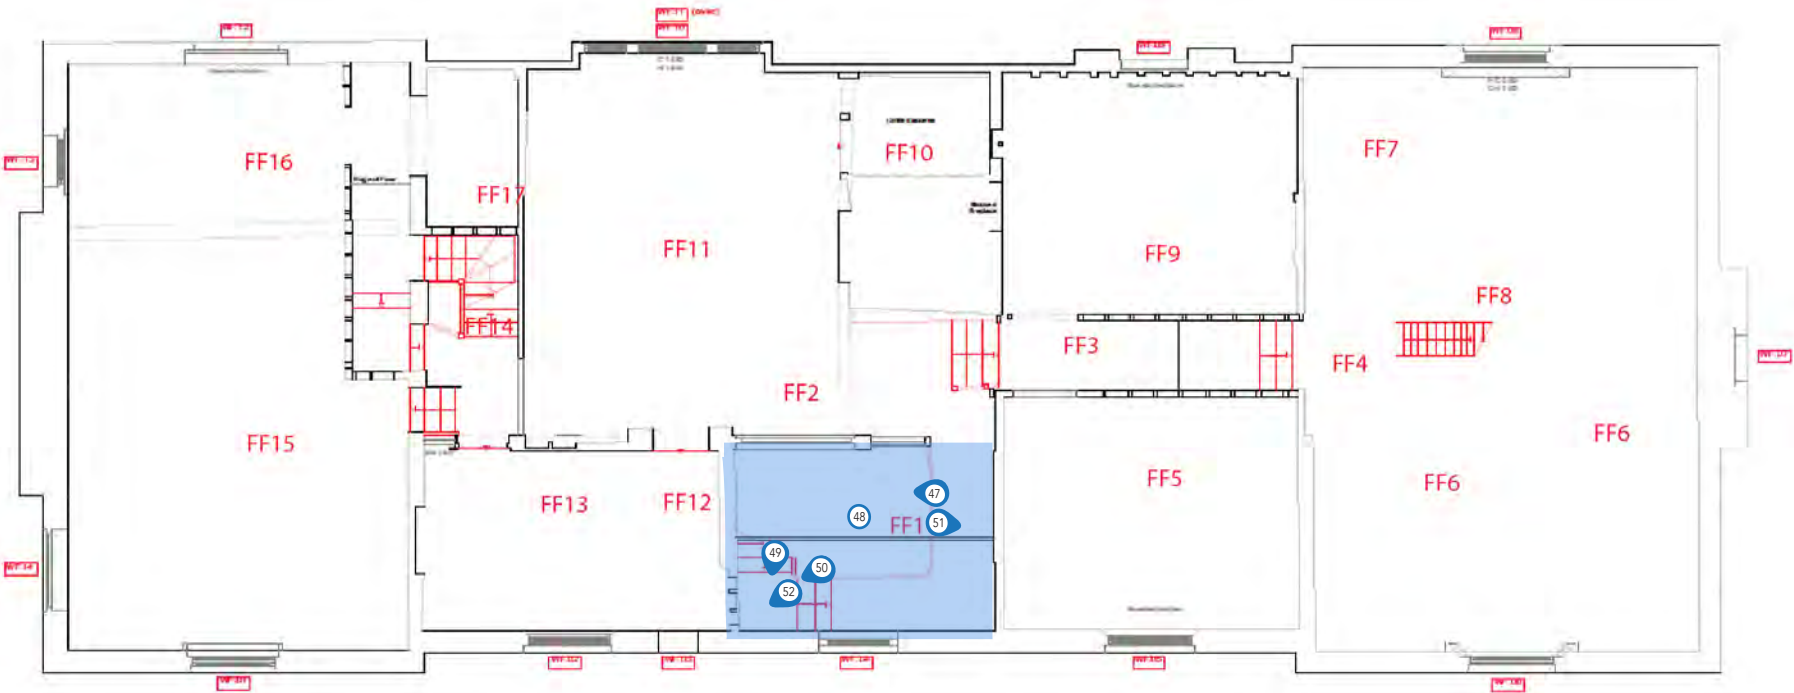
51. South inner elevation - wall plate to central chamber of 3-bay timber framed building noted with two extended areas of brickwork suggesting two phases of change and raised ceiling heights corresponding with raised floor heights to southern rooms. Note the nature of the Queen Post roof to FF5. Note the roof to the south differs over FF12 /13
