## Project-information / Inspection: 1

Project name :  
**PTA Havant Survey 2**

Date :  
**17/10/2019**

Site: **Pre Development**  
Contact Name:  
Department:  
Road: **New Lane**  
Town: **Havant**  
County: **Hampshire**  
Telephone:  
Fax:  
Mobile:  
E-mail:

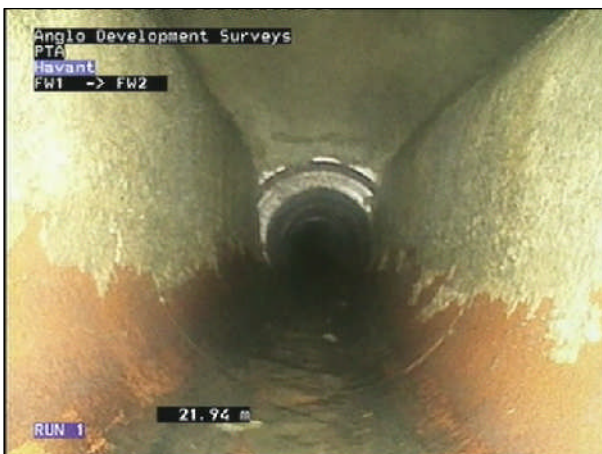
Photo: 1\_1\_8\_A.JPG  
21.9m, Finish node type, manhole reference number: FW2

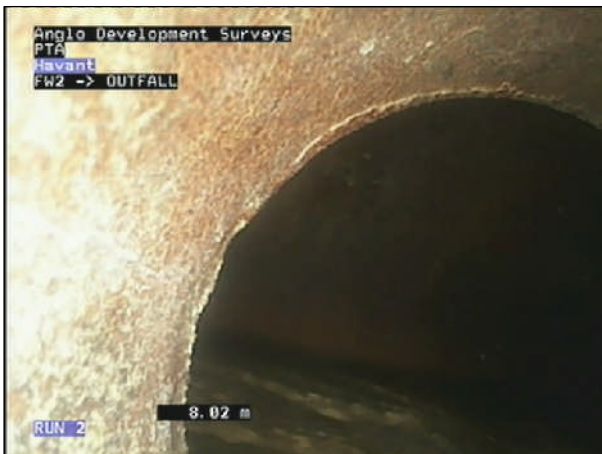
Photo: 3\_3\_13\_A.JPG  
8m, Finish node type, outfall reference number: OUTFALL

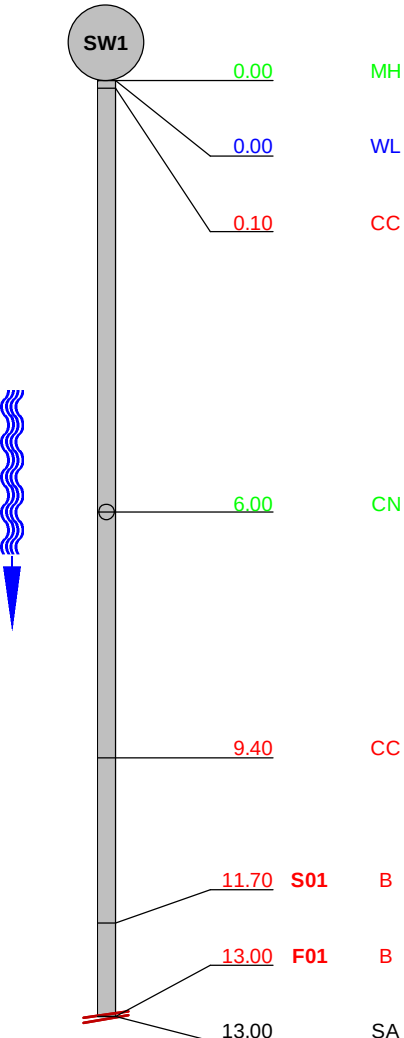
| 1:105<br>Depth: 1 | Position | Code | Observation | Grade |
|---|---|---|---|---|
| 0.10 | CC | | Crack, circumferential, from 12 to 12 o'clock | (Struct) 2 |
| 9.40 | CC | | Crack, circumferential, from 12 to 12 o'clock | (Struct) 2 |
| 11.70 S01 | B | | Broken pipe, from 12 to 12 o'clock, Start | (Struct) 4 |
| 13.00 F01 | B | | Broken pipe, from 12 to 12 o'clock, End | (Struct) 4 |

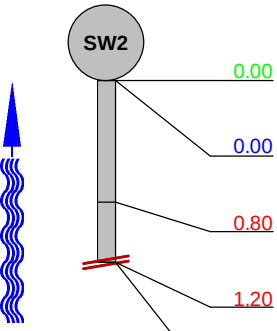
| 1:50<br>Depth: 8.75 | Position | Code | Observation | Grade |
|---|---|---|---|---|
| | | S01 | Broken pipe, from 12 to 12 o'clock, Start | (Struct) 4 |
| | | F01 | Broken pipe, from 12 to 12 o'clock, End | (Struct) 4 |

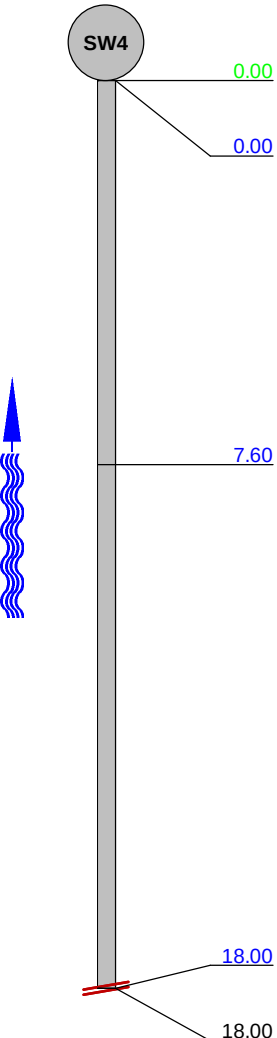
| 1:150<br>Depth: 0.55 | Position | Code | Observation | Grade |
|---|---|---|---|---|
| 0.00 | MH | | Start node type, manhole, reference number :<br>SW4 | (Constr) 0 |
| 0.00 | WL | | Water level, 10% of the vertical dimension | (Serv) 0 |
