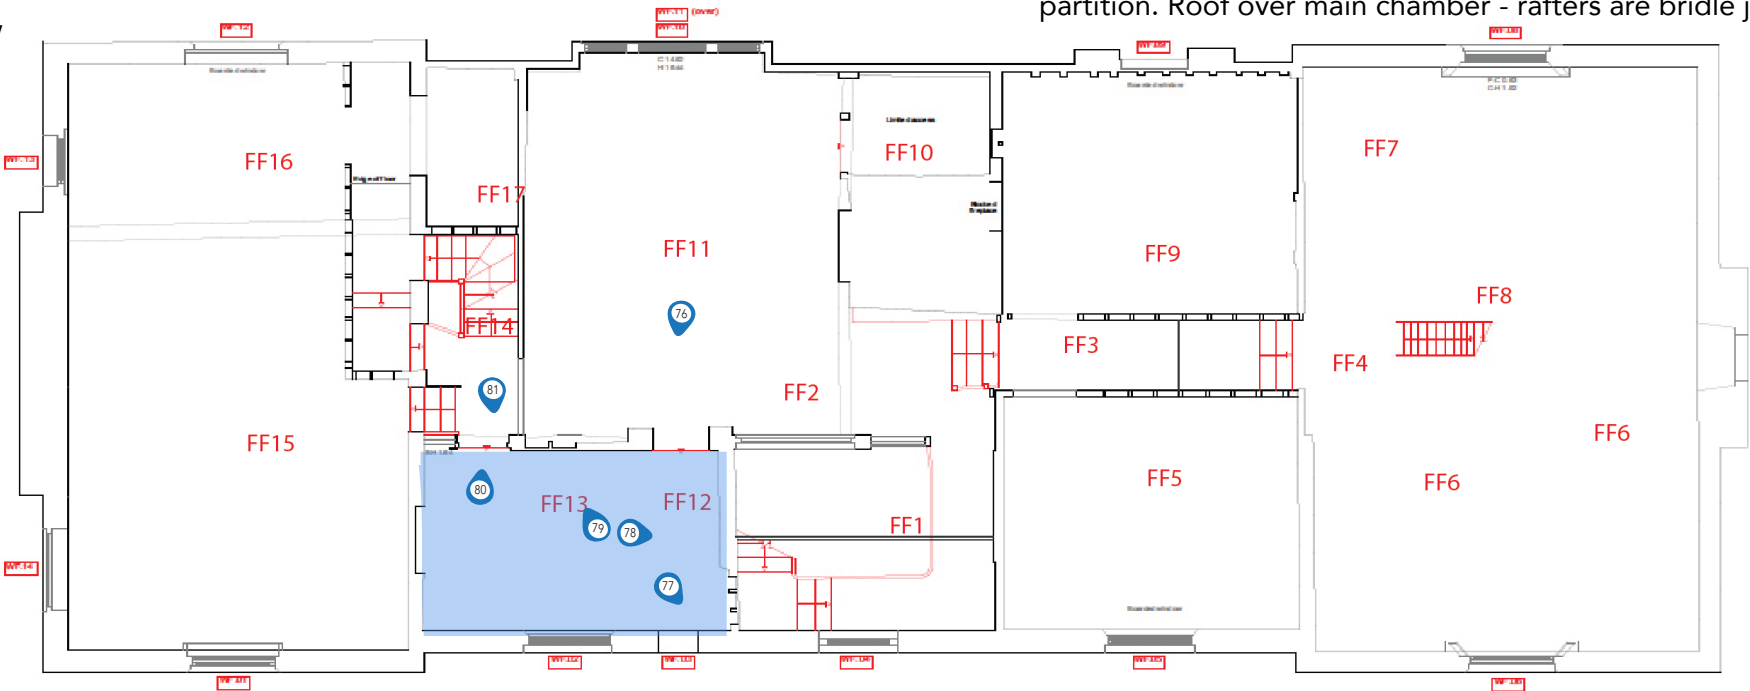
Notes:  
Refer to Dwg MHB-03A, 05A for notes and O7A.  
Reference should also be made to The Green Oak Carpentry Co details for repairs. FF12/13 pre-dates the insertion of hall / stair bay. Part of the 'ghost' north bay can be seen at the junction of FF11,13,14.
