# **ARBORICULTURAL IMPACT ASSESSMENT AND METHOD STATEMENT**

**The White House, 2 Langstone Road,  
Langstone, PO9 1RE**

**Add additional floor space to the existing guest room above  
the garage by adding a new dormer to the east side of the  
roof**

**Date – 10<sup>th</sup> August 2019**

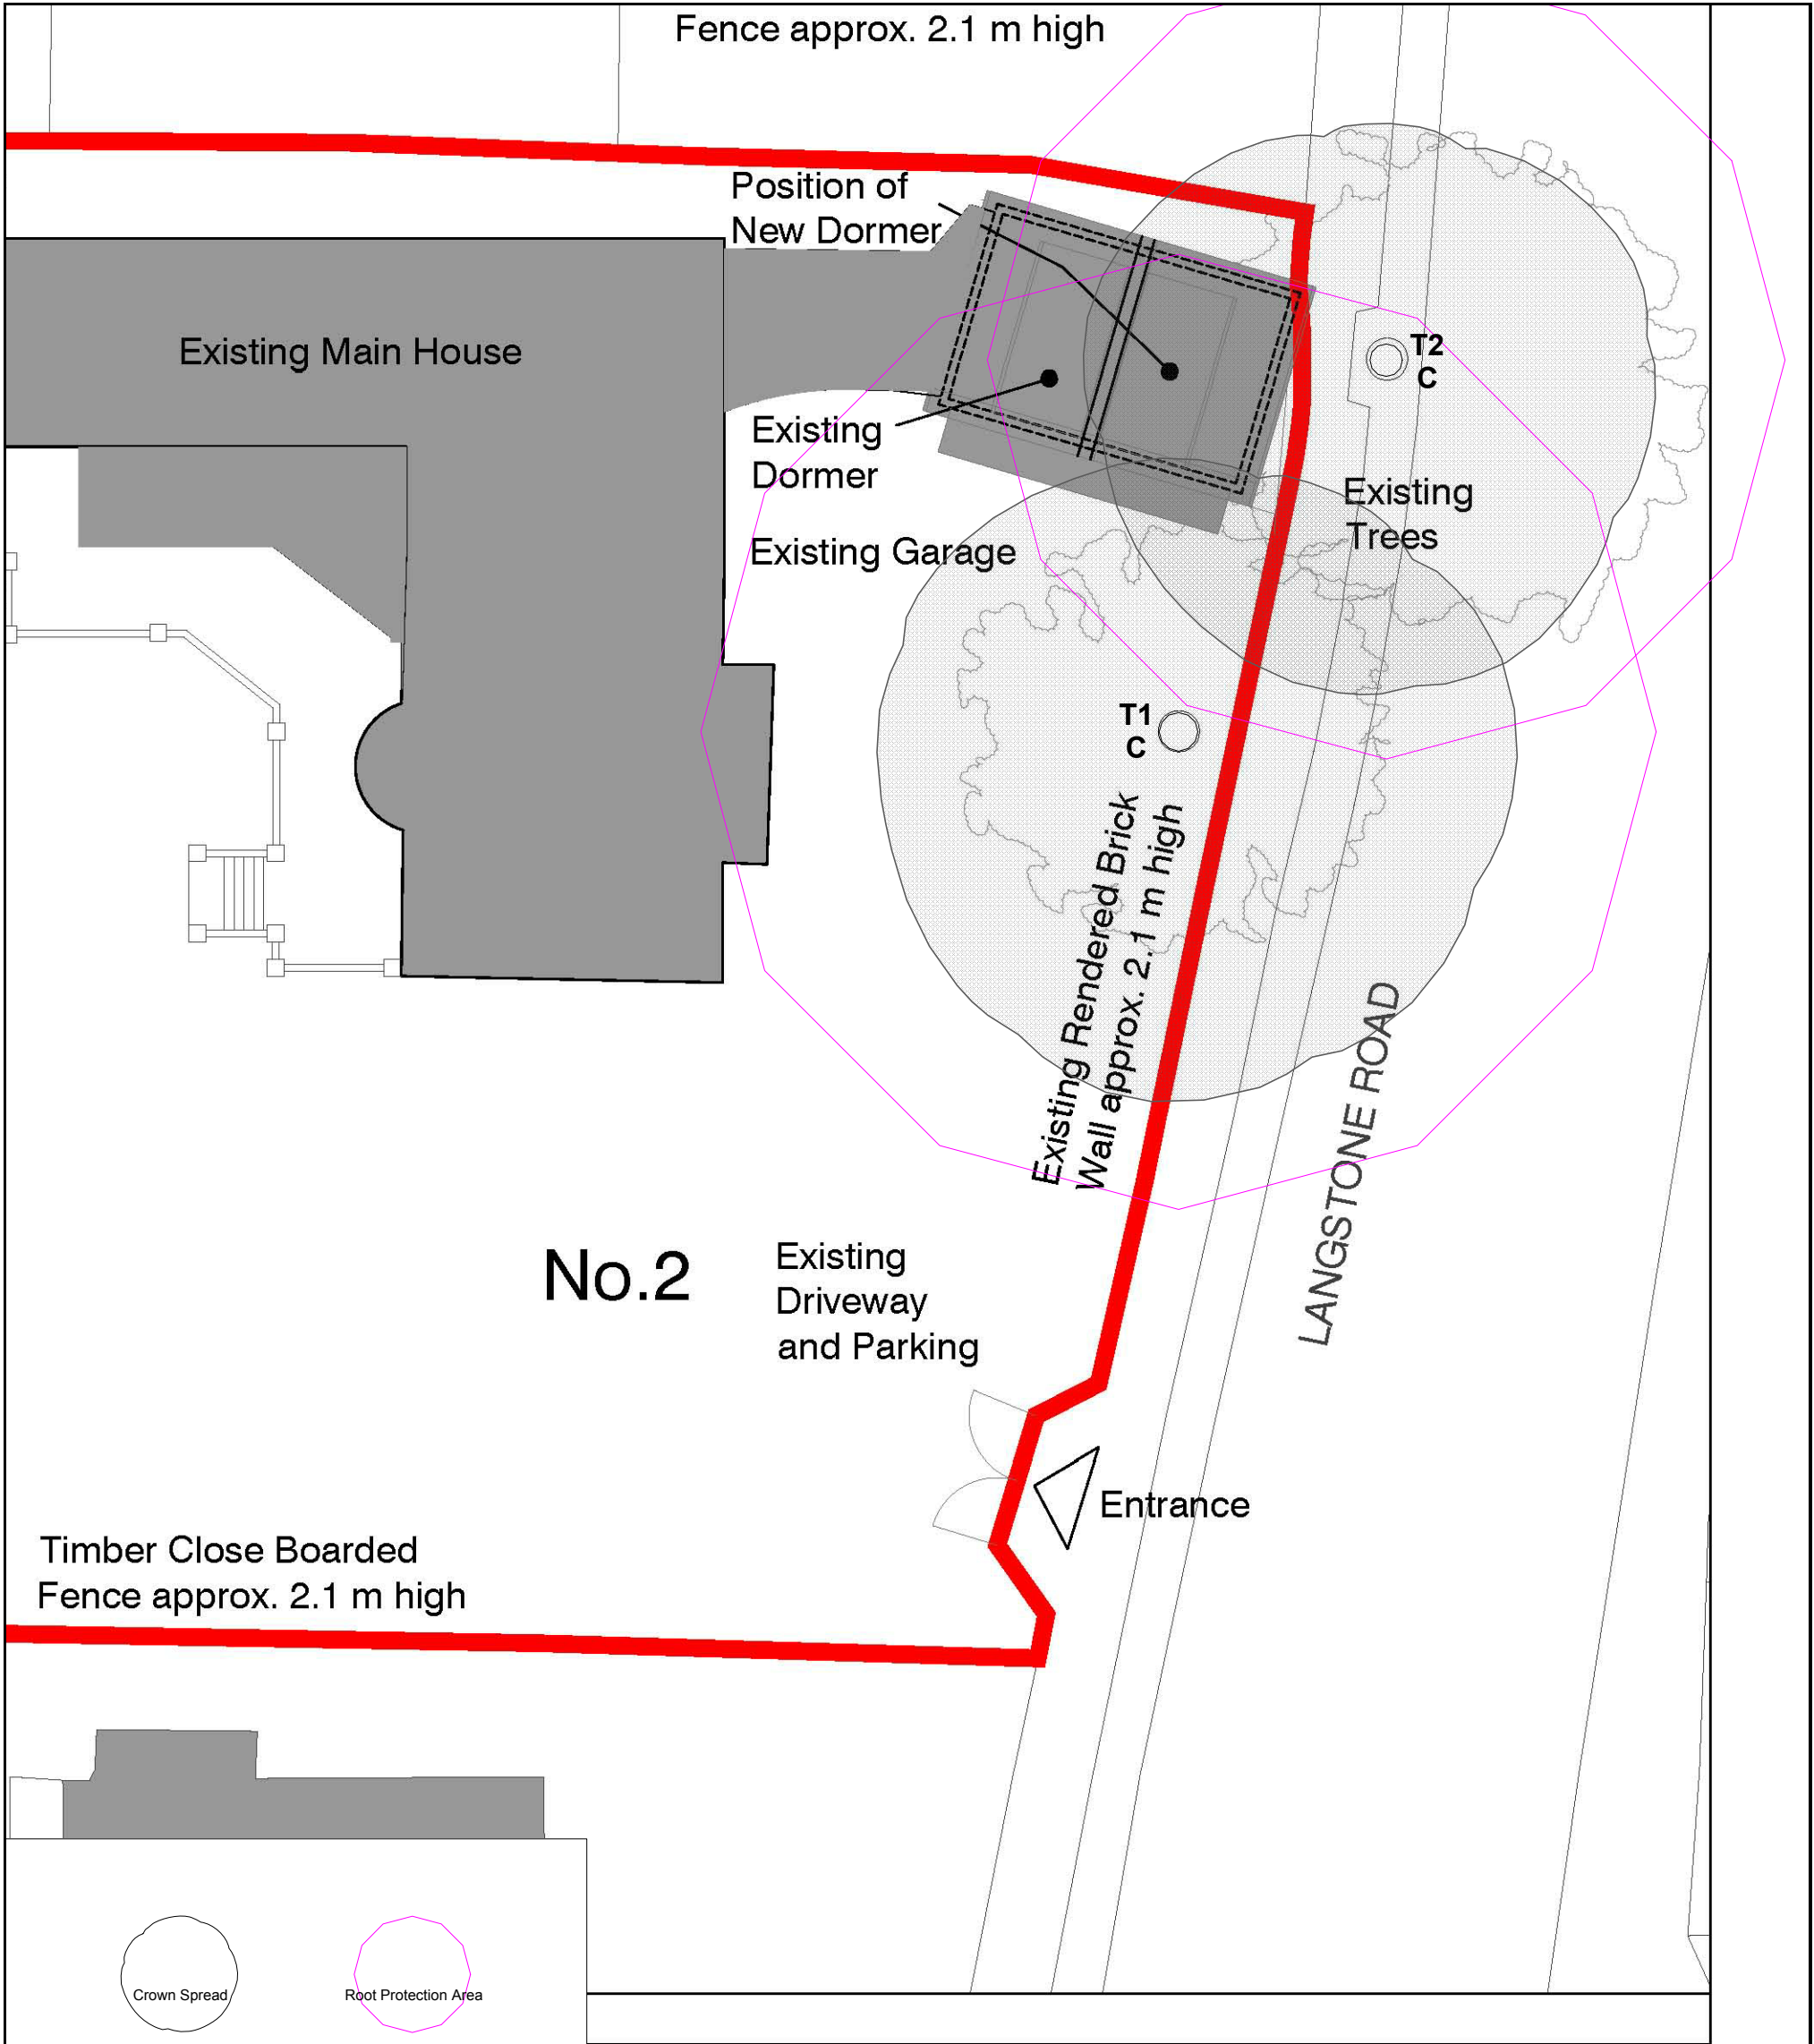
| Tree No | Species | H't (m) | Single/ Multi-Stemmed (S or MS) | Stem Diam (mm) | Root Protection Area (m²) | Root Protection Distance (m) | Branch Spread (m) | H't of Crown AGL (m) | Life Stage | Physio-logical Condition | Structural Condition and General Observations | Preliminary Management Recommendations | Est. Rem. Contrib. (Yrs) | Cat |
|---|---|---|---|---|---|---|---|---|---|---|---|---|---|---|
| 1 | Purple Beech<br><i>Fagus sylvatica</i><br><i>'Purpurea'</i> | 13 | S | 1150 | 598 | 13.8 | N 8<br>E 10<br>S 11<br>W 9 | N 4<br>E 2<br>S 3.5<br>W 3 | Mature | Fair | Structural Condition - Poor<br><br>Grow in walled shrub bed<br>Boundary wall to east<br>Bifurcated at 3m above ground level<br>Old pruning wounds on trunk and in crown<br>Tight forks with included bark<br>Previously topped at 6m above ground level with decay in wounds<br>Bleeding canker on all sides of trunk at base<br>Possible Kretzschmaria deusta fungal fruiting bodies at base of trunk on south side<br>Crown is thin due in part to loss of main trunks | Reassess within 2 years<br>Consider full ground level inspection with decay detection equipment within 2 years | 10+ | C1+2 |
| 2 | Horse Chestnut<br><i>Aesculus</i><br><i>hippocastanum</i> | 14 | S | 960 | 417 | 11.5 | N 7<br>E 8<br>S 10<br>W 9 | N 3<br>E 5<br>S 3.5<br>W 7 | Mature | Fair | Structural Condition - Fair<br><br>Offsite tree growing in public footpath<br>Multi stemmed at 3m above ground level<br>Previously crown lifted on the western side<br>Old pruning wounds on trunk and in crown<br>Epicormics on trunk and in crown<br>Bark wounds in crown<br>Minor deadwood in crown | Prune lower north east epicormic branches <50mm to provide working space and separation from proposed dormer window | 20+ | C1+2 |
