Site: The Manor, Edward Gardens, Bedhampton  
Date Visited: 27 November 2018  
Date Prepared: 04 12 2018 revised April 2019  
Area of Work: Front Porch

Porch to west elevation

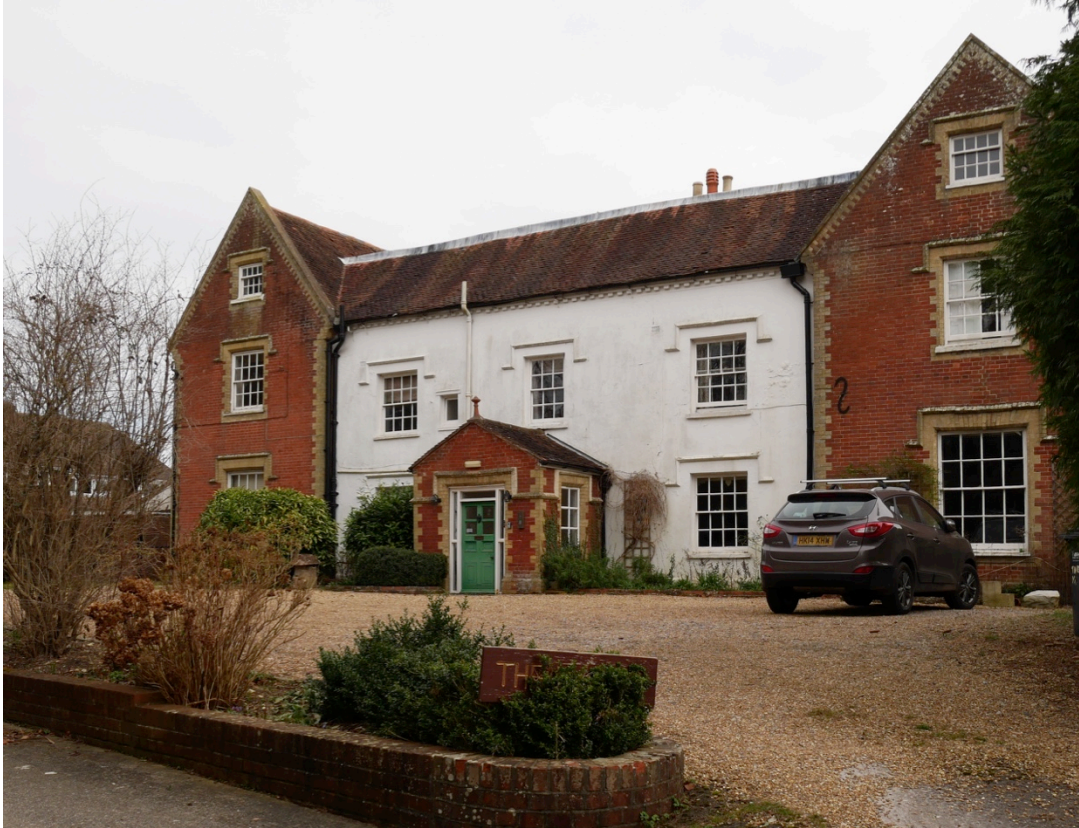
*Front West Elevation with Porch intact before works – 17 June 2018 taken by Murphy Associates in connection with conservation area appraisal work.*
