## **TREE SURVEY, ARBORICULTURAL IMPACT ASSESSMENT AND TREE PROTECTION PLAN**

Report to accompany a planning application for the demolition of a single-storey side extension, creation of an access drive and construction of a new three-bedroom bungalow on land to the rear garden of 198 London Road, Waterloooville, PO7 7AN.

*13<sup>th</sup> August 2018*

MDA reference K18

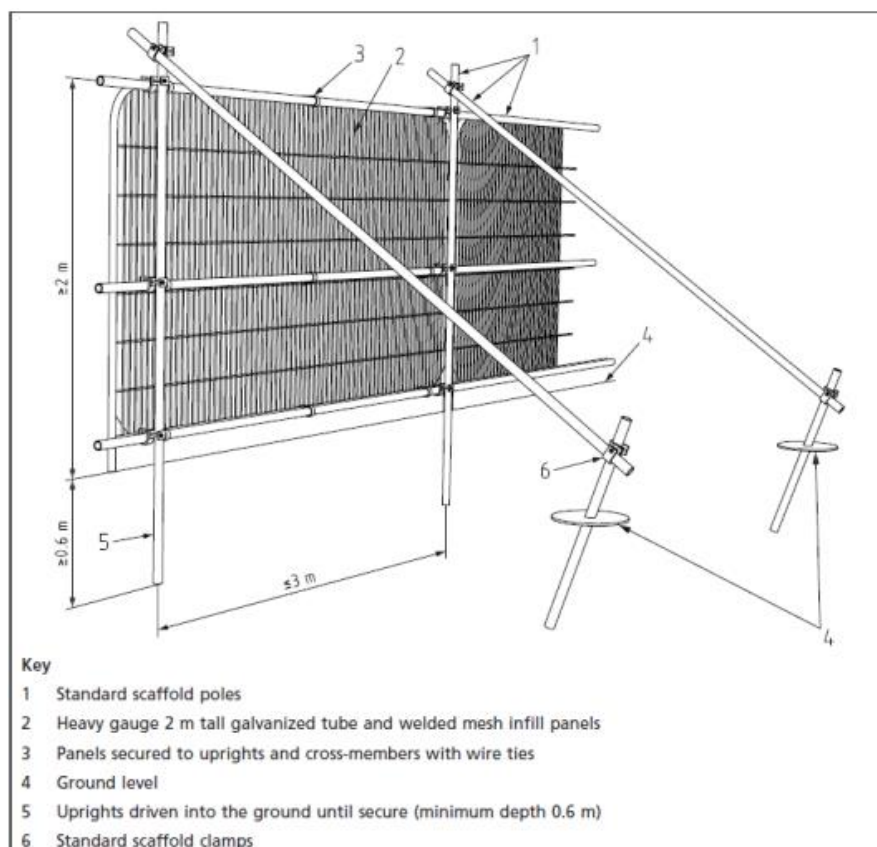
**Figure 3.** Diagram to illustrate design of protective fencing with scaffolding anchored into the ground

- 5.3 Tree protection will comprise of 2 m tall fencing installed in the positions shown at **MD4** before demolition takes place or materials are delivered to site or construction commences. The fencing will consist of a scaffold framework, well braced to resist impacts, with vertical tubes spaced at a maximum interval of 3 m (Figure 3). Onto this, weld mesh panels or 2 m high shuttering board will be securely fixed with wire or scaffold clamps. Un-braced weld mesh panels on unsecured rubber or concrete feet will not be used as these are not resistant to impact and are too easily removed by site operatives. An alternative system of bracing which does not require a scaffold framework is shown in Figure 4.

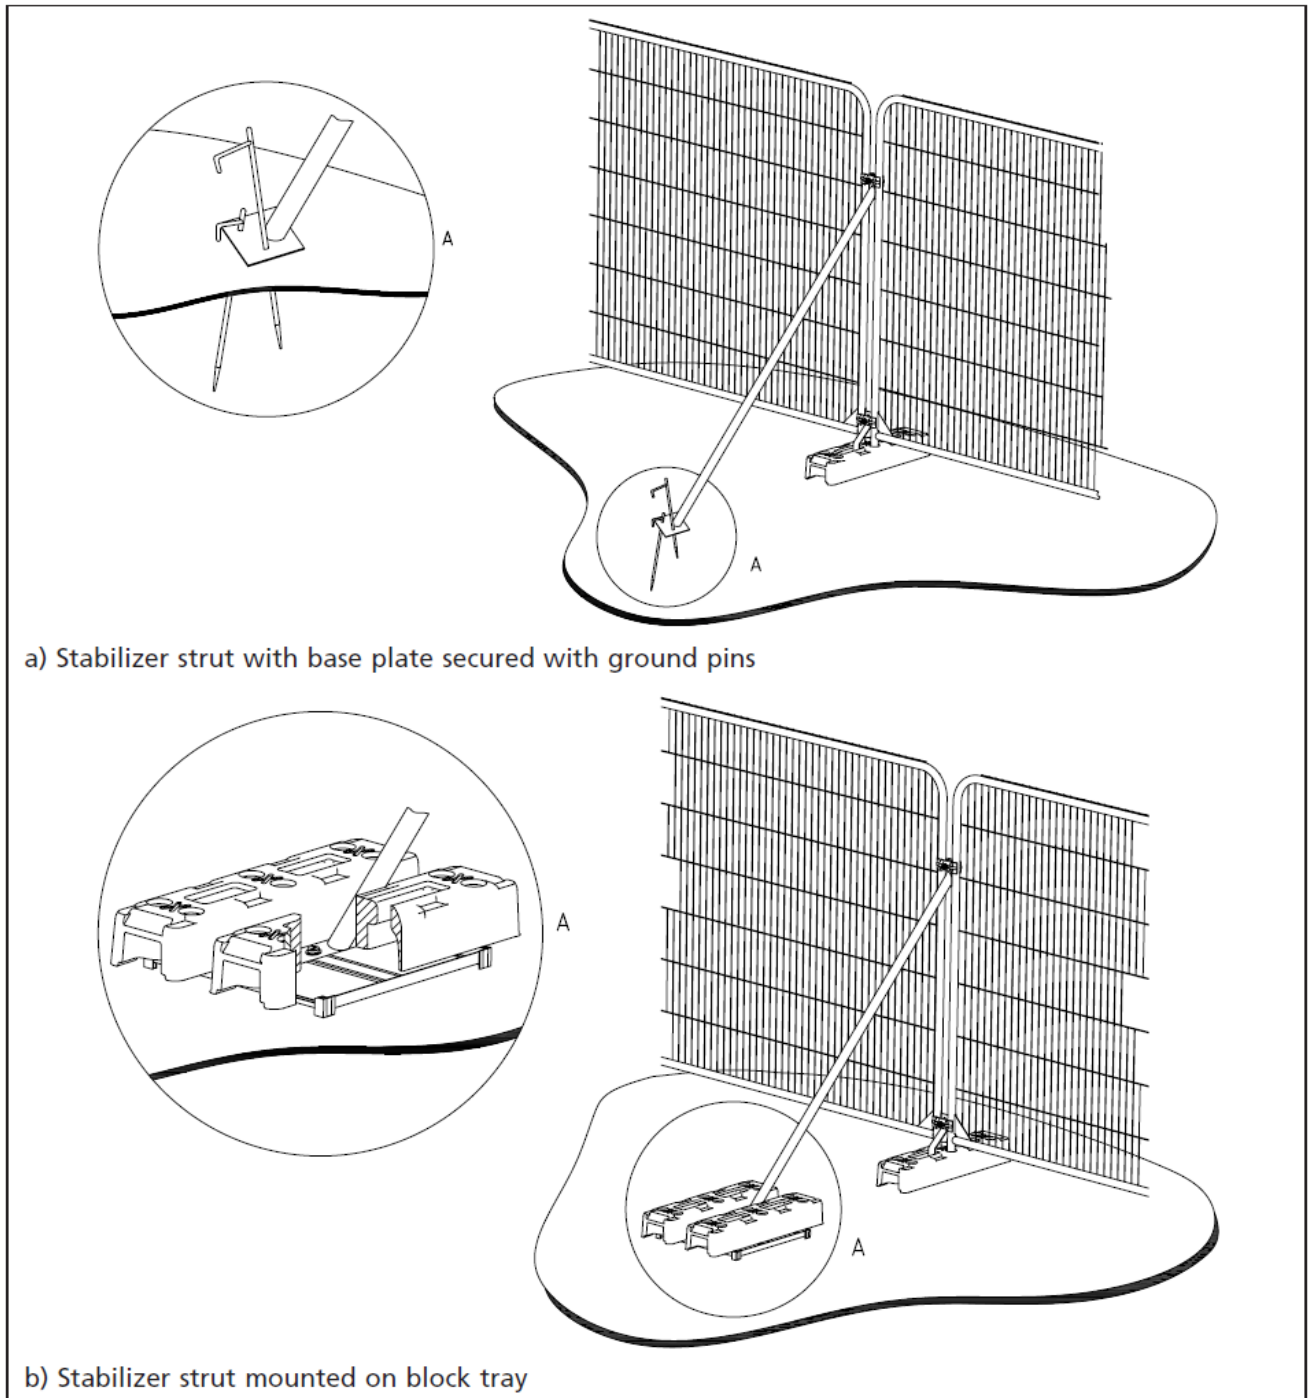
**Figure 4.** Diagram to illustrate alternative design of protective fencing

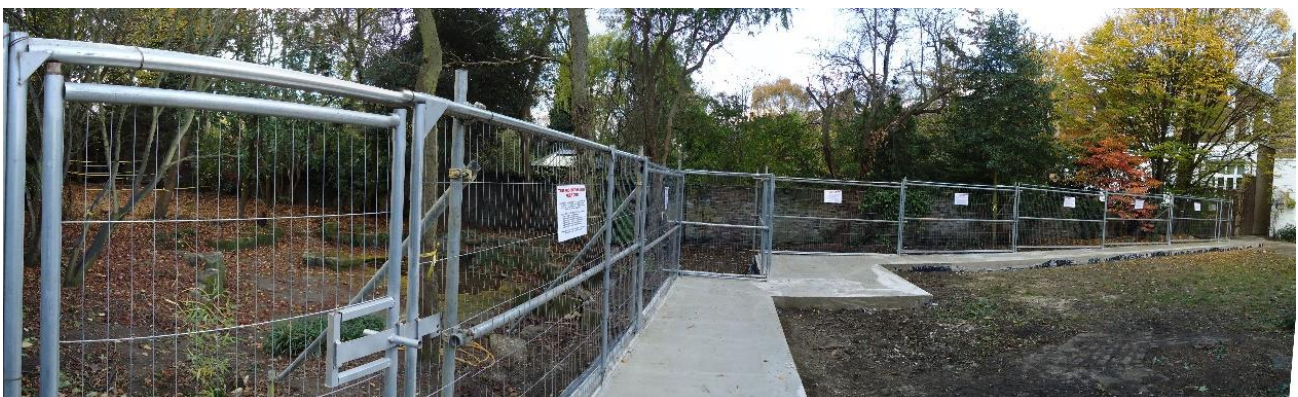
**Figure 5.** Photograph to illustrate installed protective fencing
