**BELLWAY HOMES LTD (WESSEX) & THE  
BORROW FOUNDATION LTD  
PADNELL GRANGE  
WATERLOOVILLE**

**FLOOD RISK ASSESSMENT AND  
DRAINAGE STRATEGY**

**MARCH 2019**

| <b>Project Code:</b> | <b>A/BHPADNELL</b> |

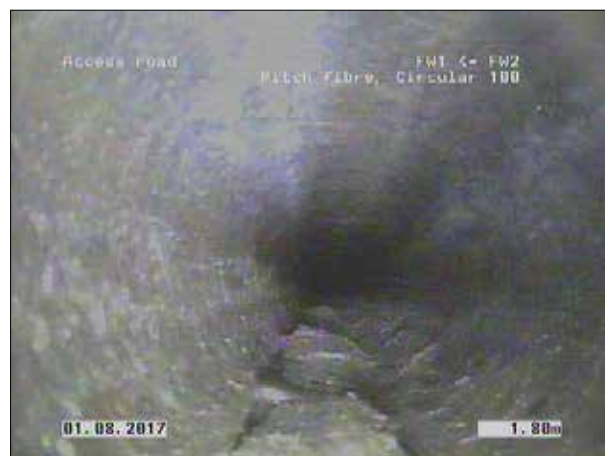
Photo: 3\_3a  
1.8m, Settled deposits hard or compacted 5 % cross-sectional area loss

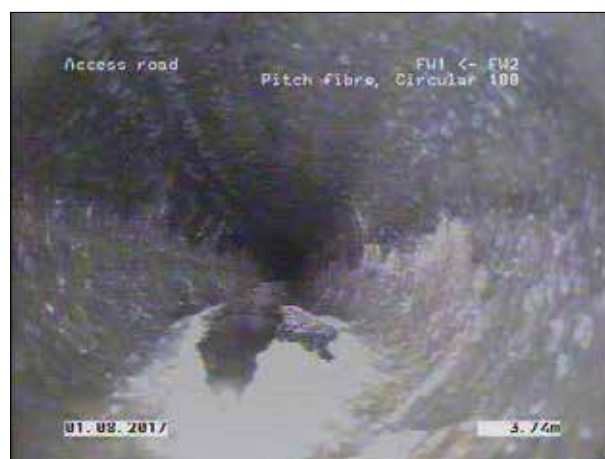
Photo: 10\_5a  
3.74m, Attached deposits encrustation from 05 to 07 o'clock 20 % cross-sectional area loss

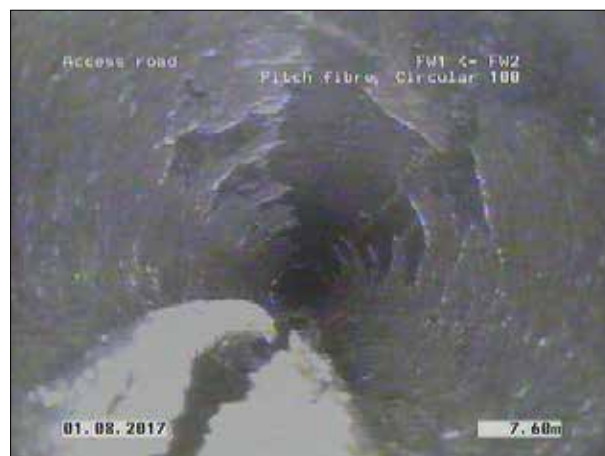
Photo: 1\_7a  
7.6m, Deformed drain/sewer 20 %

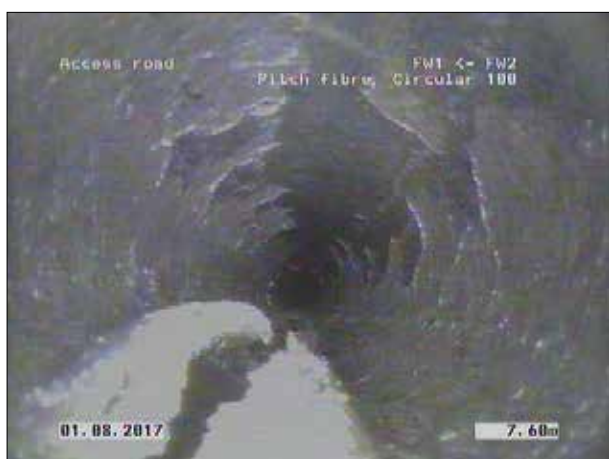
Photo: 1\_8a  
7.6m, Attached deposits encrustation from 05 to 07 o'clock 20 % cross-sectional area loss

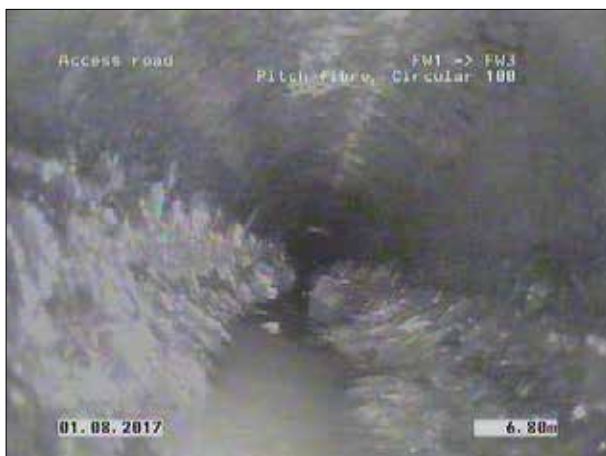
Photo: 14\_4a  
6.8m, Attached deposits encrustation from 04 to 08 o'clock 5 % cross-sectional area loss

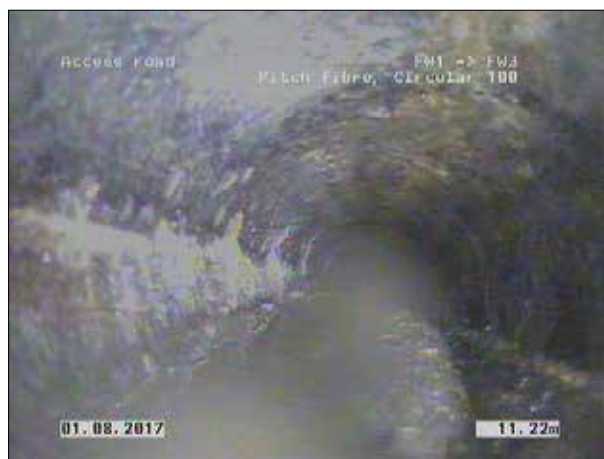
Photo: 17\_7a  
 11.22m, Deformed drain/sewer 30 %

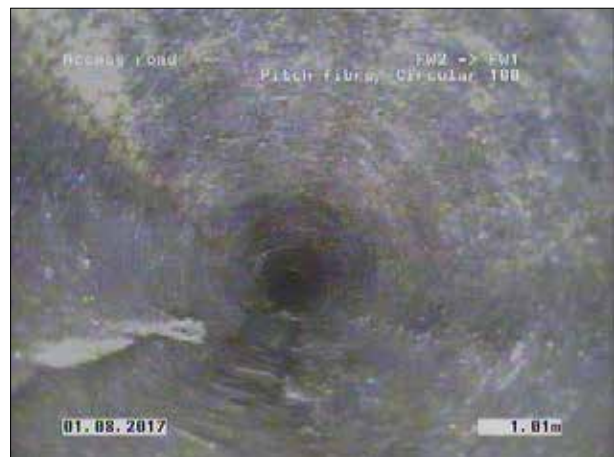
Photo: 3\_3a  
 1.01m, Attached deposits encrustation at 07 o'clock 5 % cross-sectional area loss

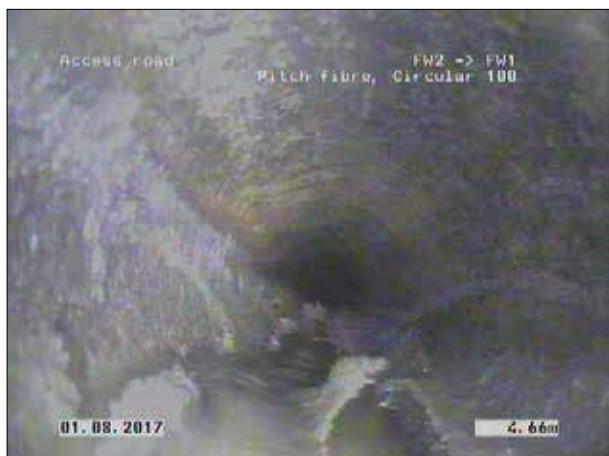
Photo: 3\_4a  
 4.66m, Deformed drain/sewer 10 % Remark: blistered pitch fiber

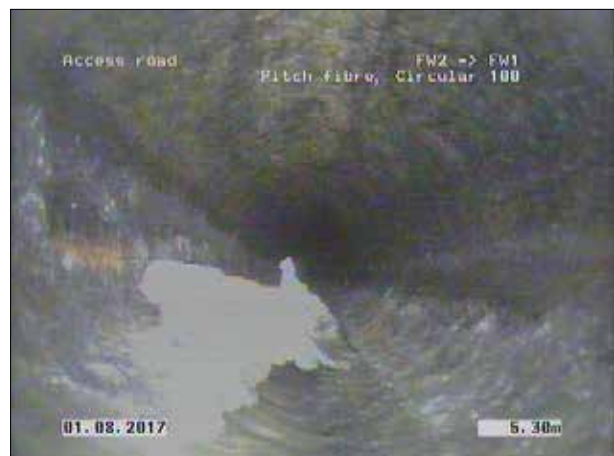
Photo: 3\_5a  
 5.3m, Attached deposits encrustation from 04 to 07 o'clock 30 % cross-sectional area loss

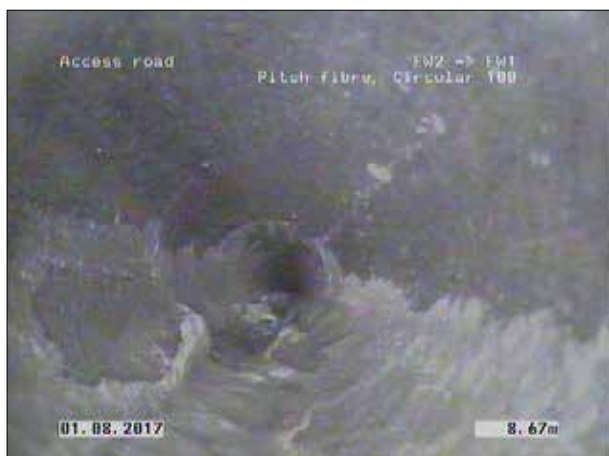
Photo: 3\_6a  
 8.67m, Attached deposits encrustation from 03 to 09 o'clock  
 10 % cross-sectional area loss

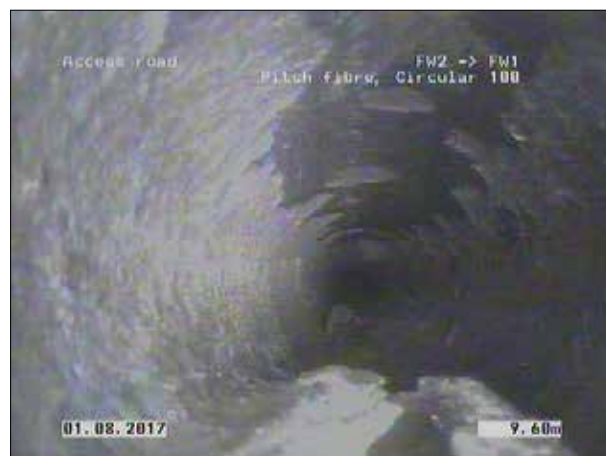
Photo: 3\_7a  
 9.6m, Deformed drain/sewer 10 % Remark: blistered pitch fiber

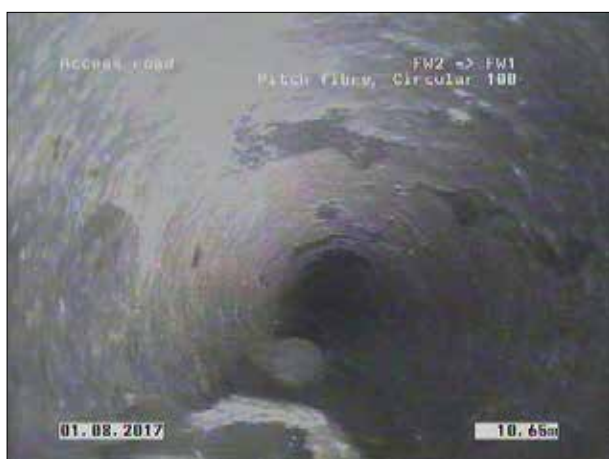
Photo: 3\_8a  
 10.65m, Deformed drain/sewer 10 %

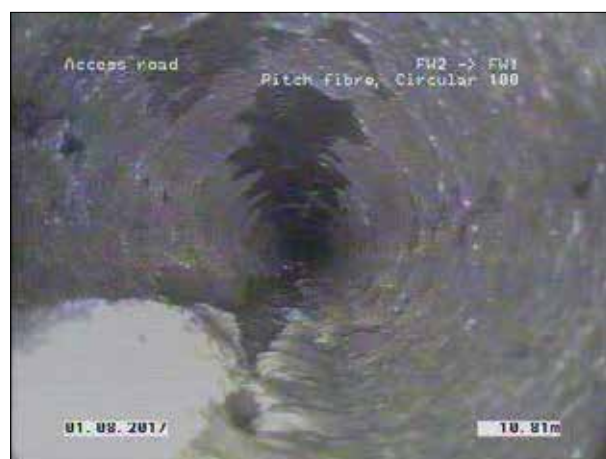
Photo: 3\_9a  
 10.81m, Deformed drain/sewer 5 % Remark: blister pf

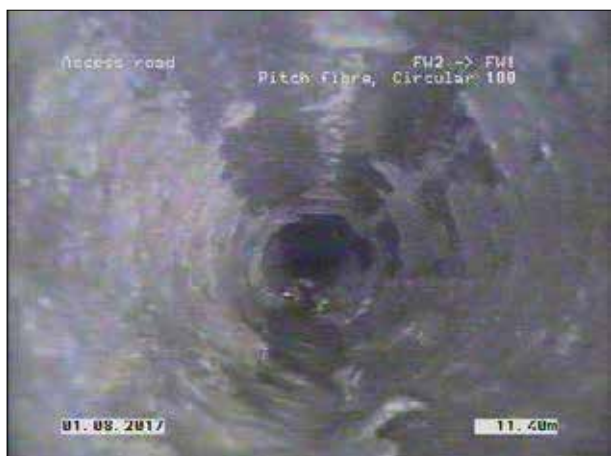
Photo: 30\_10a  
 11.4m, Attached deposits encrustation from 02 to 11 o'clock 5 % cross-sectional area loss

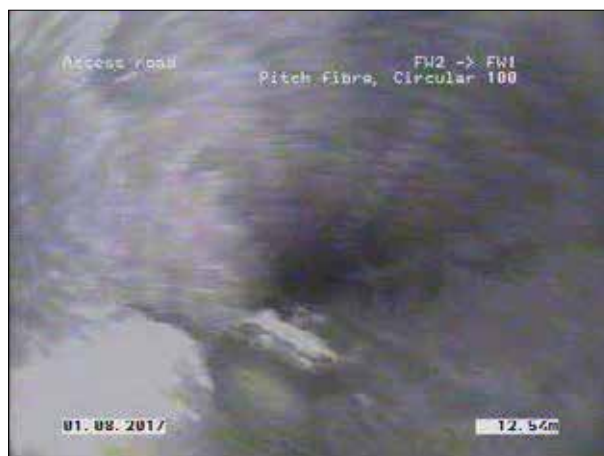
Photo: 31\_11a  
 12.54m, Deformed drain/sewer 5 % Remark: blister pf

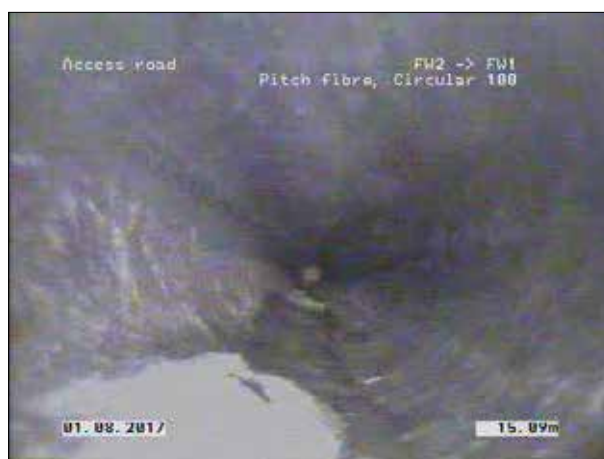
Photo: 33\_13a  
 15.09m, Deformed drain/sewer 5 % Remark: blistered pf

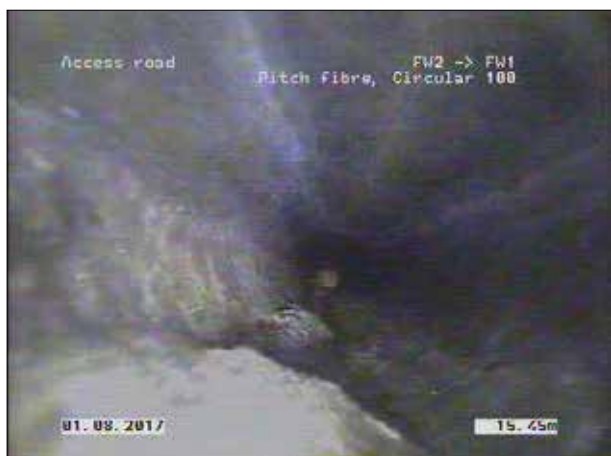
Photo: 34\_14a  
15.45m, Deformed drain/sewer 5 % Remark: blistered pf

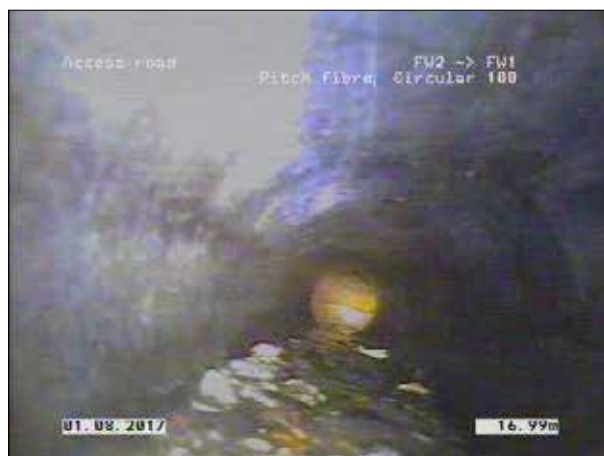
Photo: 35\_15a  
16.99m, Settled deposits coarse 5 % cross-sectional area loss

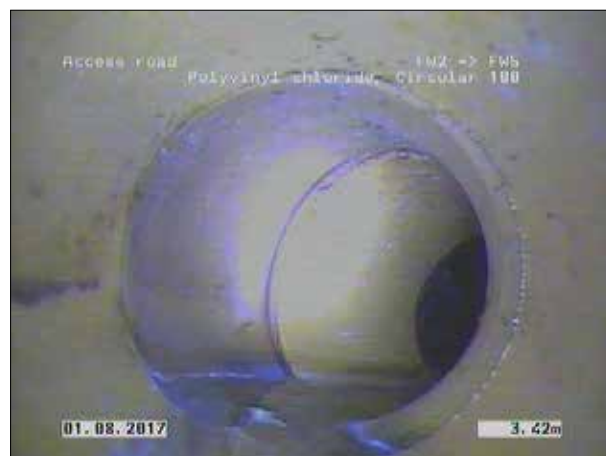
Photo: 4\_3a  
3.42m, Line of drain/sewer deviates right

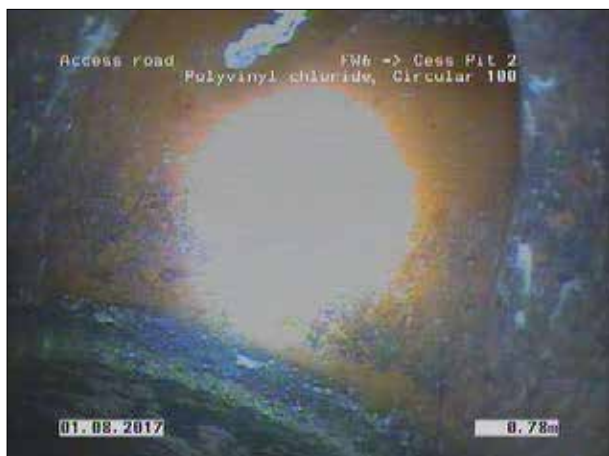
Photo: 47\_3a  
 0.78m, Survey abandoned, Remark: back drop to cess pit

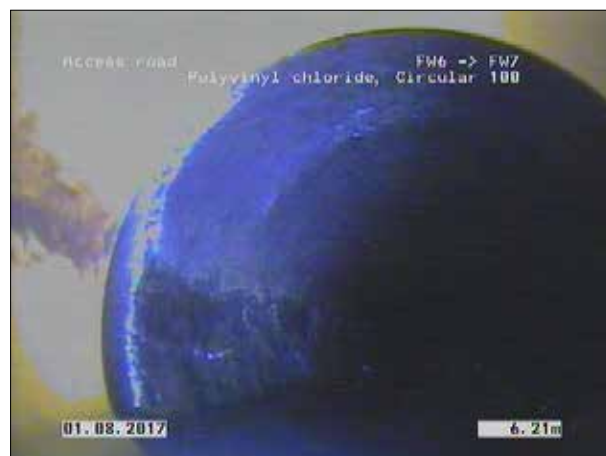
Photo: 7\_3a  
6.21m, Line of drain/sewer deviates right

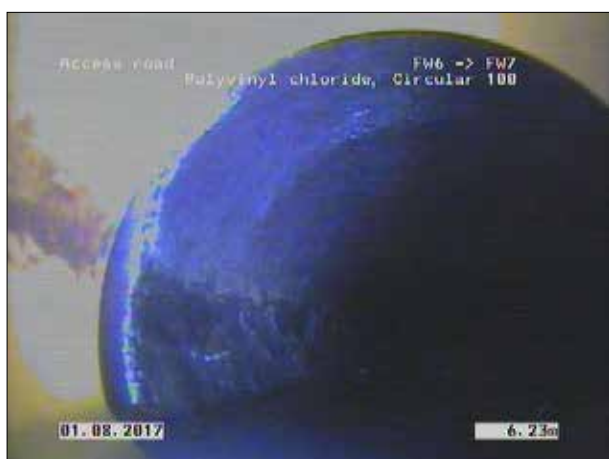
Photo: 7\_4a  
6.21m, Material of drain/sewer changes to Pitch fibre

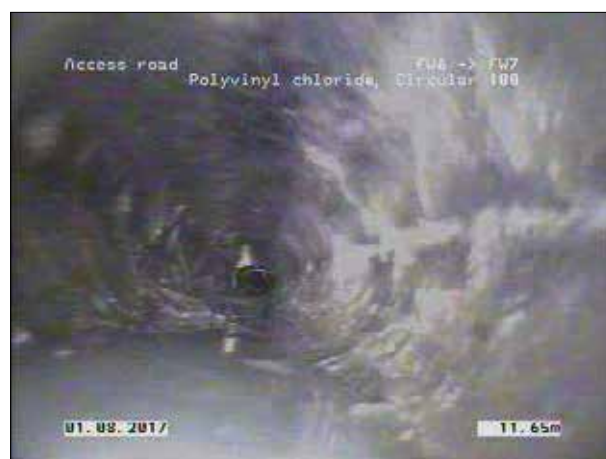
Photo: 7\_5a  
11.61m, Deformed drain/sewer 10 % Remark: blistered pf

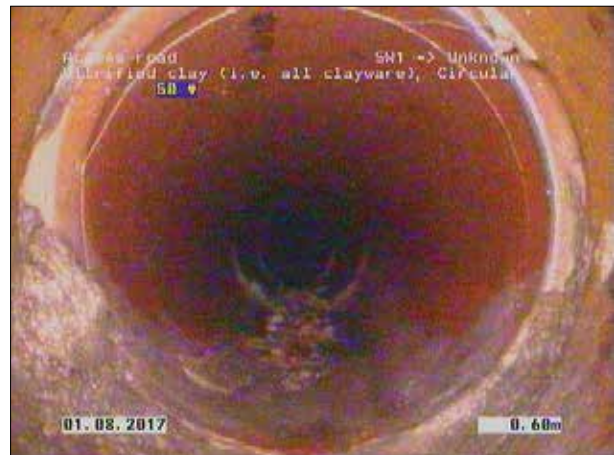
| | 0.60 | S1 | DES | Settled deposits fine 5 % cross-sectional area loss, Start | 66_3a | 1 |

Photo: 66\_3a  
0.6m, Settled deposits fine 5 % cross-sectional area loss, Start

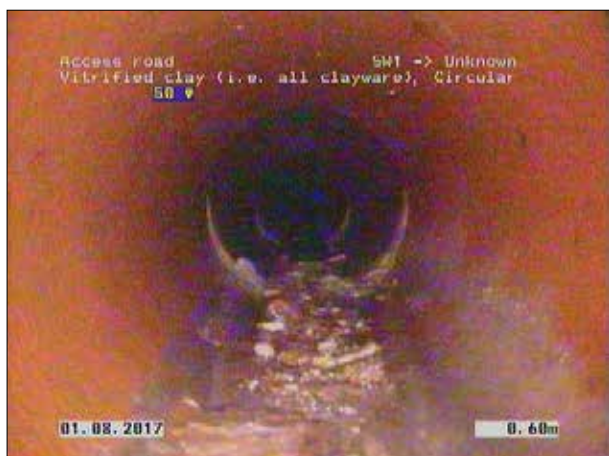
Photo: 68\_5a  
 0.6m, Settled deposits coarse 5 % cross-sectional area loss

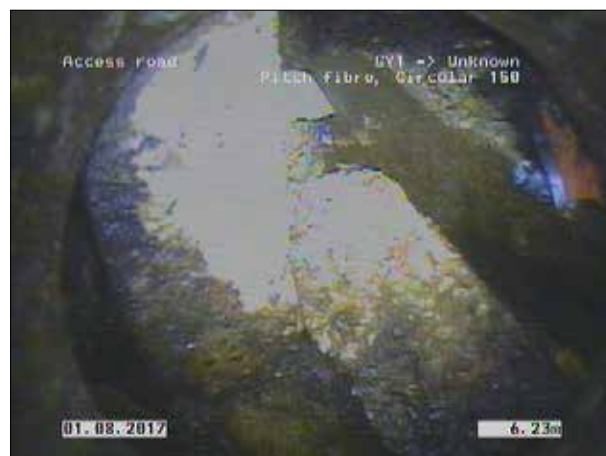
Photo: 72\_3a  
 6.16m, Collapsed drain/sewer

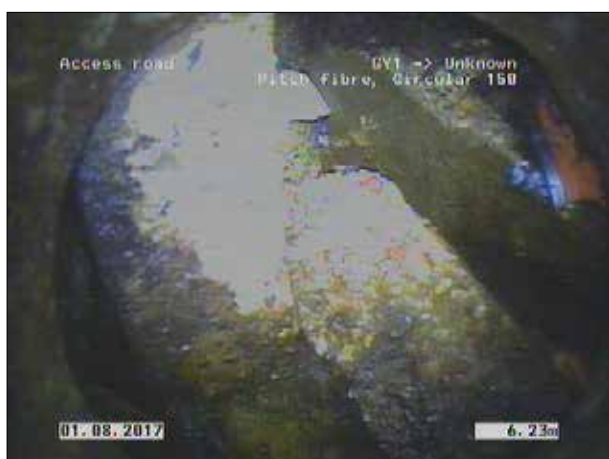
Photo: 73\_4a  
 6.23m, Survey abandoned, Remark: collapsed line

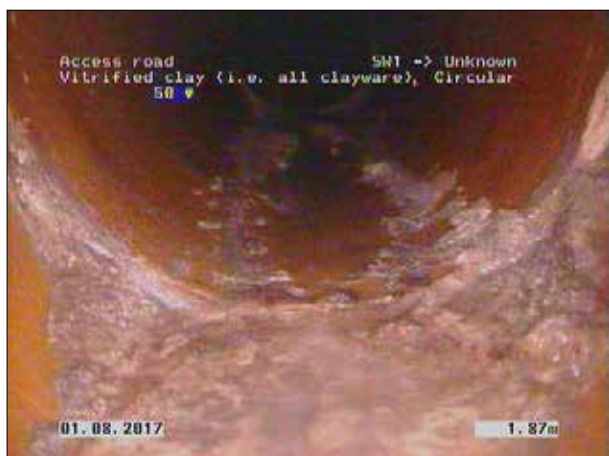
Photo: 78\_5a  
1.87m, Attached deposits encrustation from 04 to 07 o'clock 5 % cross-sectional area loss

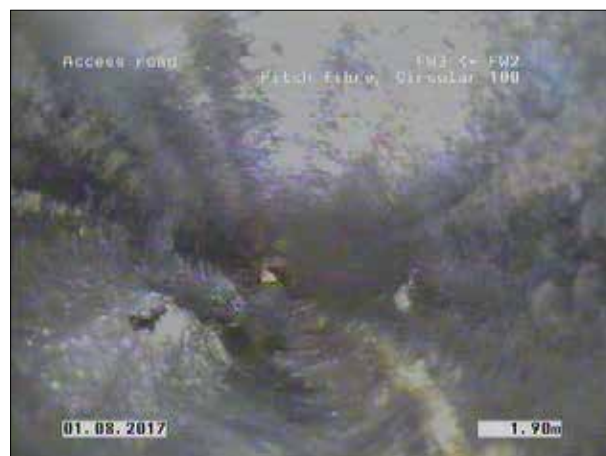
Photo: 103\_3a  
 1.9m, Deformed drain/ sewer 10 % Remark: blistered PF

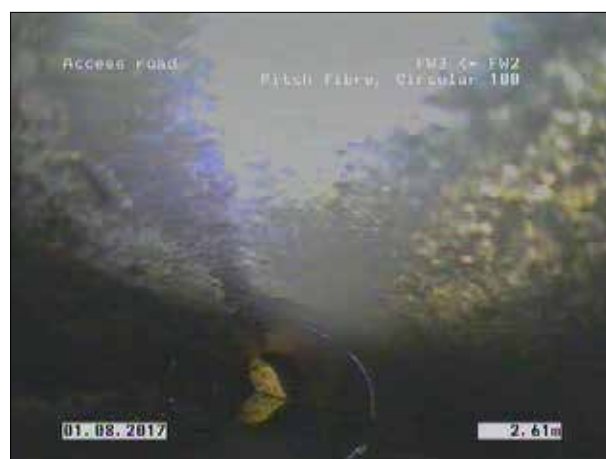
Photo: 105\_5a  
 2.61m, Survey abandoned, Remark: deformed PF line

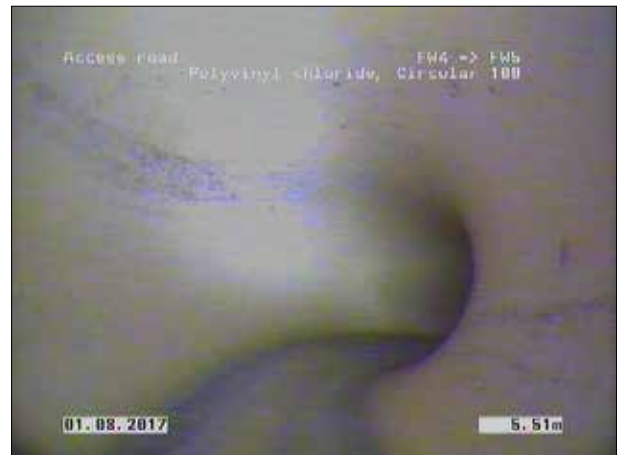
Photo: 111\_3a  
5.51m, Line of drain/sewer deviates right

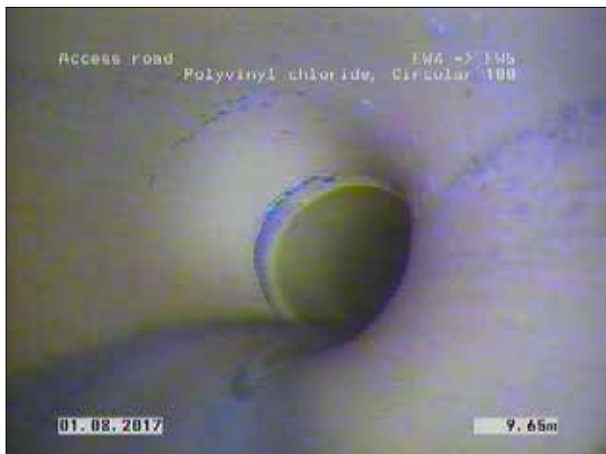
Photo: 17\_4a  
9.65m, Line of drain/sewer deviates right

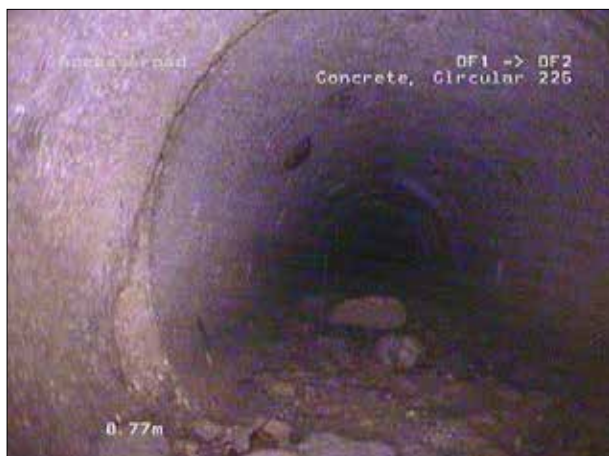
Photo: 119\_3a, 00:00:00  
0.77m, Settled deposits coarse 10 % cross-sectional area loss

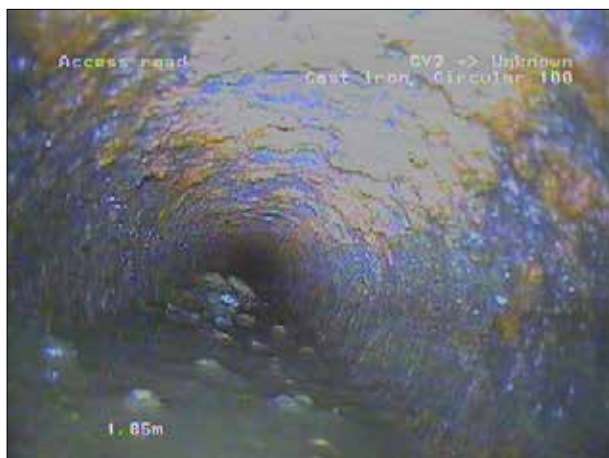
Photo: 124\_4a, 00:00:00  
 1.85m, Settled deposits coarse 10 % cross-sectional area loss

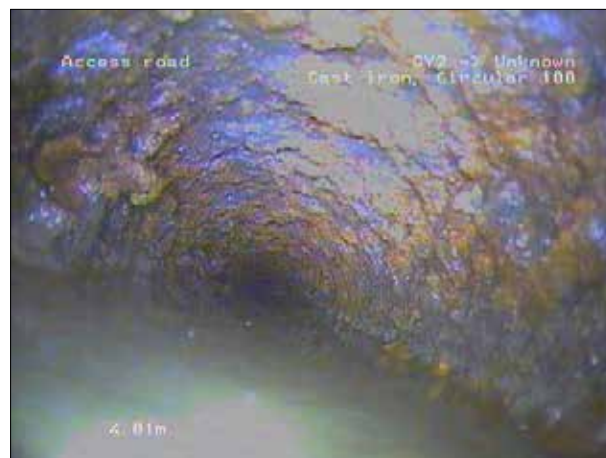
Photo: 126\_6a, 00:00:00  
 4.01m, Loss of vision, camera under water

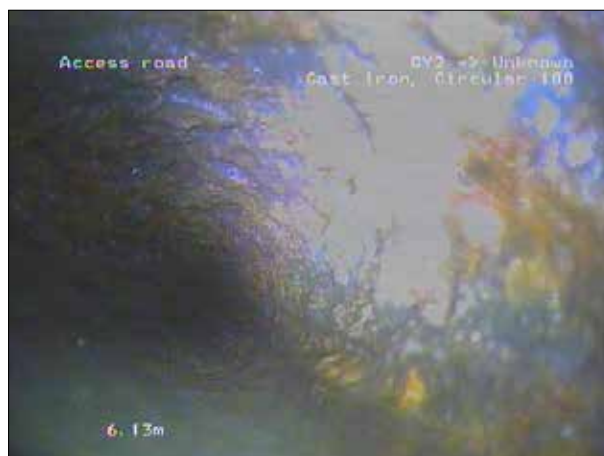
Photo: 128\_8a, 00:00:00  
6.13m, Survey abandoned, Remark: unable to push camera further

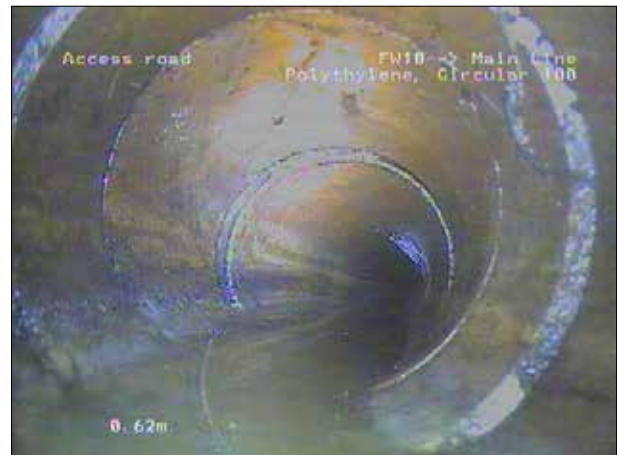
Photo: 149\_3a, 00:00:00  
 0.58m, Line of drain/sewer deviates right

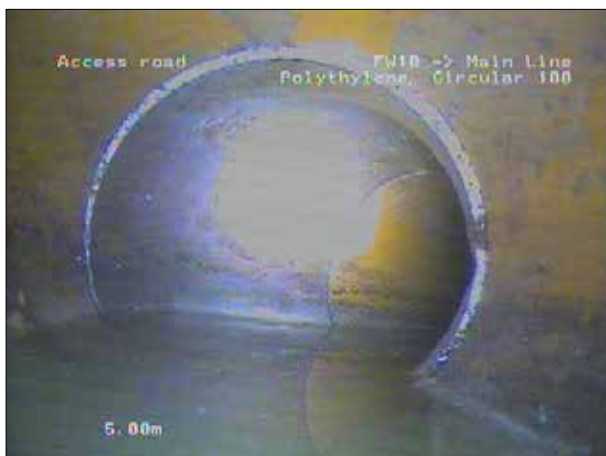
Photo: 150\_4a, 00:00:00  
 5m, Line of drain/sewer deviates right

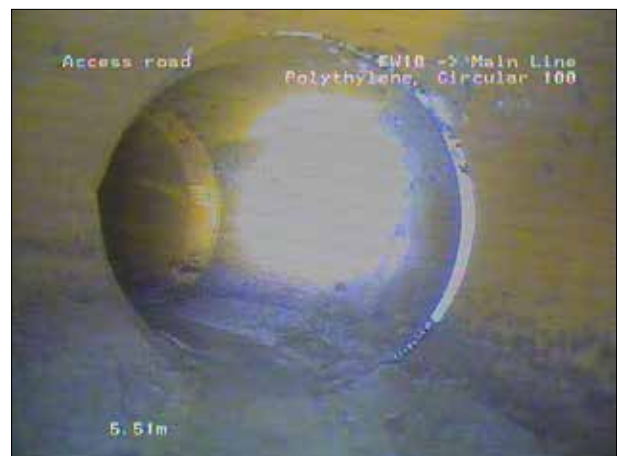
Photo: 151\_5a, 00:00:00  
 5.51m, Line of drain/sewer deviates left

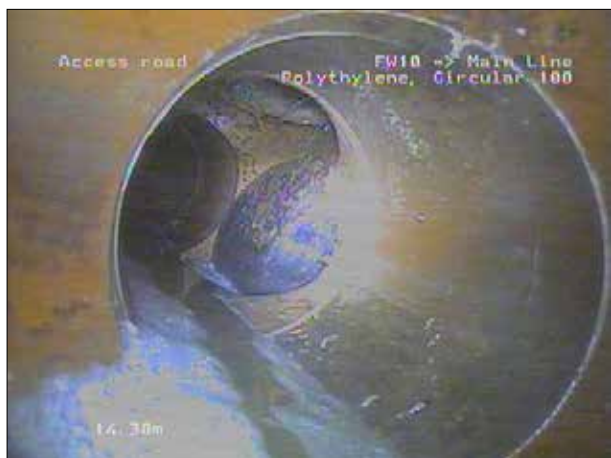
Photo: 154\_8a, 00:00:00  
 14.38m, Line of drain/sewer deviates left

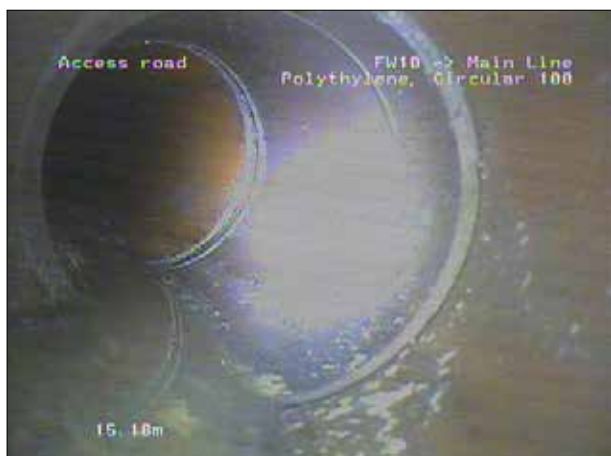
Photo: 156\_10a, 00:00:00  
 15.18m, Line of drain/sewer deviates left

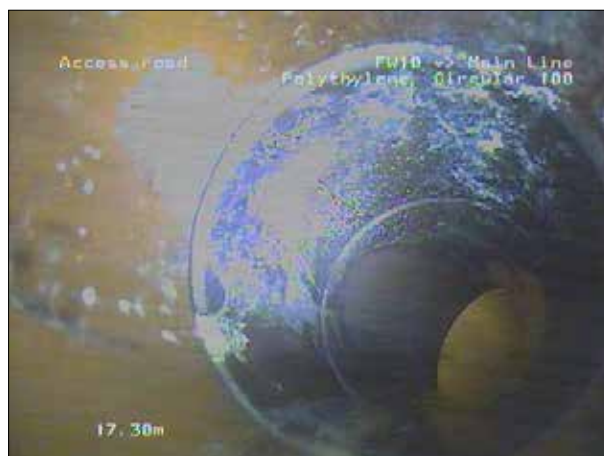
Photo: 157\_11a, 00:00:00  
 17.3m, Line of drain/sewer deviates right

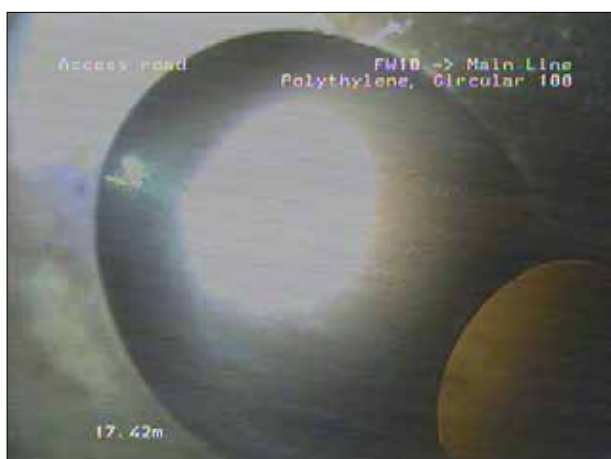
Photo: 158\_12a, 00:00:00  
 17.42m, Major connection without manhole

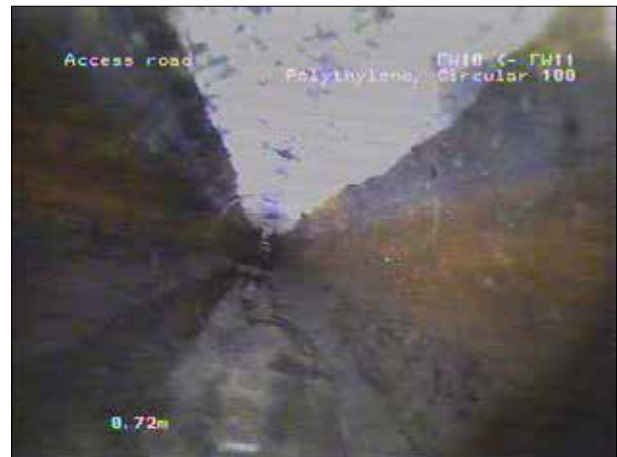
Photo: 24\_3a, 00:00:00  
 0.72m, Attached deposits encrustation from 04 to 07 o'clock 5 % cross-sectional area loss, Start

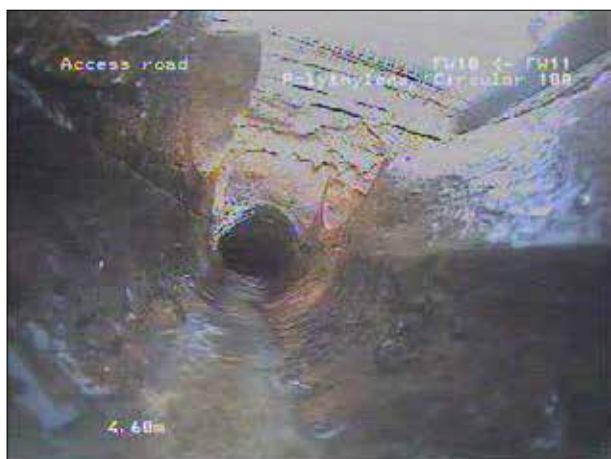
Photo: 169\_7a, 00:00:00  
 4.59m, Attached deposits encrustation from 04 to 07 o'clock  
 10 % cross-sectional area loss Finish

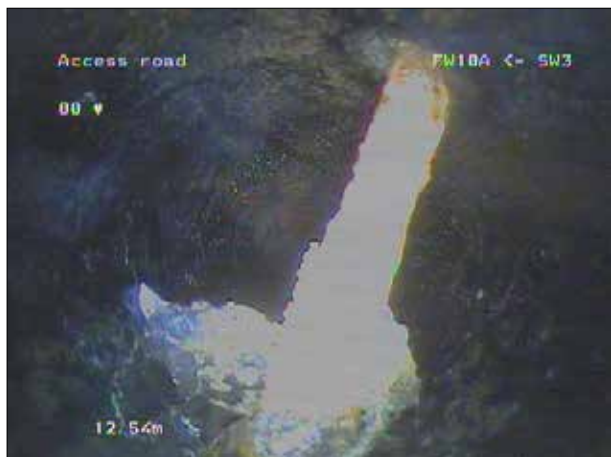
Photo: 175\_6a, 00:00:00  
 12.54m, Other obstacles, other from, from 02 to 06 o'clock, 50  
 % cross-sectional area loss

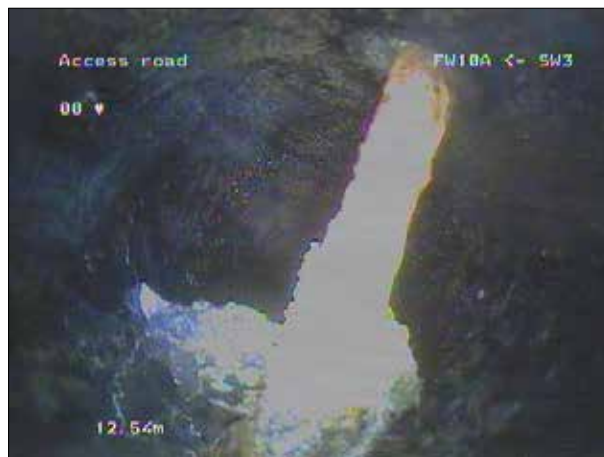
Photo: 176\_7a, 00:00:00  
 12.54m, Survey abandoned, Remark: protruding metal in line

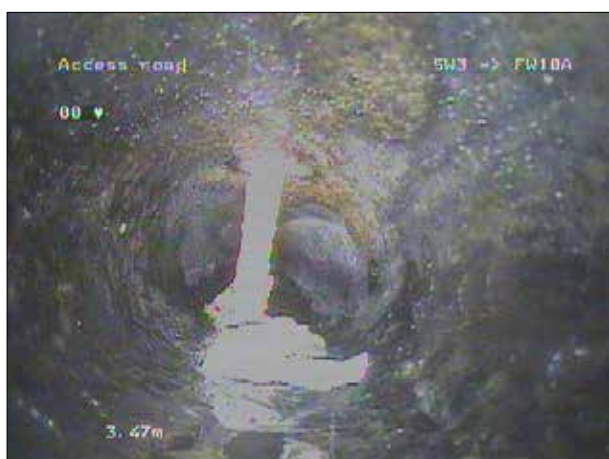
Photo: 182\_4a, 00:00:00  
 3.47m, Other obstacles, other from, from 12 to 06 o'clock, 50 % cross-sectional area loss

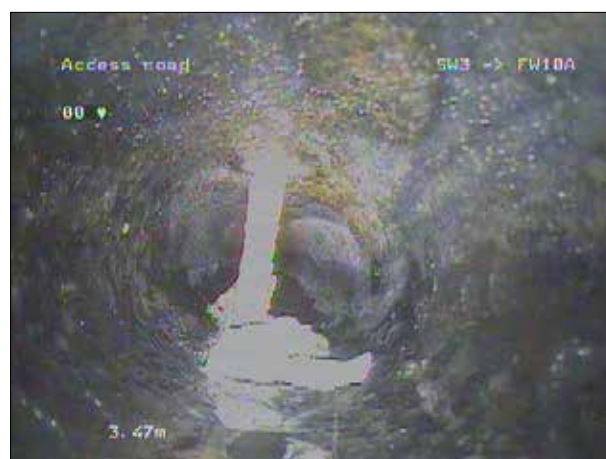
Photo: 183\_5a, 00:00:00  
 3.47m, Survey abandoned, Remark: overlap to protruding metal in line

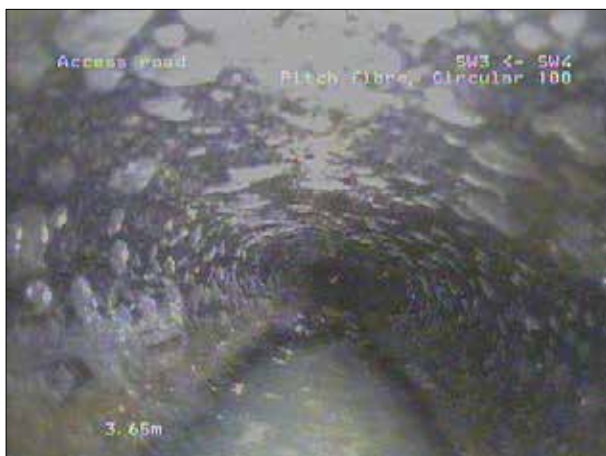
Photo: 187\_4a, 00:00:00  
 3.65m, Survey abandoned, Remark: line to deformed to continue
