BS 5837 Report on the Trees in Relation to  
Bosmere Junior School in Havant

**Client: Hampshire County Council**

**Date: December 2017**

| <b>Date Revised:</b> | 22/02/18 | <b>Authored by:</b> | Laurence Johns, Arboriculturalist, BSc. | 1 of 35 |

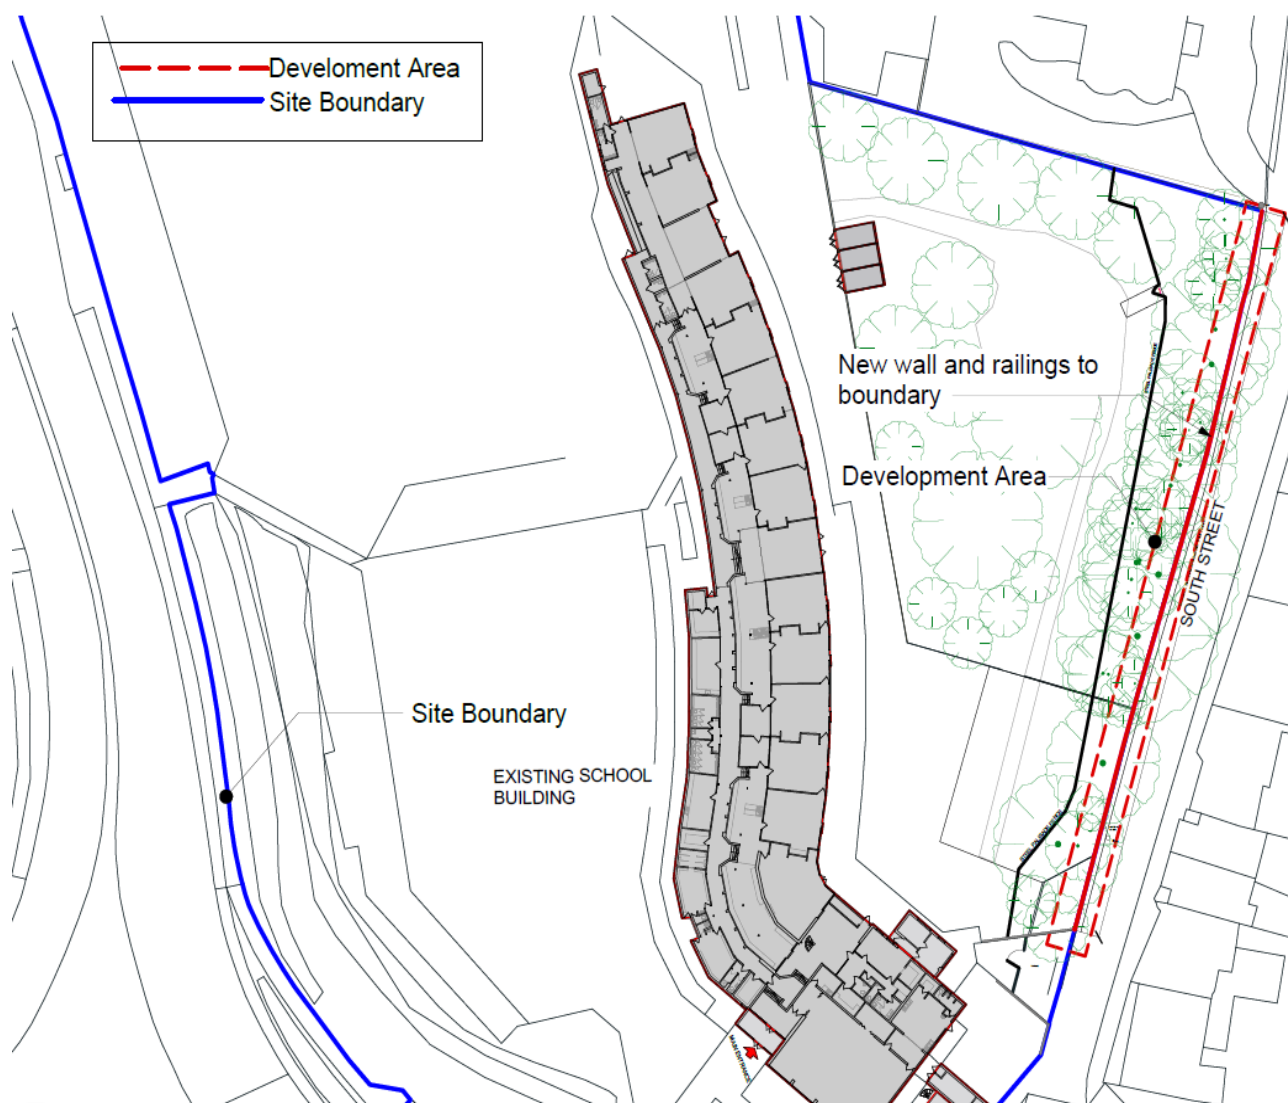
Drawing 1: Site Plan

- 1.1 Bosmere School is a community junior school with 360 children. Outside the school buildings there are generous grounds which have multipurpose uses. Children have access, at playtimes, to a hard play area, a large field and an adventure play-ground. Additionally, they have an area dedicated to gardening, a wooded copse, and a range of quiet seating areas. A number of mature trees offer shade during the summer, allowing the grounds to become teaching areas when the weather allows.
- 1.2 The school wishes to replace a boundary wall which has been considered as unstable, with a new metal rail fence. Due to the school being within a Conservation Area and the copse a group TPO, special remedial works has been recommended. (See **Appendix 1**: Drawing 1: Site Plan).

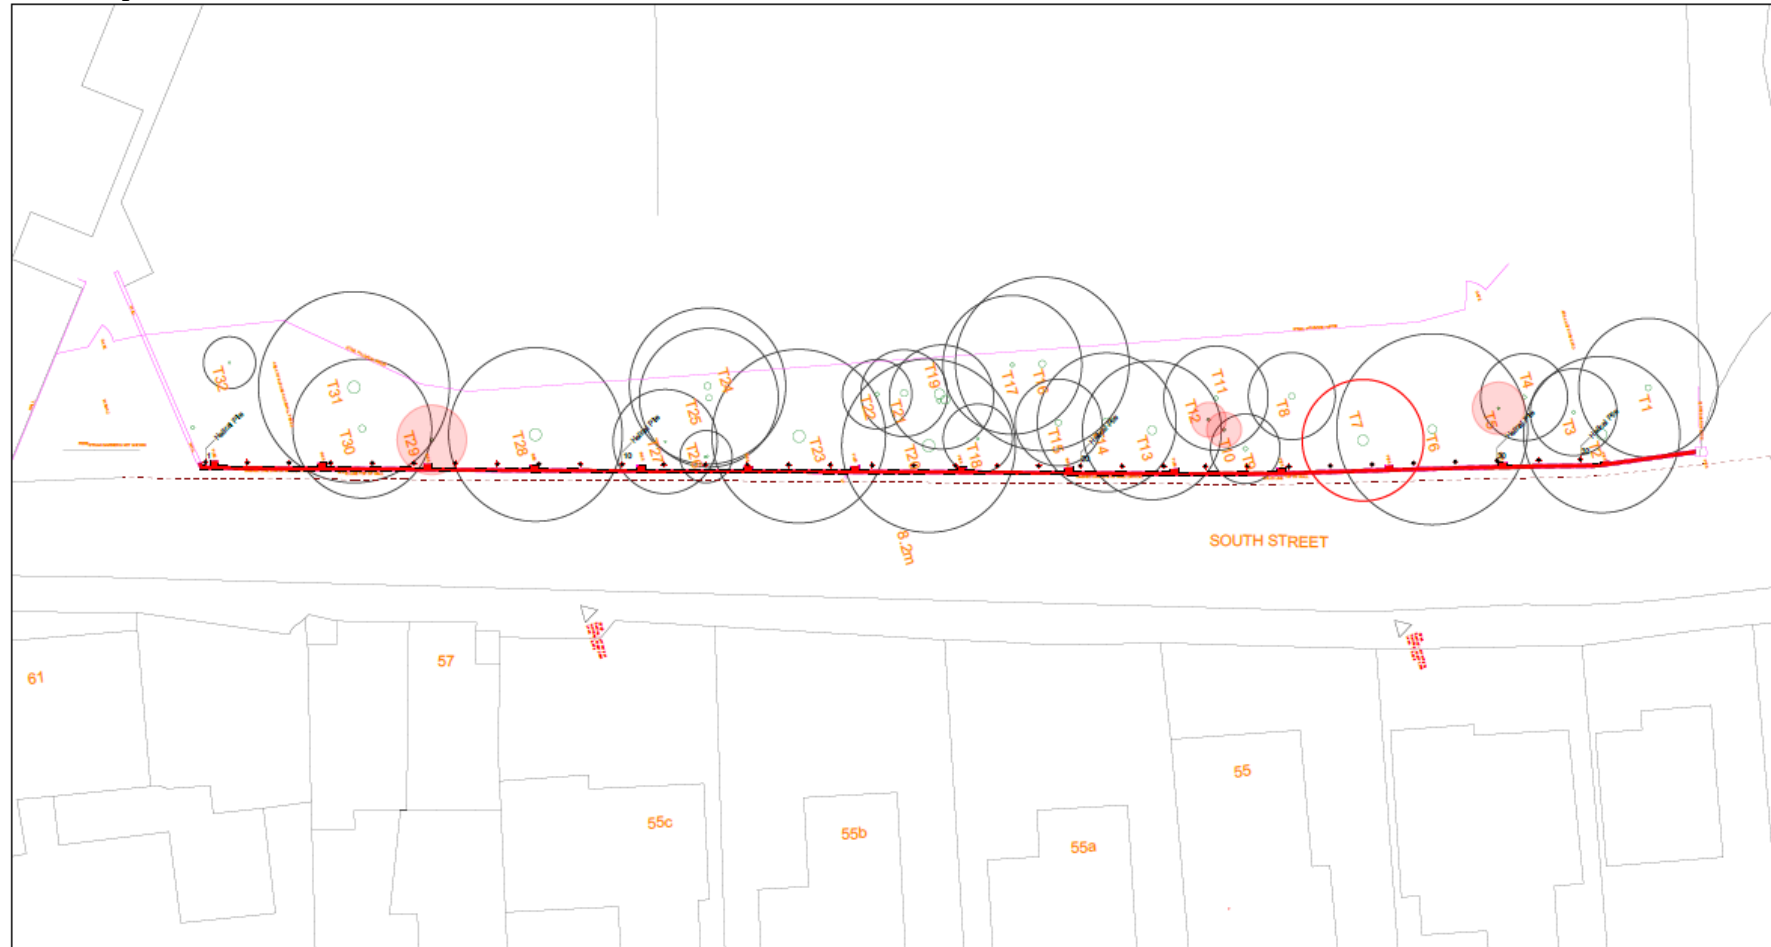
**FIGURE 2: Proposed Remedial Works**

- 3.1 Bosmere Junior School require some remedial works to their boundary wall which has become un-stable. Due to the school being within a Conservation Area the wall can not be re-built because of the existing trees in close vicinity to the structure. Therefore recommendations are to replace the wall with a metal rail fence, using the wall's original foundations.

- 7.5 The supporting helical screw piles will be drilled into the ground within the RPA's of surrounding trees. They will only impact and potentially damage a very small area of the RPA's, and this should not affect the trees significantly. This plan was the best remedial solution found to cause the less possible impact to the surrounding trees RPA's.
