**MILL RYTHE HOLIDAY VILLAGE,  
HAYLING ISLAND, HAMPSHIRE**

**PRELIMINARY ROOST ASSESSMENT**

Report No: RT-MME-123420-02

Date: September 2016

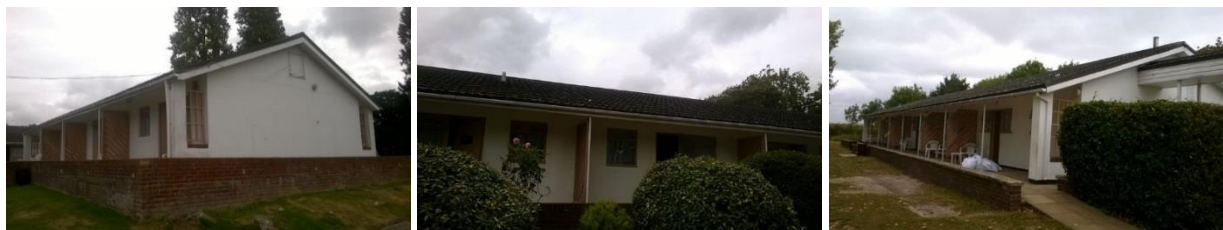
The majority of the holiday units were single storey brick buildings with rendered walls. These buildings had pitched roofs with interlocking concrete tiles and uPVC soffits (Plate 4.1). The majority of the buildings were in a good state of repair, with the rendered walls and roof tiles in good condition with no gaps or crevices recorded suitable for roosting bats (Plate 4.2).

**Plate 4.1: Example of the single storey holiday units**

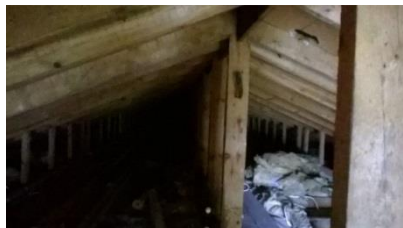
Internally, all the buildings were of similar construction and supported timber beams and rafters, with a ridge beam (Plate 4.4). The floor to apex height was approximately 1 m. Timber boards were present between the beams and roof tiles and the floors were insulated (Plate 4.5).

**Plate 4.4: Internal view of the loft spaces**

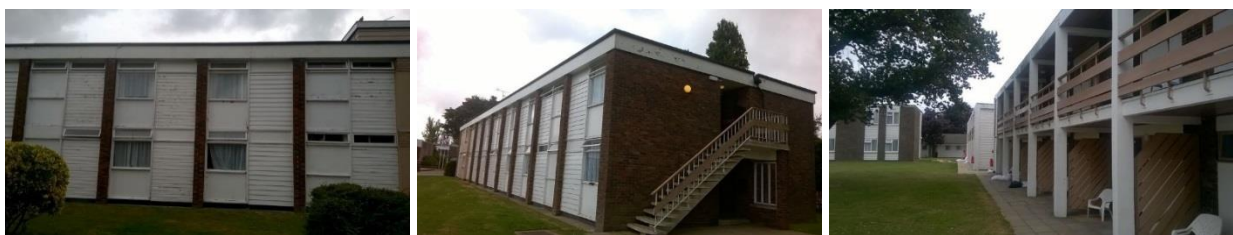
The remainder of the accommodation units were two storey brick buildings with some elevations covered by timber and uPVC cladding. The buildings supported flat felted roofs, with timber soffit boxes (Plate 4.7). The majority of the buildings were in a good state of repair with the walls, timber and PVC cladding and the felt in good condition.

**Plate 4.7: Example of the two storey accommodation units**

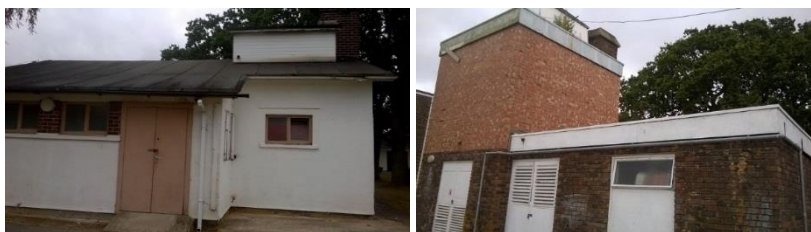
The boiler houses were single storey brick buildings with pitched felted roofs and some areas with flat roofs and a brick chimney breast (Plate 4.9). The majority of the buildings were in a good state of repair with the walls, brickwork and the roofing felt in good condition with no gaps or crevices recorded suitable for roosting bats (Plate 4.9).

**Plate 4.9: Example of the boiler houses**

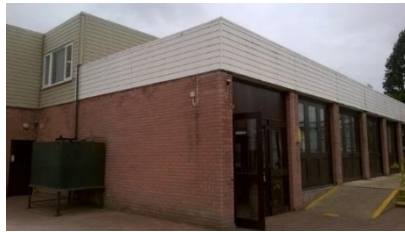
Building 9 was used as an indoor swimming pool, restaurant and reception area and supported a mixture of single storey and two storey brick buildings with PVC cladding on the walls (Plate 4.11). This building contained a number of flat roofs covered by a mixture of roofing felt and metal cladding. An extension to the south of this building, had breezeblock walls and a corrugated metal roof (Plate 4.12). Building 9 was in a good state of repair with the walls, cladding and roofing felt/metal sheets in a good state of repair with no gaps or crevices recorded suitable for roosting bats.

**Plate 4.11: View of Building 9**

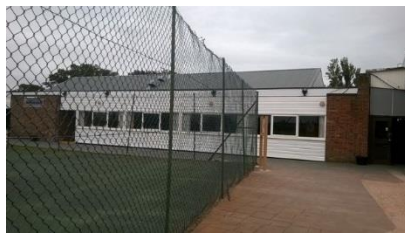
**Plate 4.12: Southern extension of Building 9**

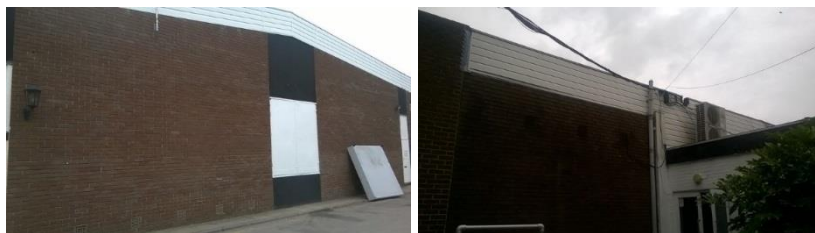
Building 10 was used as an entertainment hall with an arcade located adjacent to it and was a large brick building with uPVC cladding and a flat felted roof (Plate 4.13). The southern section of this building supported a smaller flat roofed brick extension. The western gable end of Building 10 had a large pitched roof with interlocking clay tiles and wooden cladding (Plate 4.14).

**Plate 4.13: View of Building 10**

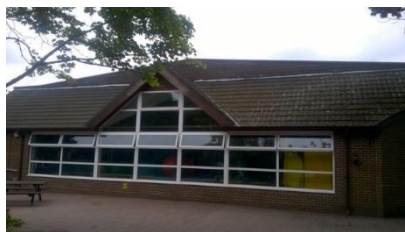
**Plate 4.14: The western gable end of Building 10 with a large pitched roof with interlocking clay tiles and wooden cladding**

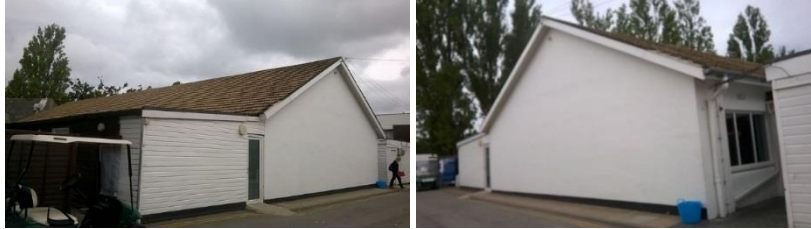
Building 12 was a single storey brick building with rendered walls and a pitched roof with interlocking concrete tiles. A small extension was present on the southern elevation with a flat felt roof and wooden cladding (Plate 4.16). This building was in a good condition with no potential gaps or crevices recorded suitable for roosting bats.

**Plate 4.16: View of Building 12**

No evidence of roosting bats, e.g. droppings, urine staining, feeding remains or scratch marks, and no potential features were recorded during the survey.

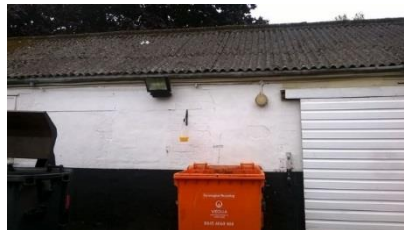
Building 13 was a large brick building with a pitched corrugated metal roof and was used for storage at the time of survey (Plate 4.17). The building was in good condition with no potential gaps or crevices recorded.

**Plate 4.17: View of Building 13**

No evidence of roosting bats, e.g. droppings, urine staining, feeding remains or scratch marks, and no potential features were recorded during the survey.

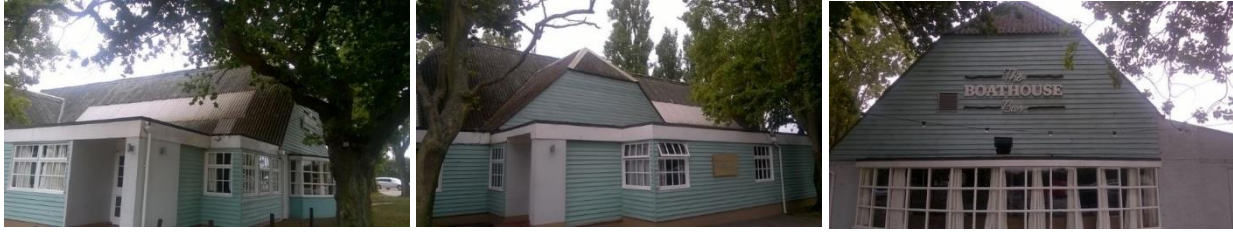
Building 11 was a brick building covered by wooden cladding. The building had a mixture of pitched and hipped roofs covered by corrugated metal sheets and flat roofs covered by black felt sarking (Plate 4.18). Wooden soffits were recorded along the eaves. The building was in a good state of repair with no gaps or crevices recorded suitable for roosting bats.

**Plate 4.18: View of Building 11**

No evidence of roosting bats, e.g. droppings, urine staining, feeding remains or scratch marks, and no potential features were recorded during the survey.

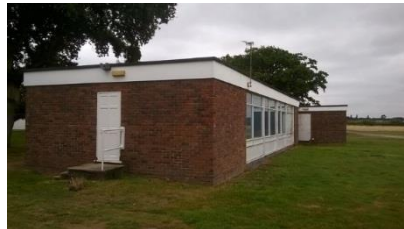
Building 42 was a single storey brick building with a flat felted roof and uPVC fascia. (Plate 4.19). The building was in good condition with no potential gaps or crevices recorded suitable for roosting bats.

**Plate 4.19: View of Building 42**

No evidence of roosting bats, e.g. droppings, urine staining, feeding remains or scratch marks, and no potential features were recorded during the survey.

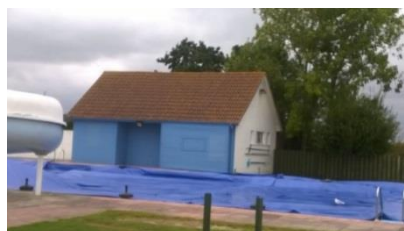
Building 48 was a single storey rendered building with a pitched roof covered by interlocking concrete tiles (Plate 4.20). It was not possible to access the building therefore it was not possible to fully inspect its potential for bats.

**Plate 4.20: View of Building 48**

No evidence of roosting bats, e.g. droppings, urine staining, feeding remains or scratch marks, and no potential features were recorded during the survey.

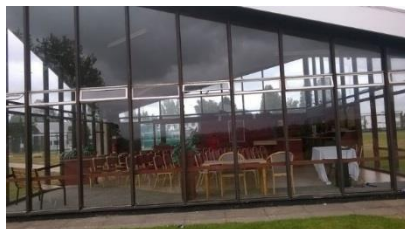
Building 49 was a glass, concrete and timber building (Plate 4.21). The building was in good condition with no features suitable for roosting bats.

**Plate 4.21: View of Building 49**

No evidence of roosting bats, e.g. droppings, urine staining, feeding remains or scratch marks, and no potential features were recorded during the survey.
