## Tree Survey Report (BS5837:2012)

Proposed Gap Plant Hire, Hermitage Park, Harts Farm Way, Havant,  
Hampshire, PO9 1JN

July 2017

Report Reference: A3355

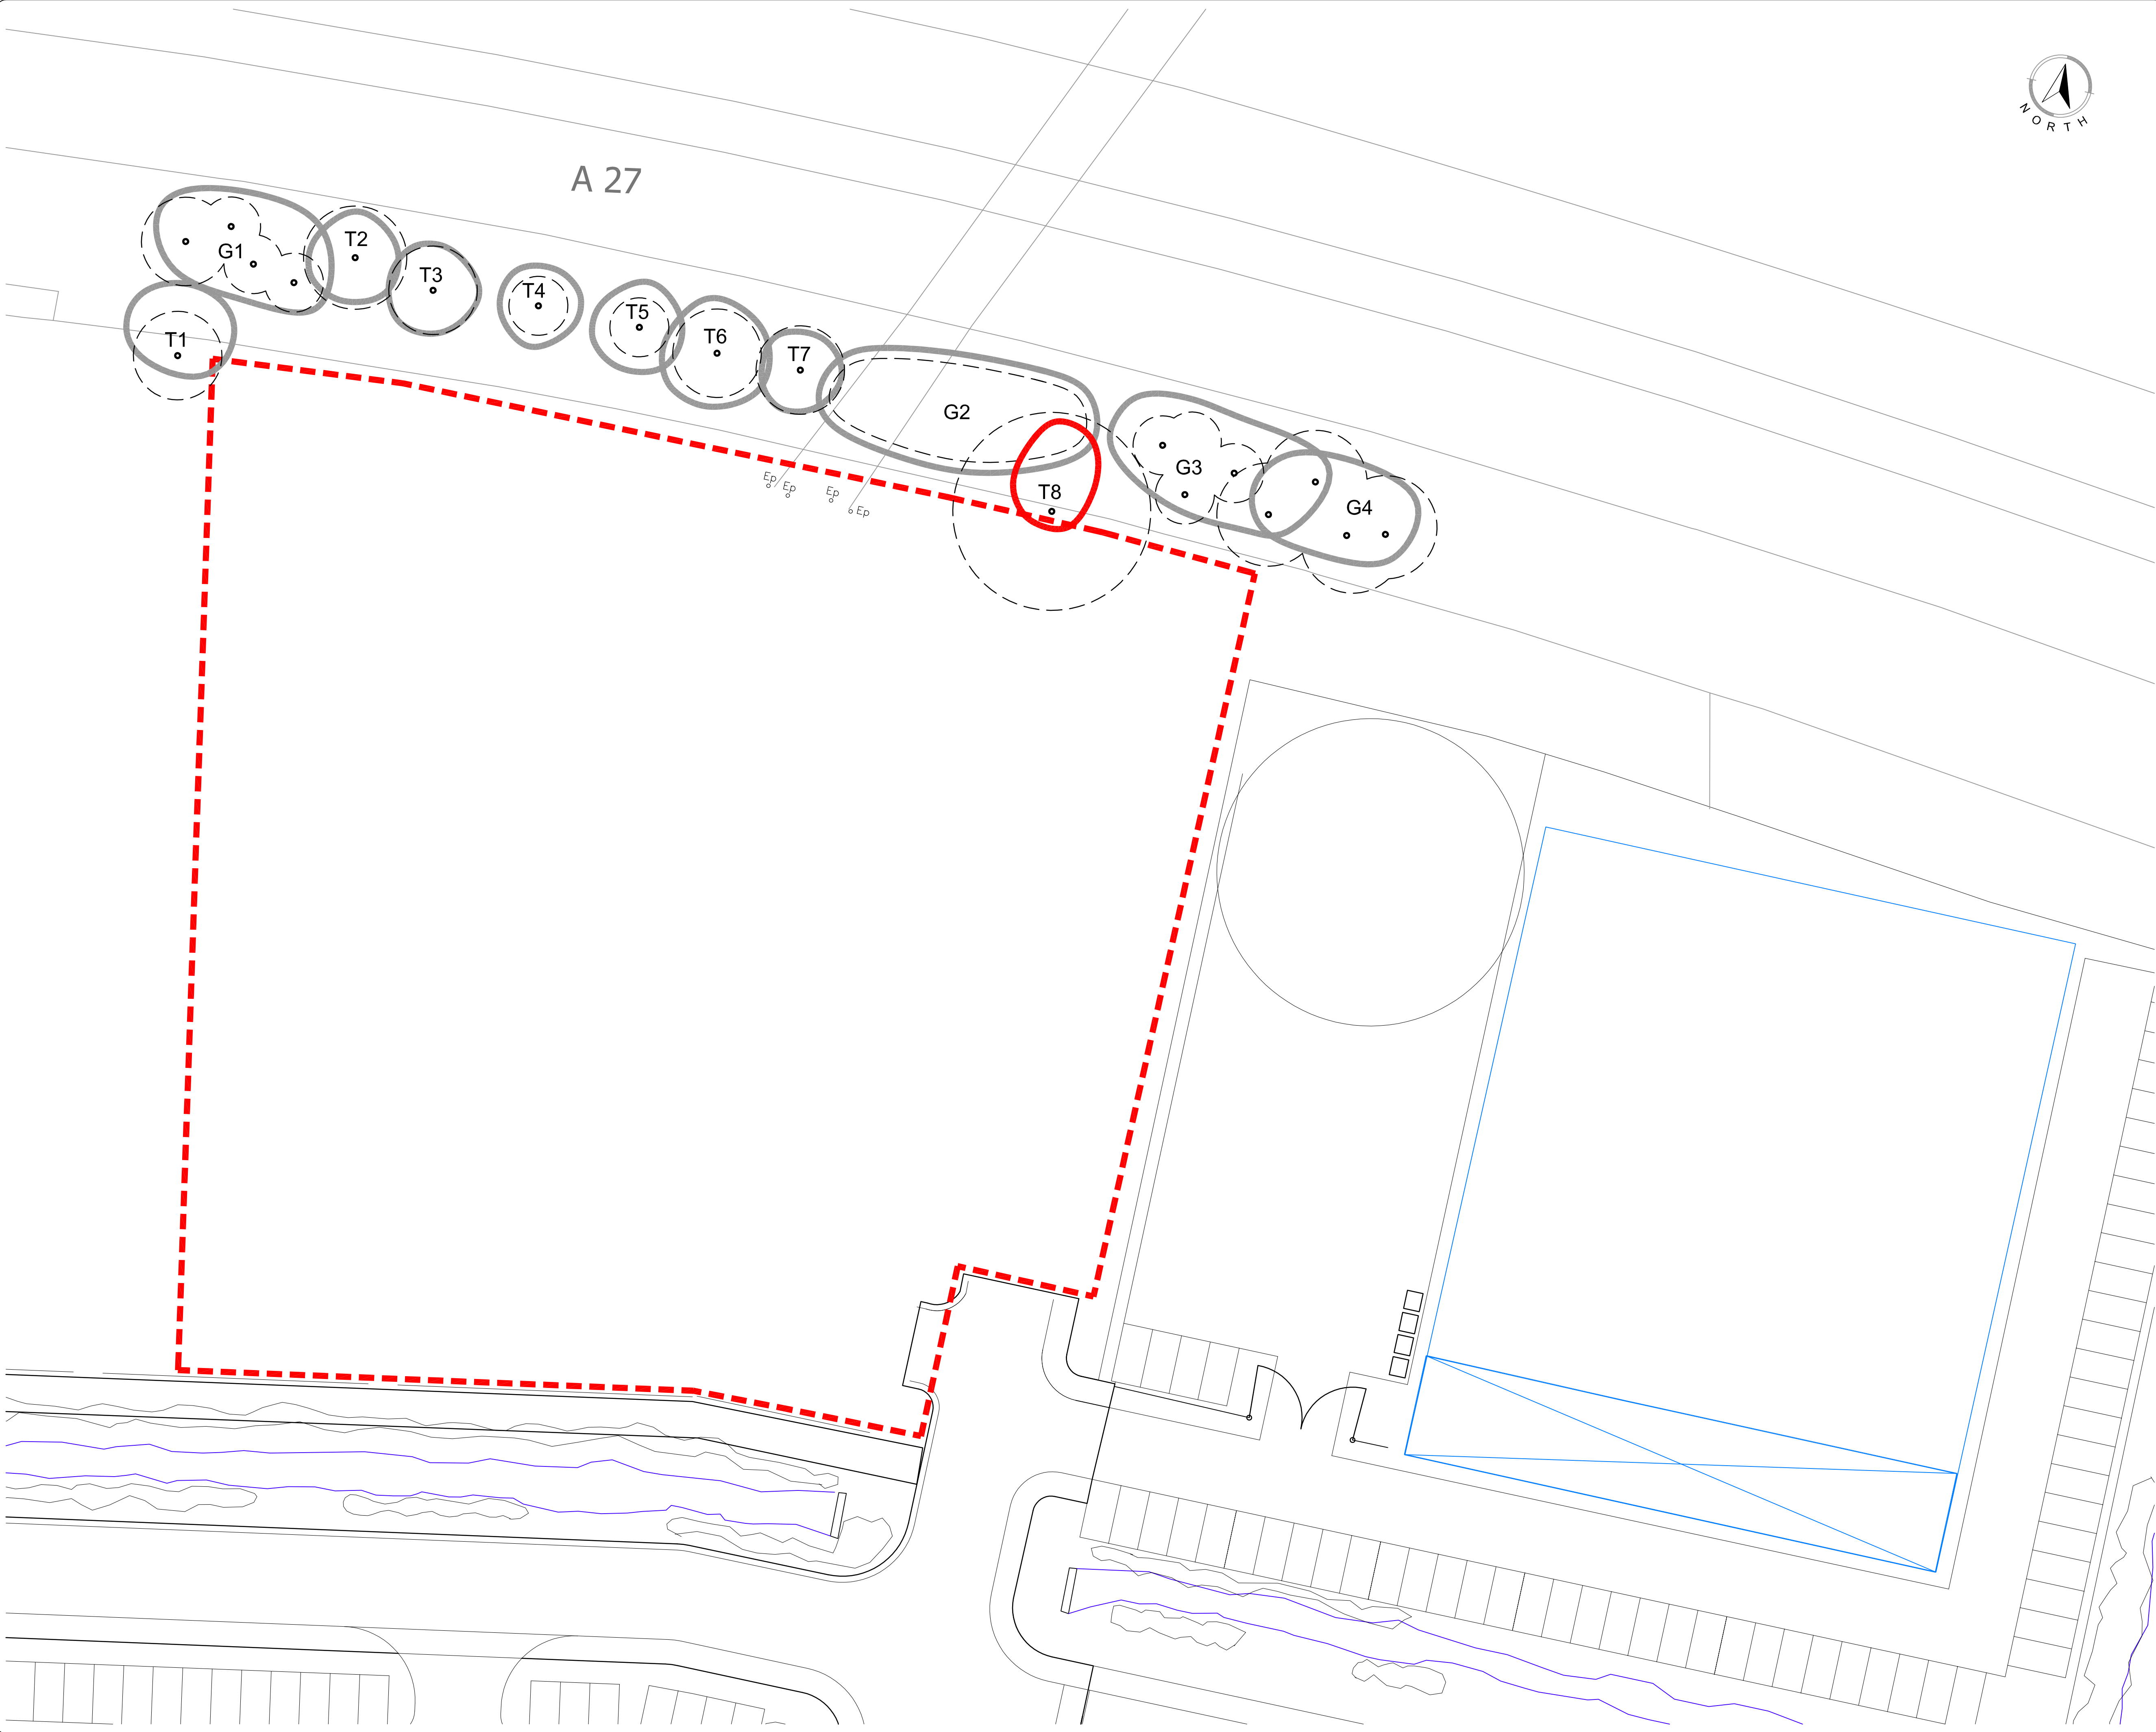
## Appendix B - Tree Survey Plan and Tree Constraints & Protection Plan

- 3.5 The exception is T8, an Ash tree in serious decline which would be inappropriate to be retained in its current condition and should be considered for removal before works commence on site.

- 3.7 There are several existing trees and groups of trees beyond the northern boundary of the site within a shelterbelt adjacent to the A27 motorway, which have been recorded in this survey.
- 3.8 Most of the trees have been classified as grade C2, ie trees of low quality, present in groups, conferring on them greater collective landscape value rather than individual arboricultural merit. There are some very poor trees including one which has been given a U classification ie showing signs of significant and/or irreversible overall decline, which are recommended for removal. Details of the Root Protection Area (RPA) is provided on the Tree Survey Plan appended to this report.
- 4.3 A tree schedule containing full details of the survey is also attached in the appendix.

- 6.1 Construction works should follow the Arboricultural Method Statement in Appendix D at the back of this report including the erection of protective fencing to separate the existing trees from the construction works.
- 6.2 Heras fencing should be erected around the trees as shown on the Tree Constraints Plan to prevent damage to the trees from the construction work on site. See AMS for details.
