Arboricultural assessment/method statement report for:

1B Park Road

Purbrook

Surveyed by Ian Lansley 10/7/2017

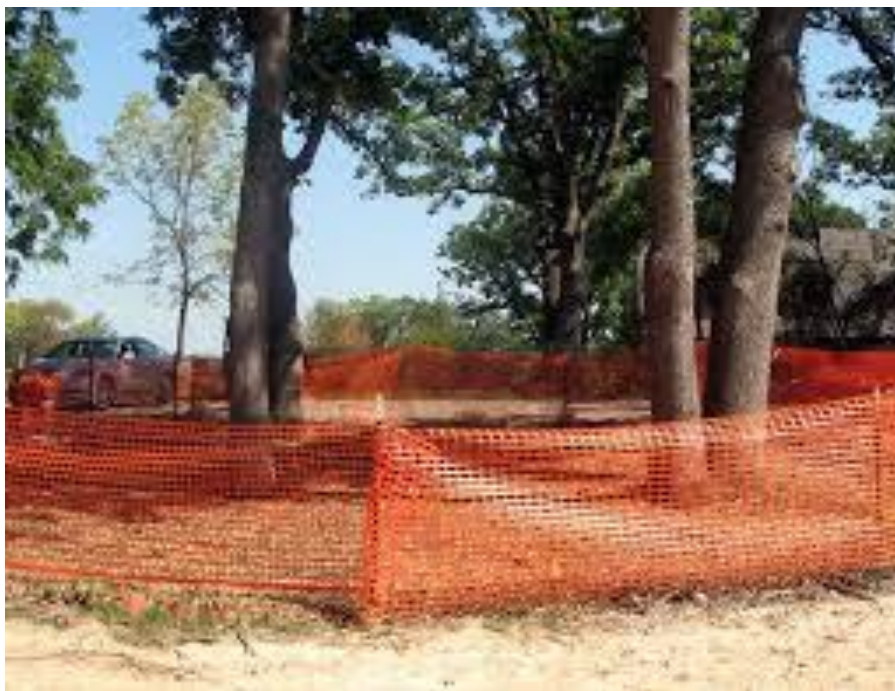
— Root protection.      ● Trees/shrubs      Macrocarpa      Lilac

As this is not a commercial build I feel that 1.8m Herras fencing would be a little excessive. Orange plastic netting would be more than suitable to mark out the root protection area.

This should be installed from the rear fence line to encompass the Macrocarpa at a radius of 6.5m and extend along the Eastern boundary by 5m from the existing fence line as shown, cutting in at 5m to encompass the Hazel. The Lilac should be removed as an overgrown existing garden shrub.
