**1. Introduction**

- 1.1 Martin Dobson Associates Ltd was instructed by Lesley Severs on 07 September 2016 to carry out a safety inspection of one oak tree at the rear of 36 Gladys Avenue, Cowplain, PO8 8HS.

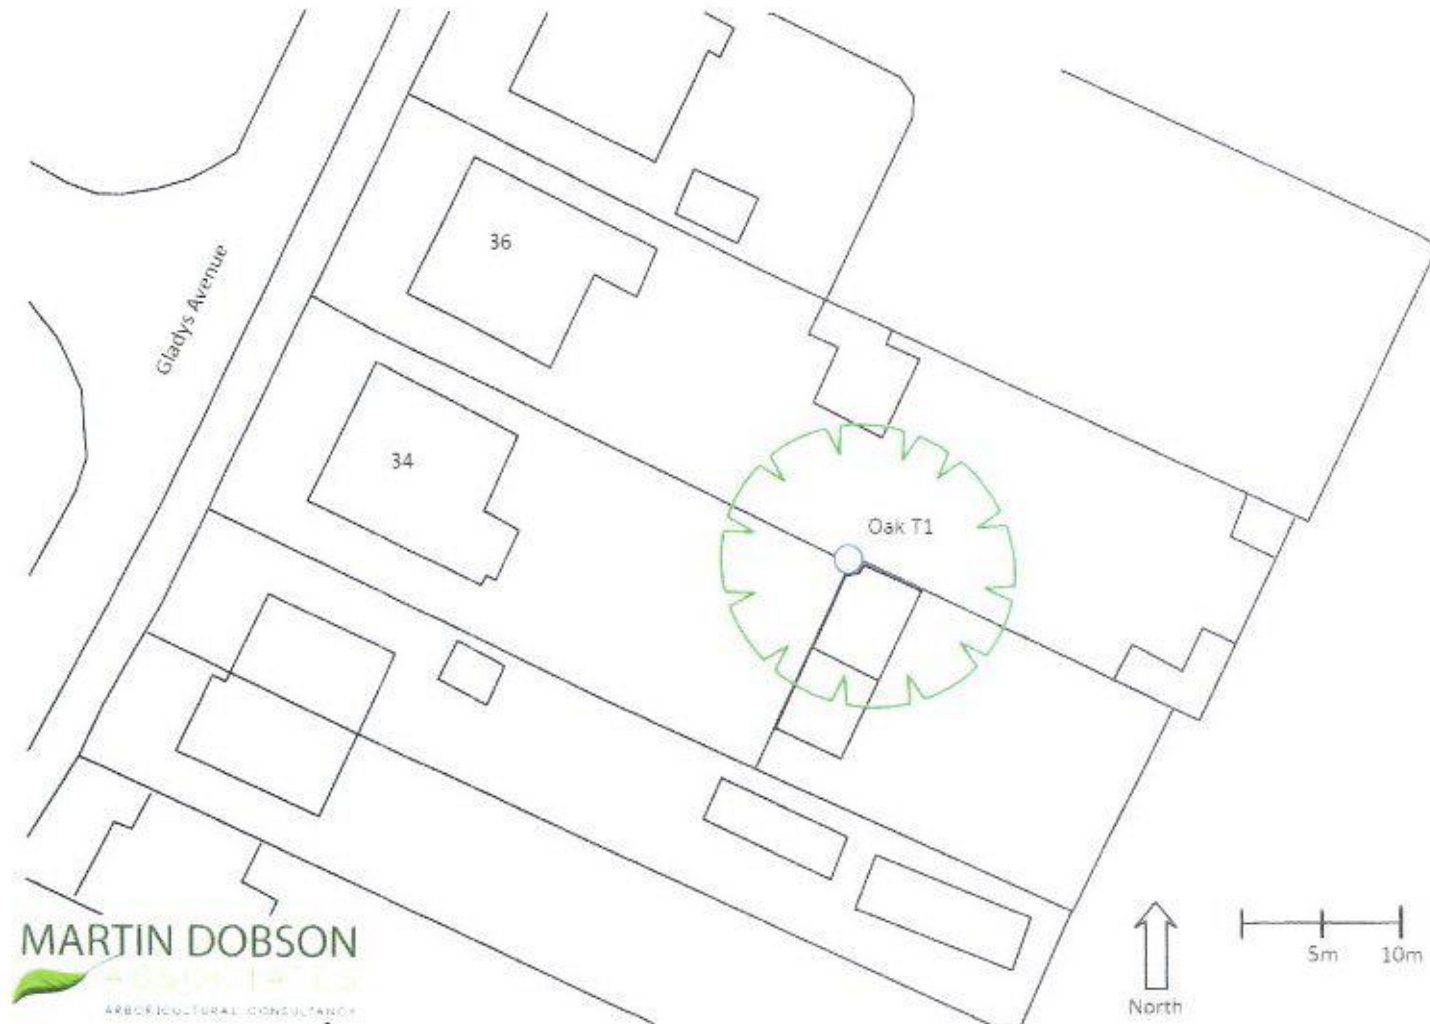
**APPENDIX MD3**  
**Site plan showing tree location.**

- 2.3 One mature oak tree has been surveyed which is situated just inside Mrs Severs' property. Part of the base of the stem is located within the neighbouring two properties. Its location is plotted on the site plan at **MD3**.
