Contamination Report for

**"The Dairy"**

Northwood Farm Northwood Lane Hayling Island.

May 2016

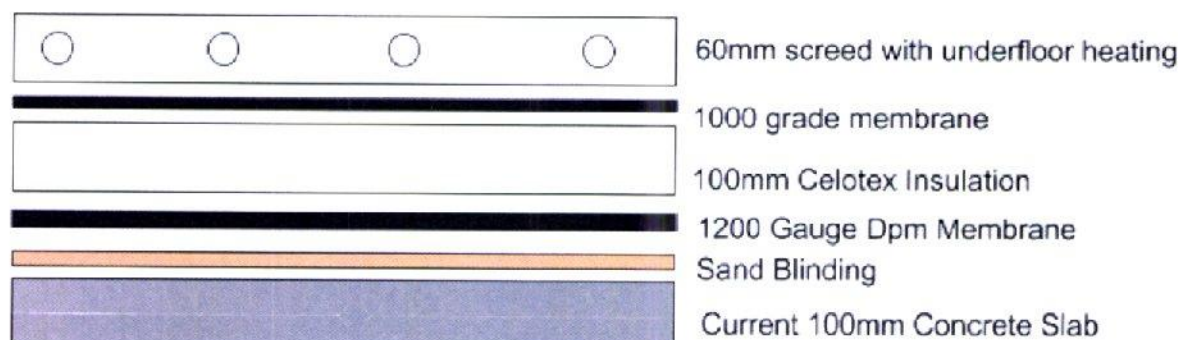
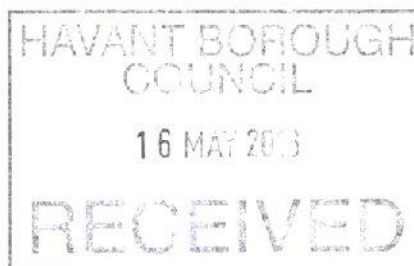
Due to the internal floor service being a sound 100mm thick concrete slab that is uncracked and level throughout it has been considered removal of this is not necessary and the floor surface should follow a system as illustrated in the design below.
