Our Ref. 2844

4<sup>th</sup> May 2010

Re: **86 West Street, Havant, Hampshire.**  
**Existing Front South Elevation.**

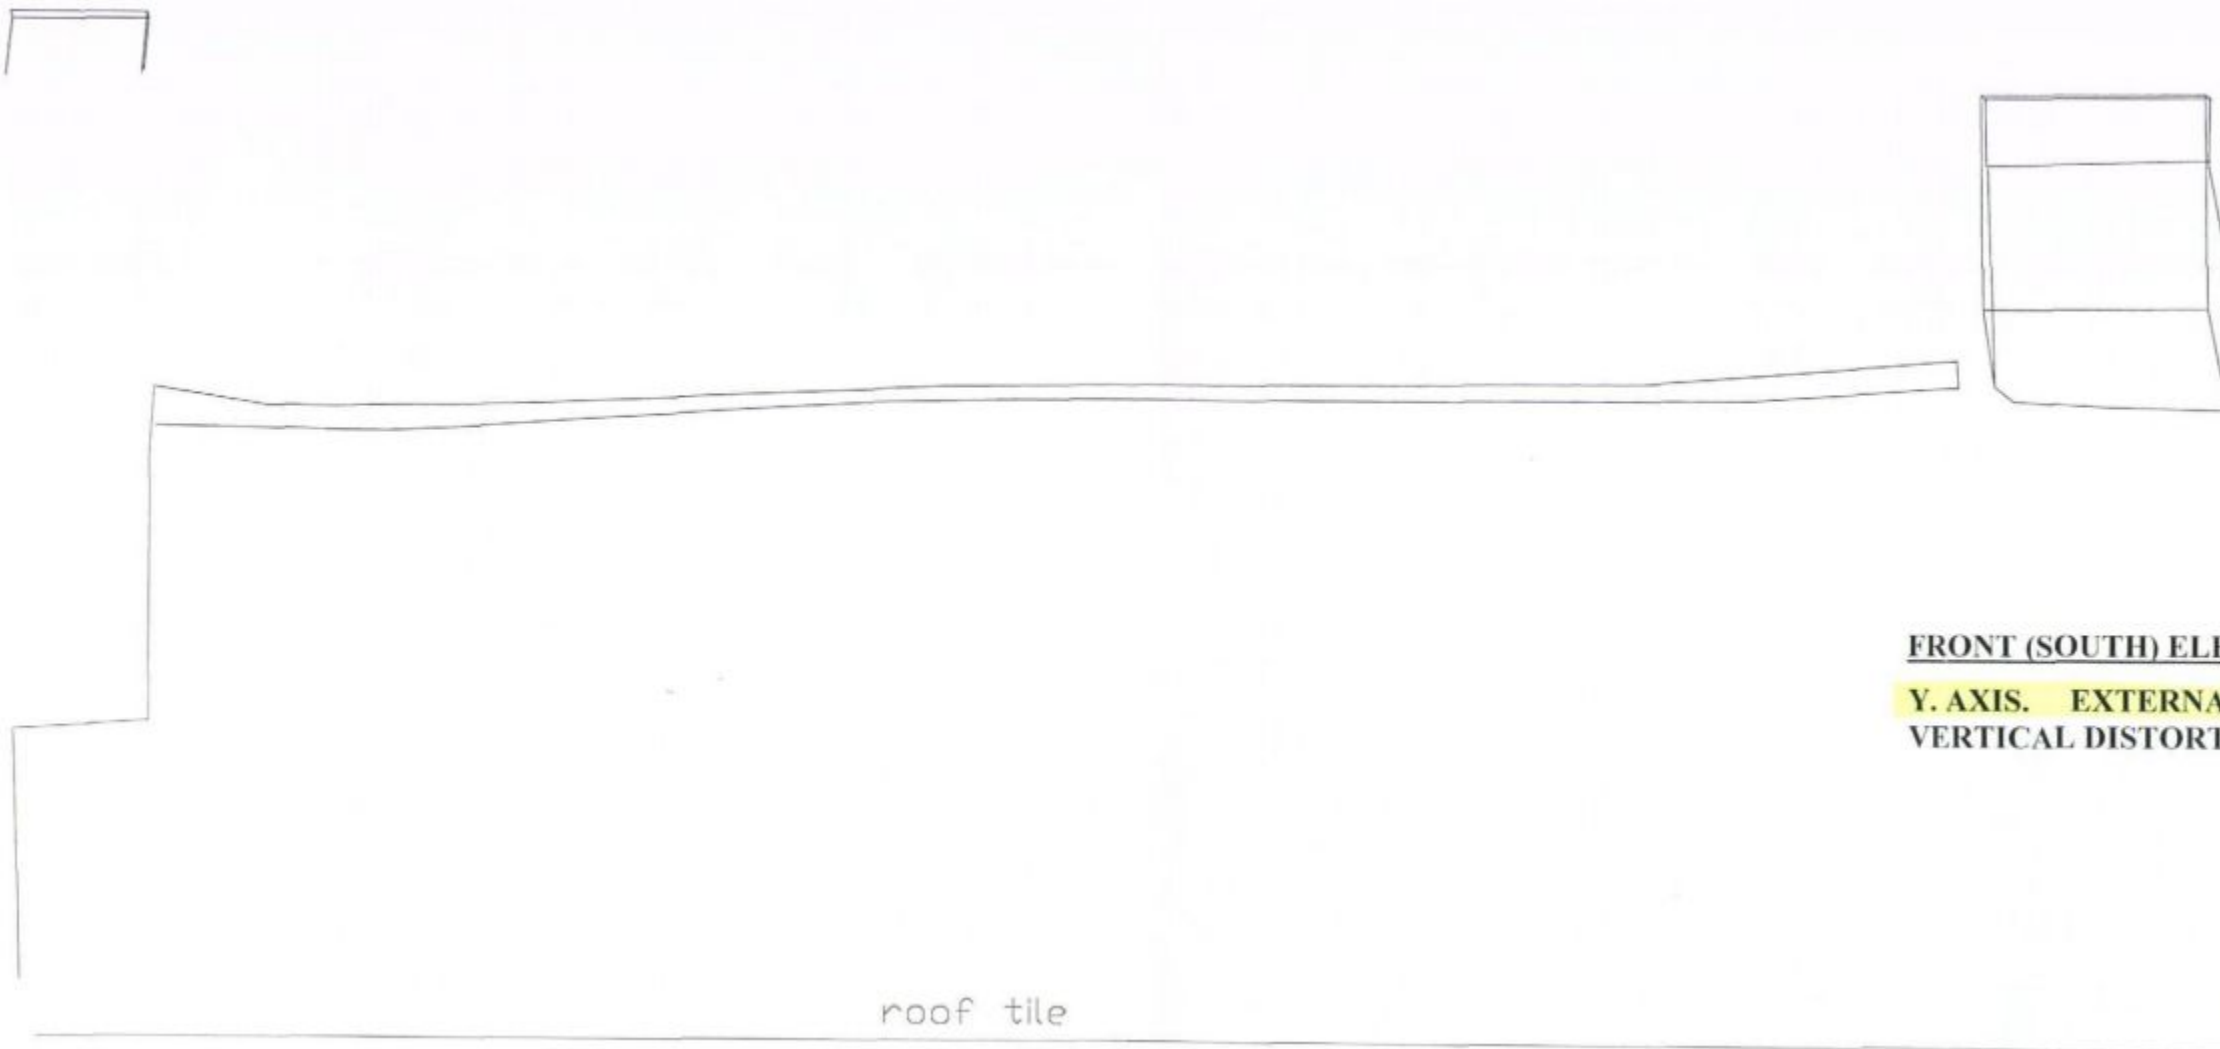
Y. AXIS. EXTERNAL  
VERTICAL DISTORTION

The external distortion over the height in relation to the base of the wall is at its worst at the west, varying from 44mm at the east to 86mm at the western window-head externally and 93mm at plate level, internally at a similar location.
