# ADDENDUM TECHNICAL REPORT ON A SUBSIDENCE CLAIM

97 Sutton Road  
Waterlooville  
Hampshire  
PO8 8PT

# TECHNICAL REPORT ON A SUBSIDENCE CLAIM

## SITE INVESTIGATION REPORT

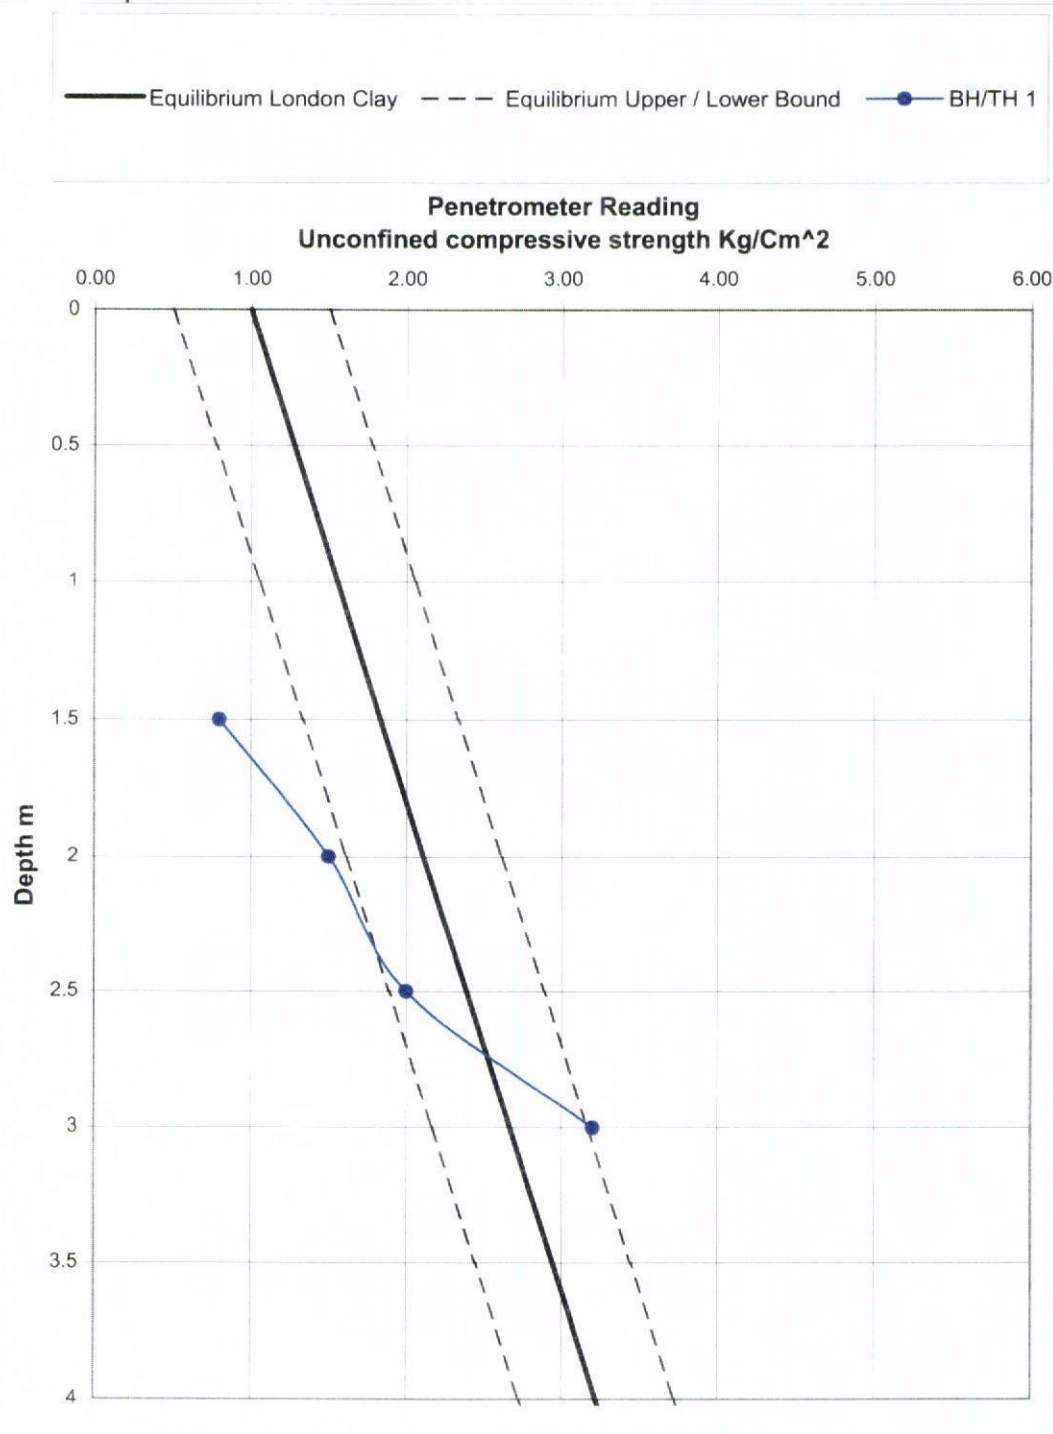
| BH/TH No | Location |
|---|---|
| 1 | Rear Right Hand Corner Of Rear Extension |

The soil was found to be highly plastic clay. Only slight desiccation was recorded due to the timing of the site investigation.

The monitoring readings show cyclical movement. This sort of movement is only associated with clay shrinkage movement. Nominal clay shrinkage through evaporation only affects the top 0.3m of soil. As the foundation is greater than 1m in depth another factor has to be in operation. The roots found, by proximity, are seen to be this factor.

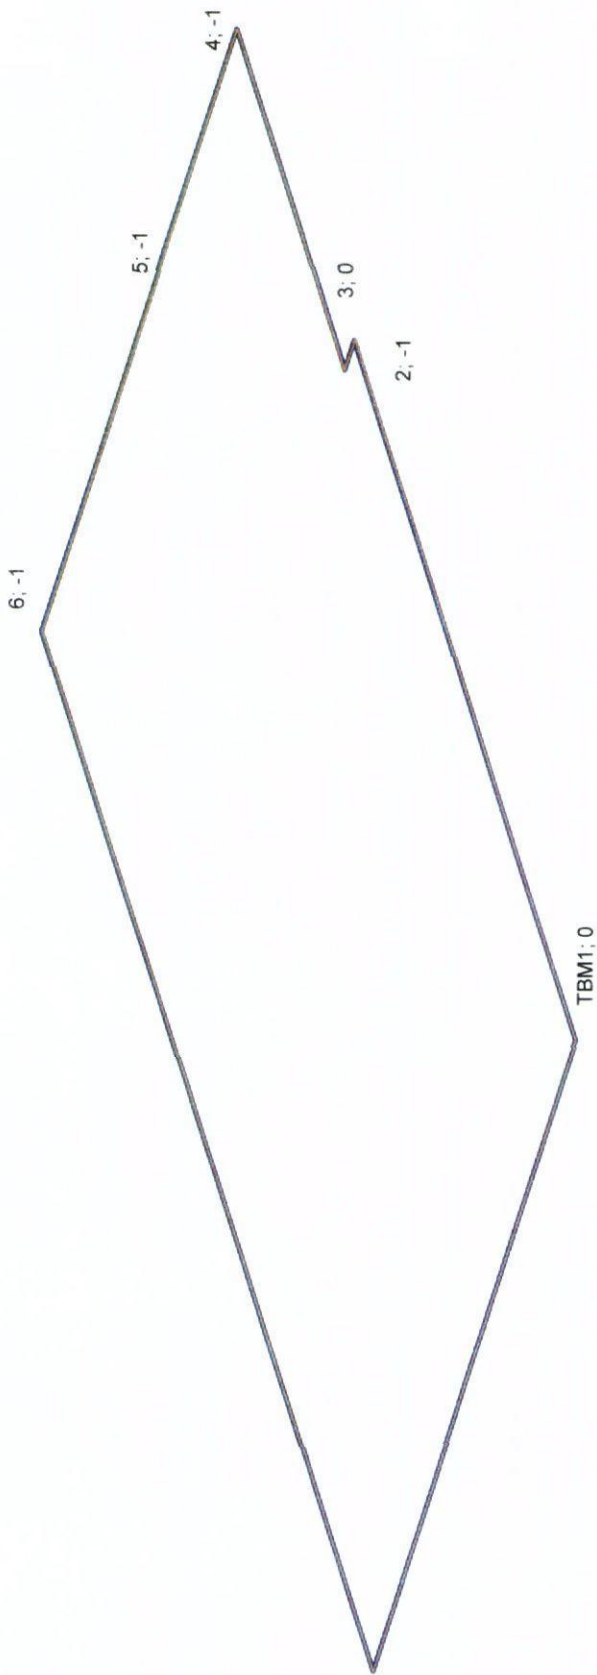
Notes:  
Vertical distorted scale 1: 20  
Point labels give level difference of last reading from original datum in mm.
