# **Gristwood & Toms Tomograph Decay Investigation Report**

**T001: Mature Oak  
St Marys Car Park  
Hayling Island  
PO11 9BY**

**15<sup>th</sup> April 2024**

**Author: Jim Mead Tech Cert (Arb) FdSc (Arb)  
MArborA.**

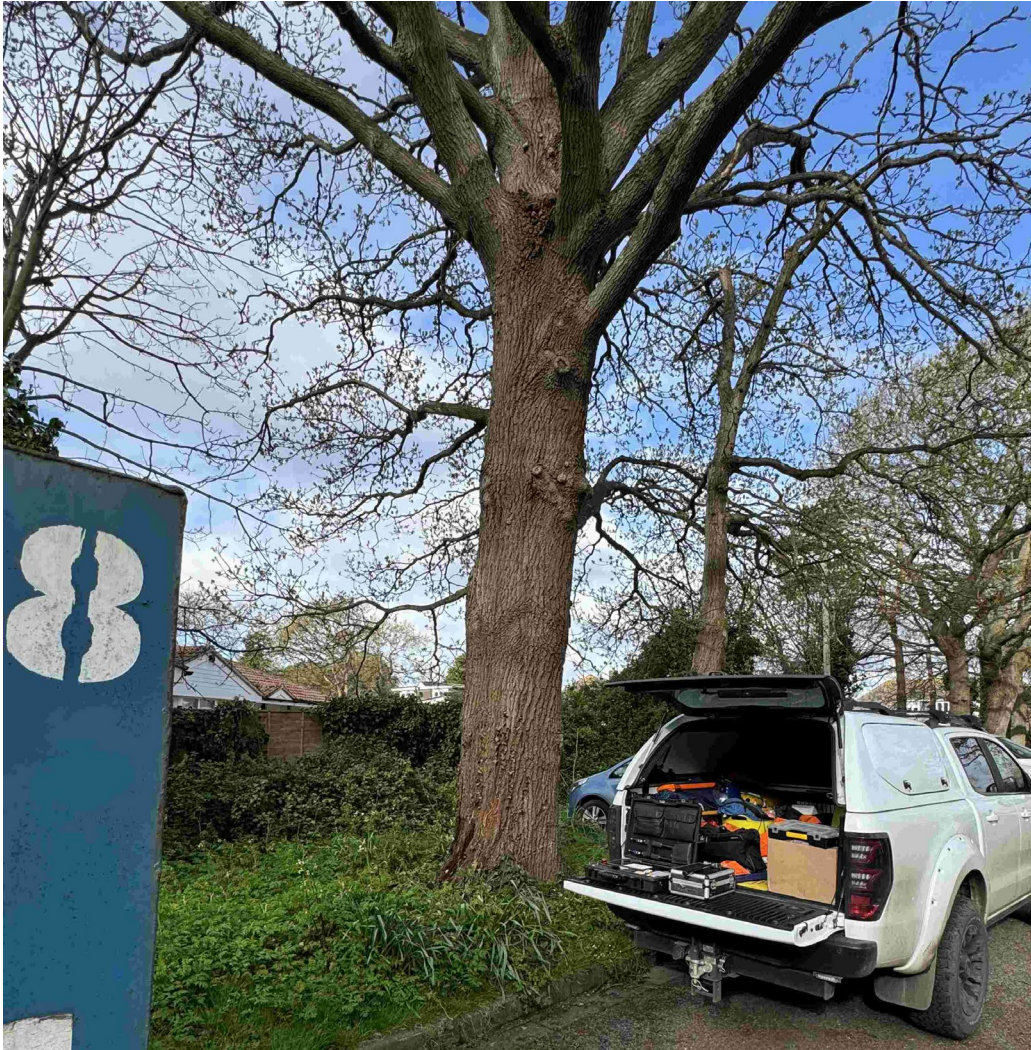
**Fig. 6: T001 Stem viewed from the east.**

Mallet sounding of the trees stem confirms extensive bark delamination and necrotic cambial tissue throughout the southern elevation, exceeding 1.5m wide at ground level and extending up to in excess of 2.5m. There are small areas of dark staining/exudation, consistent with colonisation by *Armillaria* spp. (Honey Fungus) decay pathogen, along with significant frass, from boring insects colonising the dead bark.

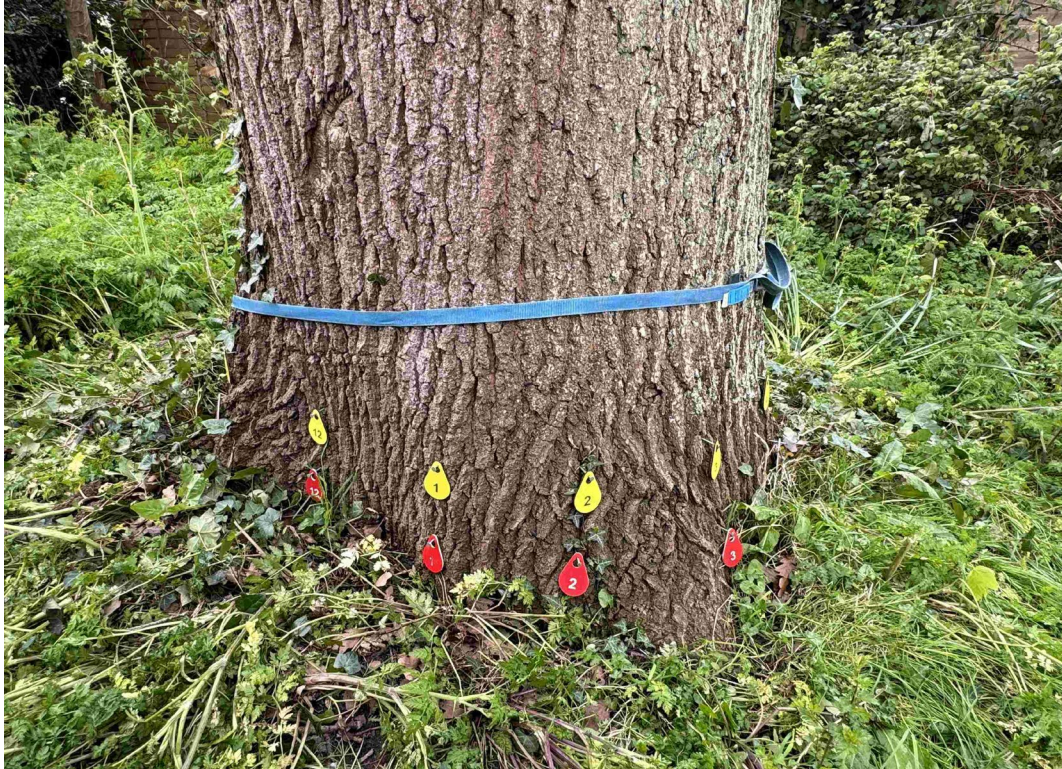
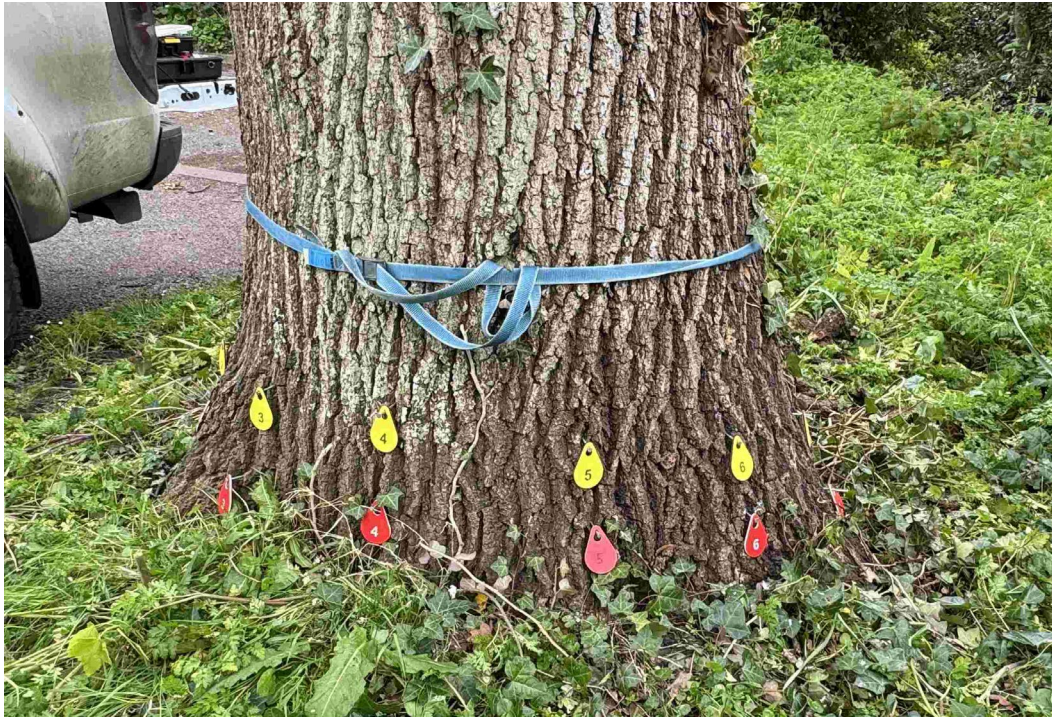
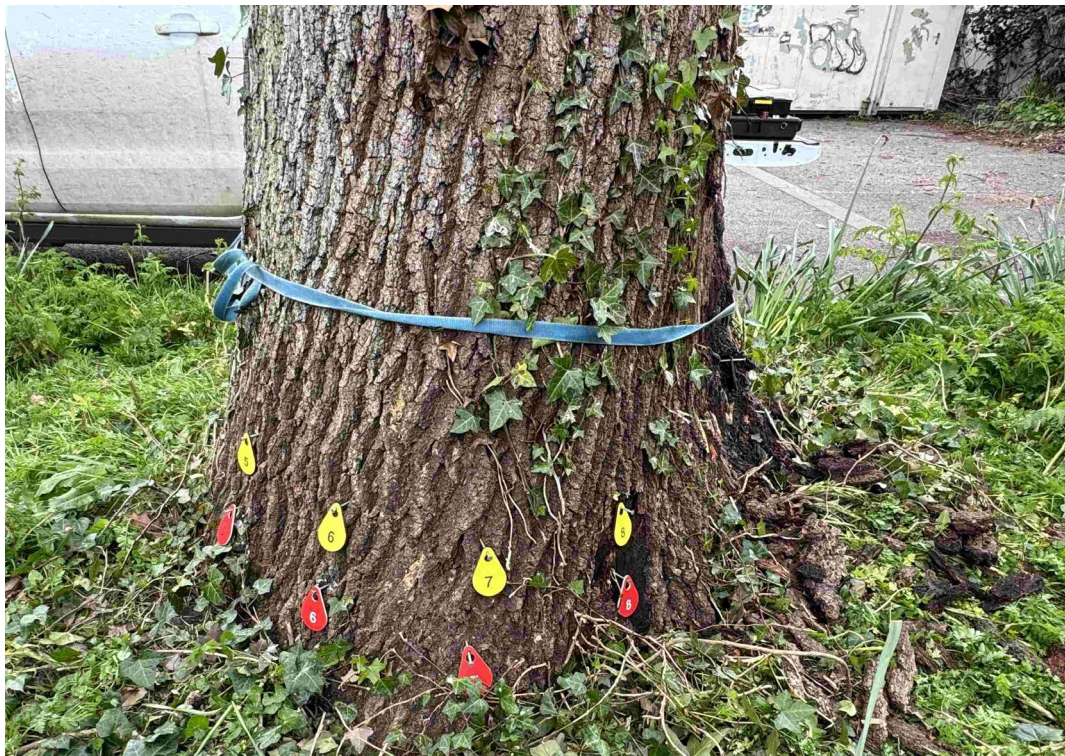
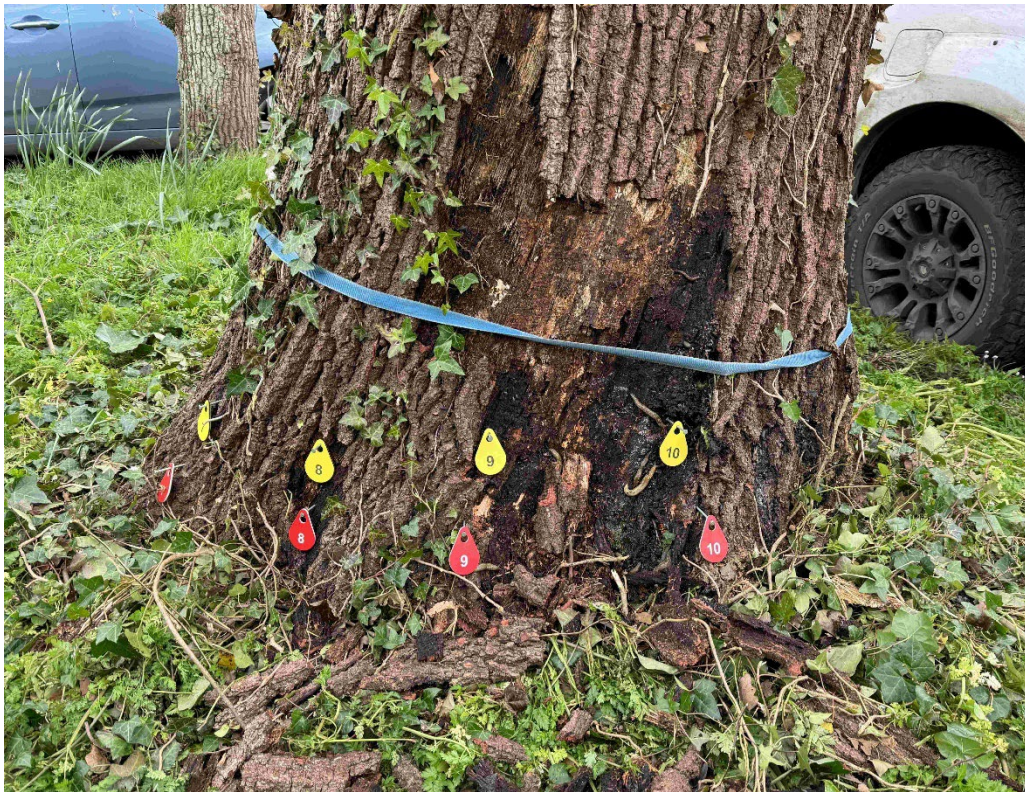
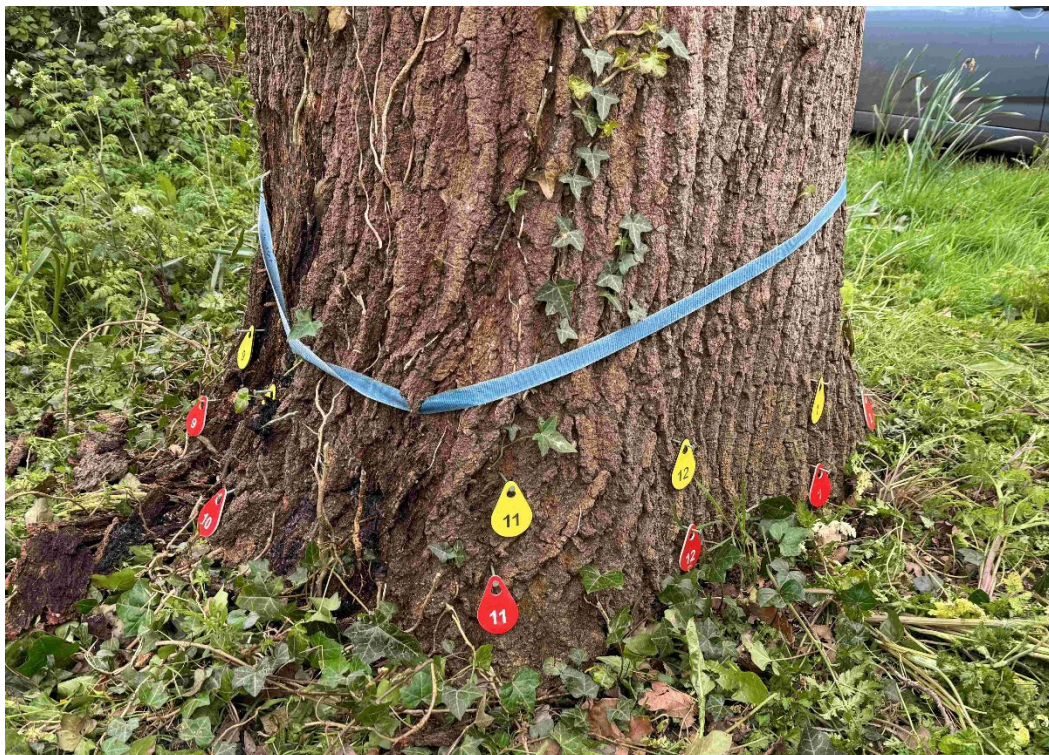
**Fig. 12: T001 Northern elevation stem showing test levels.**

**Fig. 13: T001 Western elevation stem showing test levels.**

**Fig. 14: T001 Southern elevation stem showing test levels.**

**Fig. 15: T001 Southeastern elevation stem showing test levels.**

**Fig. 16: T001 Eastern elevation stem showing test levels.**

Neither of the subject tree's test levels depicted any discernible decay, and I saw no evidence to suggest that further Ultra-Sound and or Micro Drill testing would be of benefit. The acceptable residual wall thickness is intact throughout the stem radii at each level, with no indication of compromised structural integrity due to decay.
