RE: Application for Removal of TPO Ref- pp-04078368

# Arboricultural Consultancy for HBOS

| <b>Insured</b> | Mrs C Watson | <b>Address</b> | 31 Hollybank Road, Emsworth, West Sussex, PO10 7UE | | |

Client: Lloyds Banking Group  
Client Contact: David Elliot  
Claim Number: 101431391  
Policy Holder: Mrs C Watson  
Report Date: 3 December 2013  
Our Ref: C2811S9805

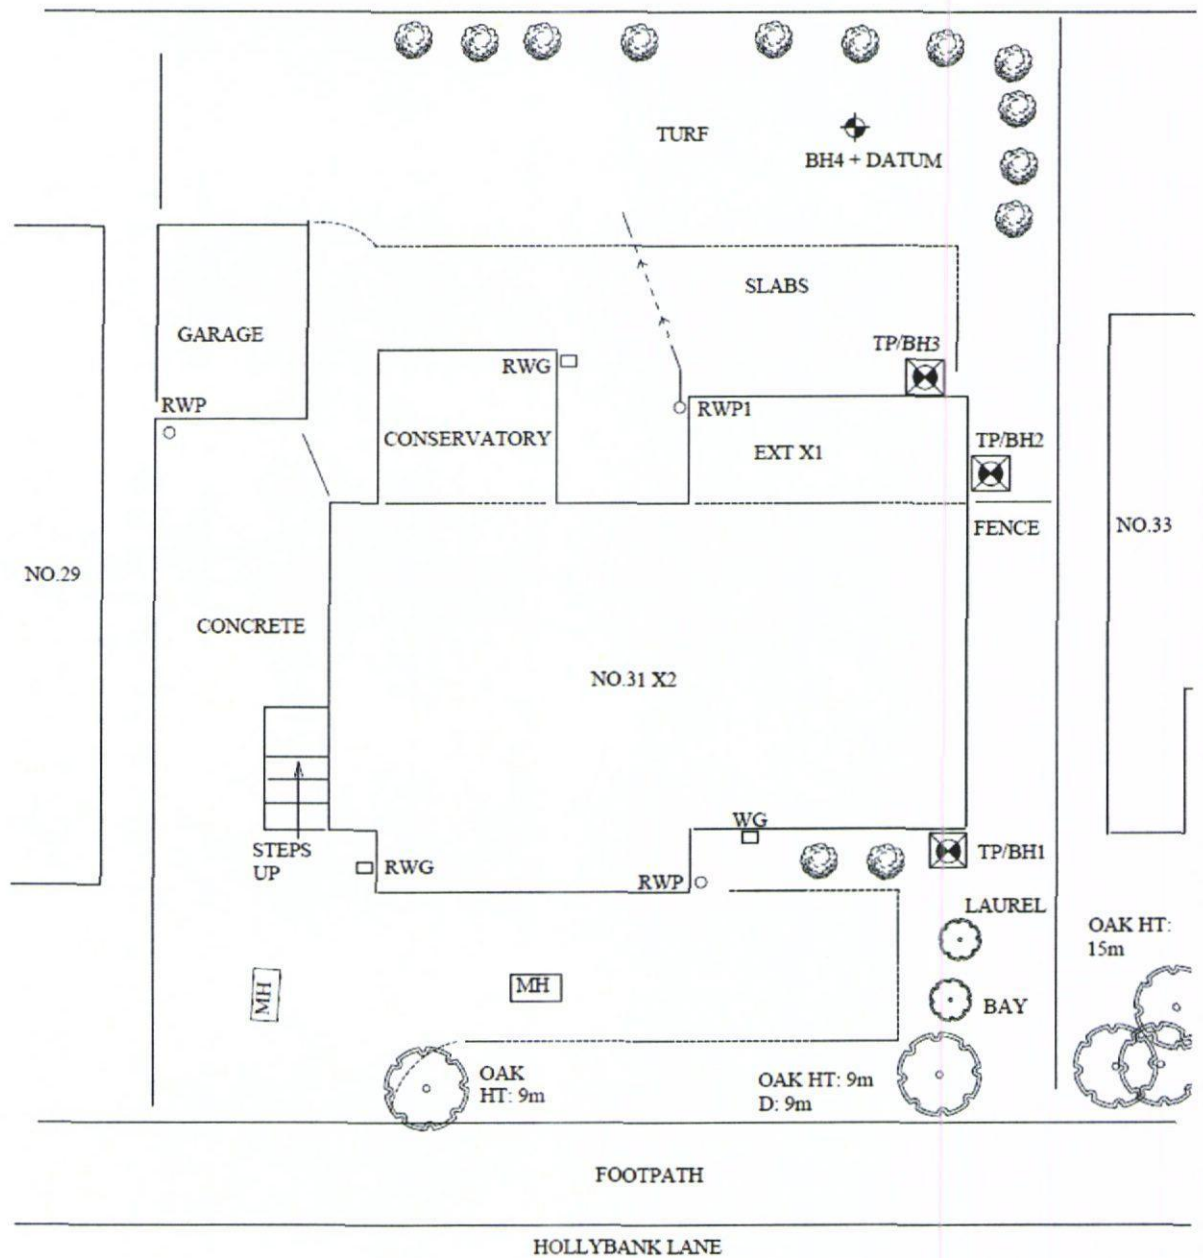
Site Plan

Whilst there is currently no positive root identification to implicate SG1 (Mixed Species Group), T2 (Oak) and TG1 (Oak) in the current damage, our assessment on site considers that the footings of the subject property fall within the anticipated rooting zone of this vegetation.

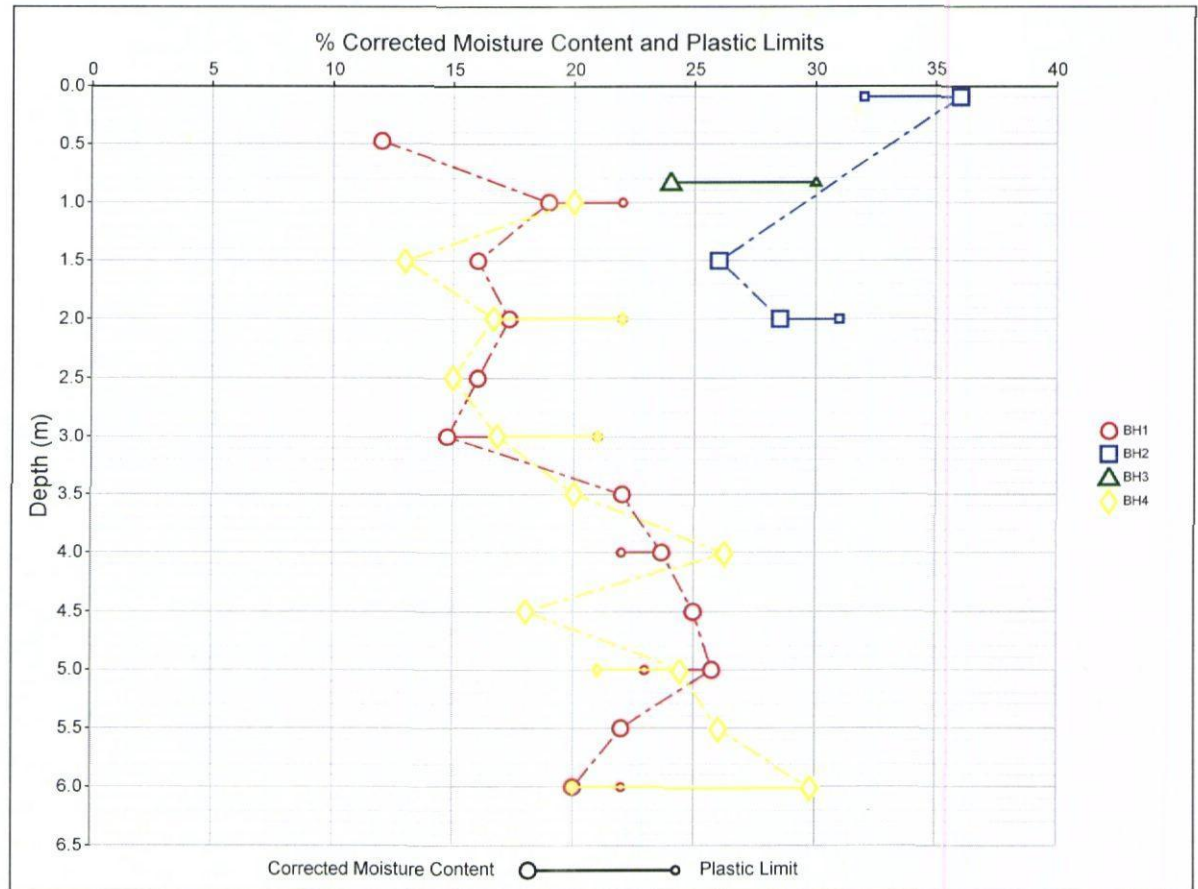
## Corrected Moisture Content and Plastic Limits Graph

The following provides a brief interpretation of the test results by comparison of the results to published classifications. The Atterberg Limit test may be used to classify the plasticity of soils; the plasticity classes defined in BS5930:1999 "Code of Practice for Site Investigations" are as follows.
