# Arboricultural Consultancy for Direct Line Insurance

| <b>Insured</b> | Mrs Elaine Potter | <b>Address</b> | 25 Galaxie Road, Waterloooville, Hampshire, PO8 9AT | | |
| <b>MT Ref</b> | LS/0710131219/JS-REV1 | <b>Consultant</b> | Jonnie Setterfield | <b>Contact No.</b> | 08702 416 180 |
| <b>Report Date</b> | 22/10/2013 Revised 04/03/2015 | | | | |

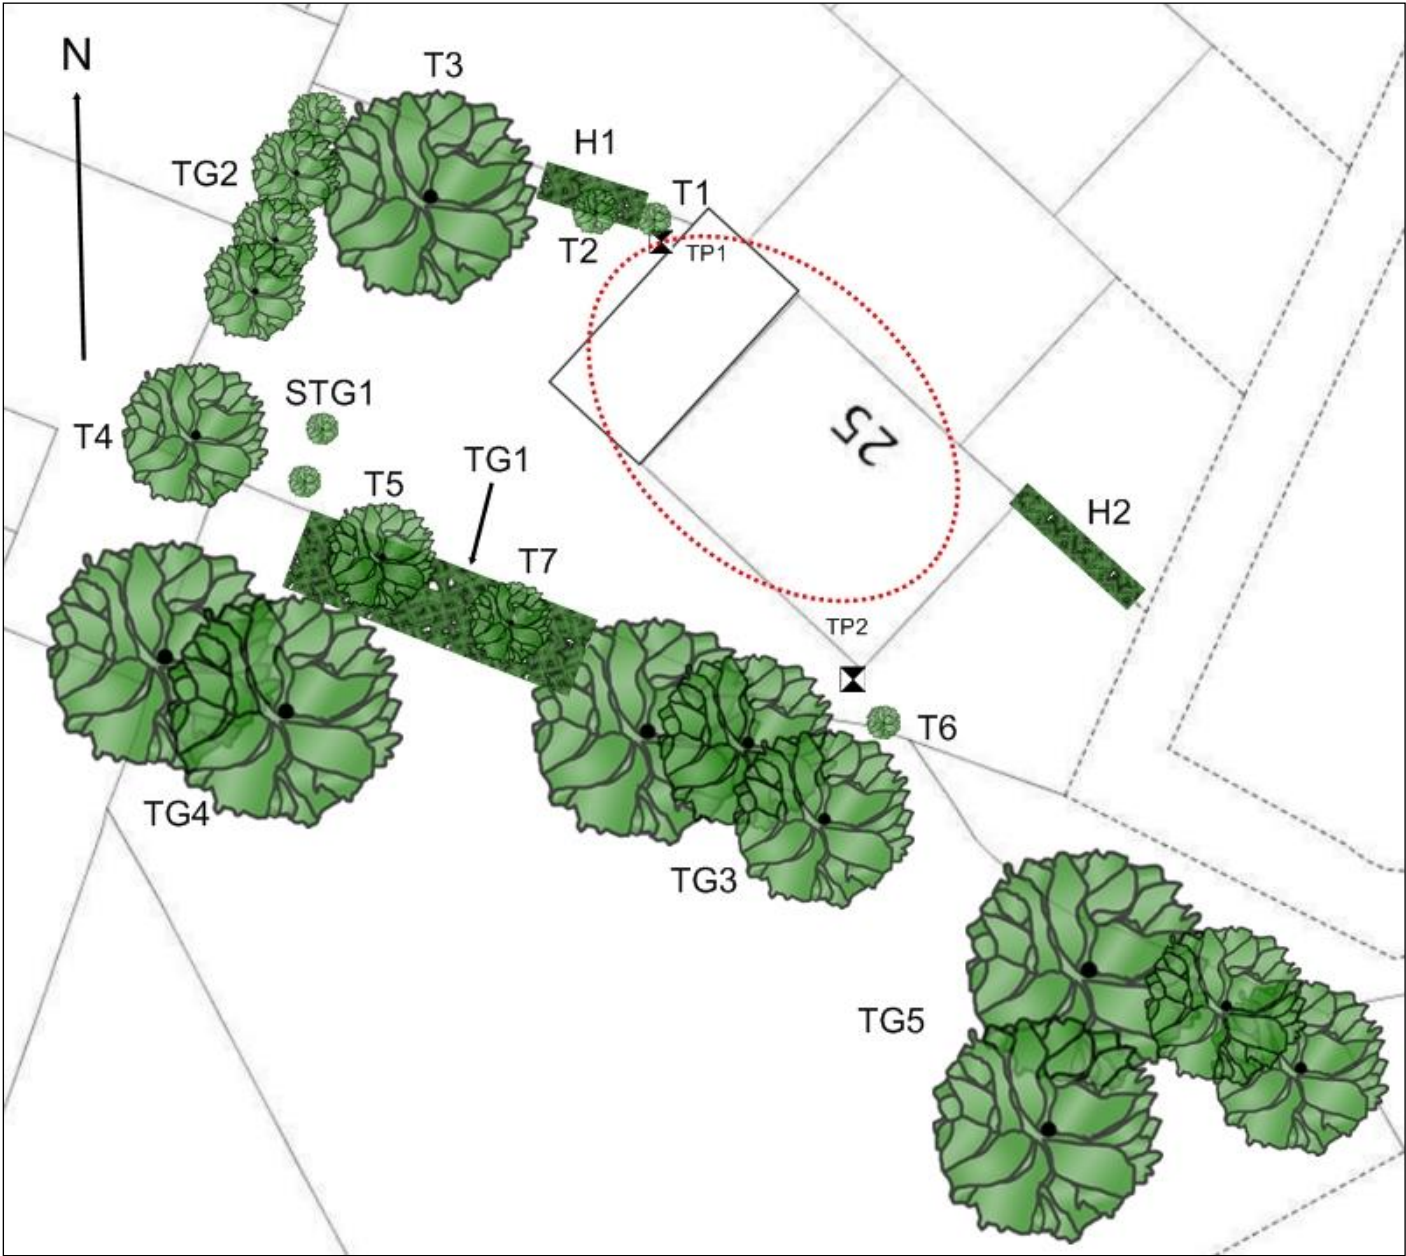
## 7. Site Plan

In assessing the potential drying influence of the vegetation on site TG3 (Oak) is considered the dominant feature and accordingly we have identified these trees as the principal cause of subsidence.

Based on their size, known species characteristics and proximity we also consider that, prior to their removal, T1 (Cypress) and T3 (Ash) were also exerting a contributory influence with respect to the current damage, albeit in a secondary capacity to that of TG3 (Oak).

In order to mitigate the current damage and allow soils beneath the property to recover to a position such that an effective engineering repair solution can be implemented we recommended that TG3 (Oak) is removed.
