RE: Application for Removal of TPO Ref- pp-04080976

# Arboricultural Consultancy for HBOS

| <b>Insured</b> | Mrs C Watson | <b>Address</b> | 31 Hollybank Road, Emsworth, West Sussex, PO10 7UE | | |

Client: Lloyds Banking Group  
Client Contact: David Elliot  
Claim Number: 101431391  
Policy Holder: Mrs C Watson  
Report Date: 3 December 2013  
Our Ref: C2811S9805

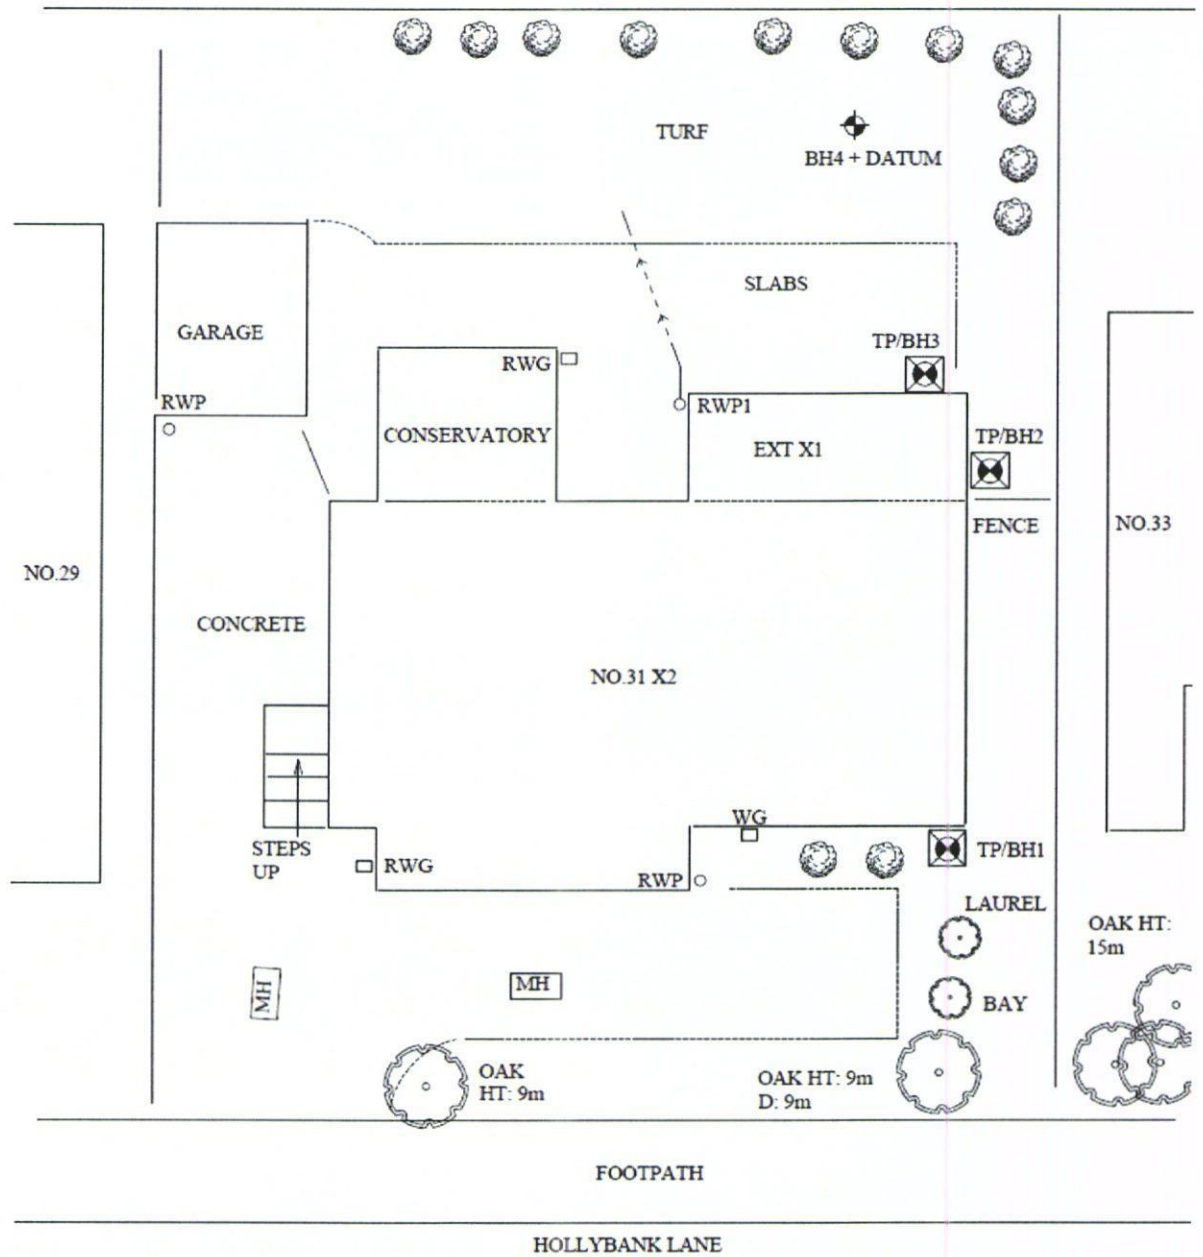
Site Plan

Whilst there is currently no positive root identification to implicate SG1 (Mixed Species Group), T2 (Oak) and TG1 (Oak) in the current damage, our assessment on site considers that the footings of the subject property fall within the anticipated rooting zone of this vegetation.
