# Arboricultural Appraisal Report

## Subsidence Damage Investigation at:

Nirvana  
Woodgaston Lane  
Hayling Island  
PO11 0RL

| REPORT DATE: | 08 January 2014 |

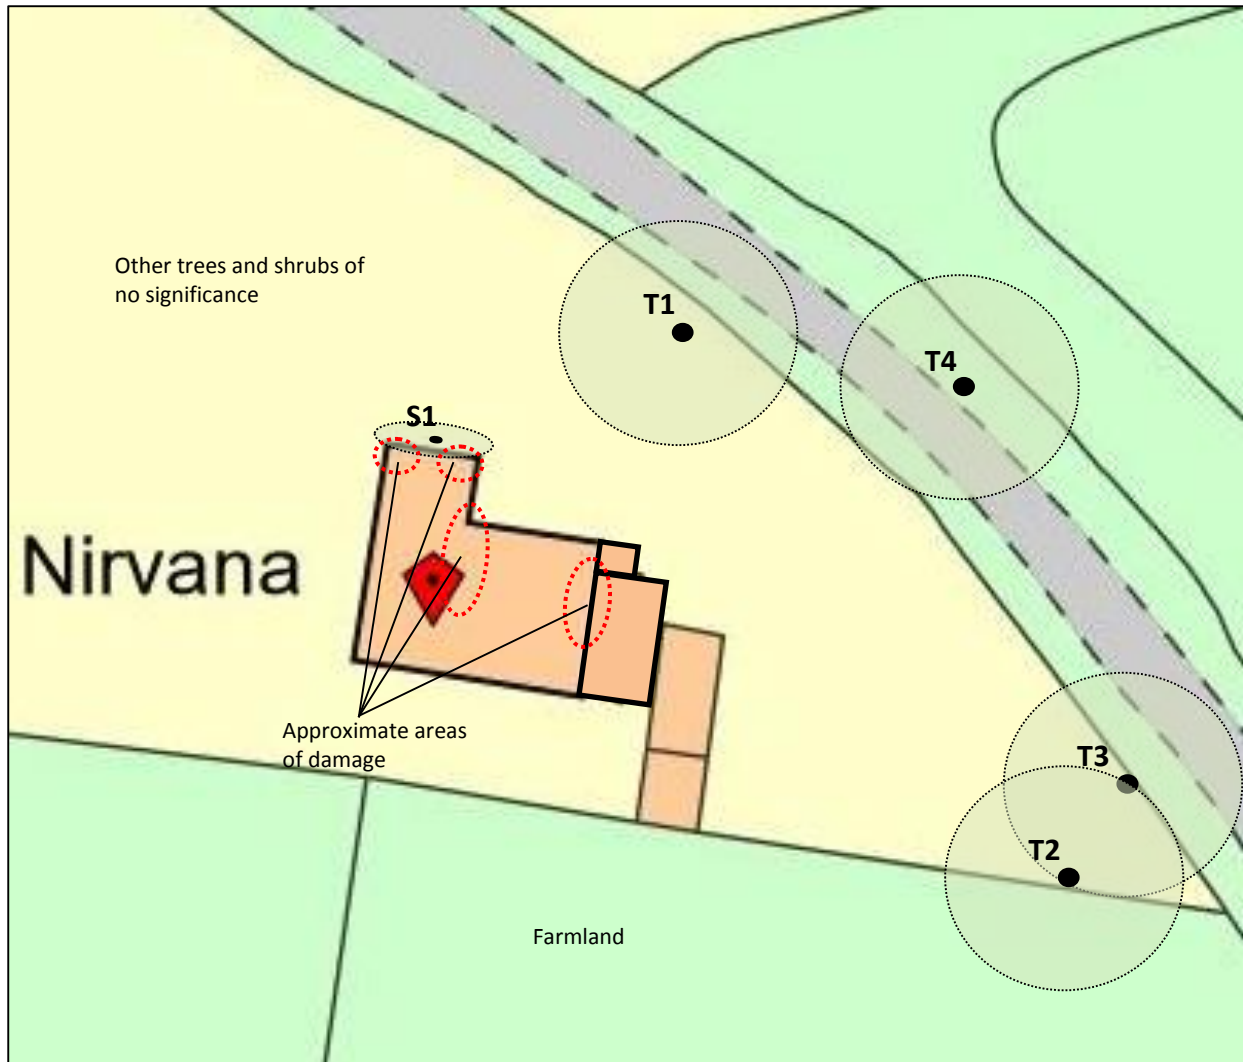
## SITE PLAN

Having considered the available information, it is our opinion that T1 Oak and S1 Pyracantha are the material cause of the current subsidence damage. T1 Oak is considered to be the principal cause of damage with S1 Pyracantha considered a contributory factor and to be causing only localised damage around the front right hand bedroom.

If an arboricultural solution is to be implemented to mitigate the current damage and allow the soils beneath the property to recover to a position such that an effective engineering repair solution can be implemented we recommend that T1 and S1 are removed.
