# Arboricultural Consultancy for HBOS

| Insured | Mrs C Watson | Address | 31 Hollybank Road, Emsworth, West Sussex, PO10 7UE |

Date: 22/11/2013

Property: 31 Hollybank Road

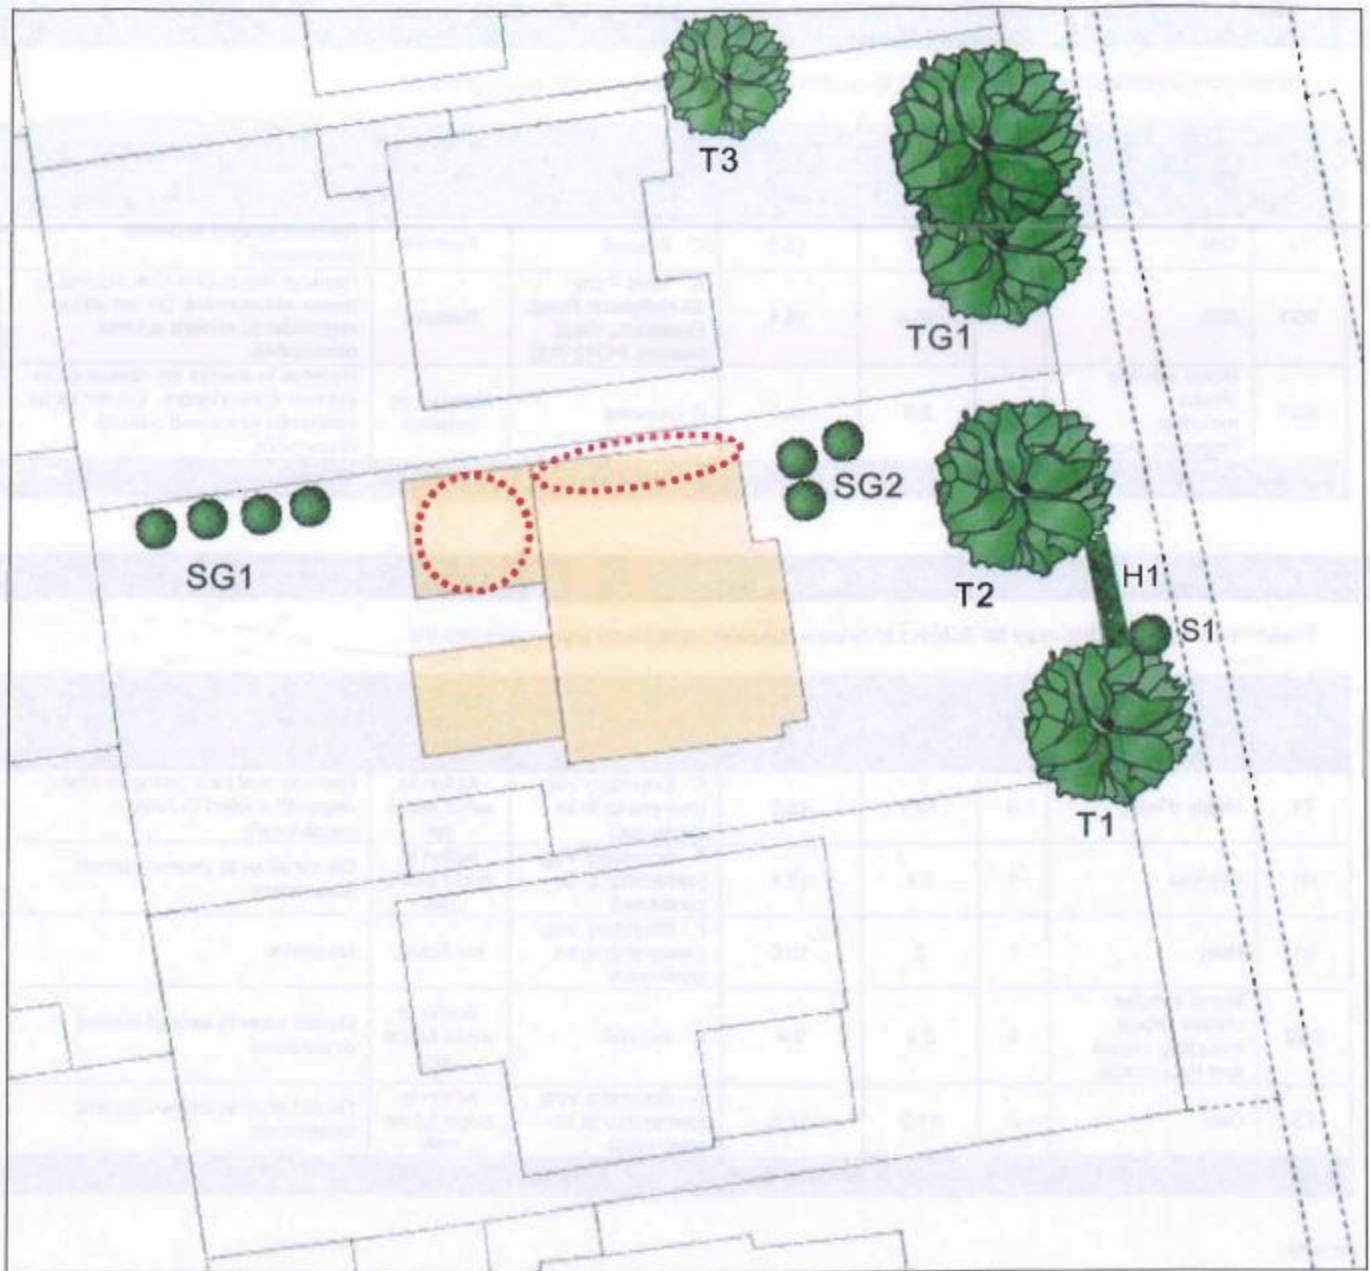
## 7. Site Plan

Damage relates to the right-hand flank of the insured dwelling and the conservatory where cracking indicates downward movement. Please refer to the engineers report for a full description of the claim history and damage.

In order to mitigate the current damage and allow soils beneath the property to recover to a position such that an effective engineering repair solution can be implemented we recommended that T2 (Oak) and TG1 (Oak) are removed. Shrubs within 4m of the rear conservatory within SG1 should be removed to eliminate them as a causal factor.
