# Subsidence management Services

## ENGINEERING ADDENDUM REPORT

Infront Innovation Reference: IFS-DLG-SUB-13-0044404

Address of Property: 25 Galaxie Road, Waterlooville, Hampshire, PO8 9AT

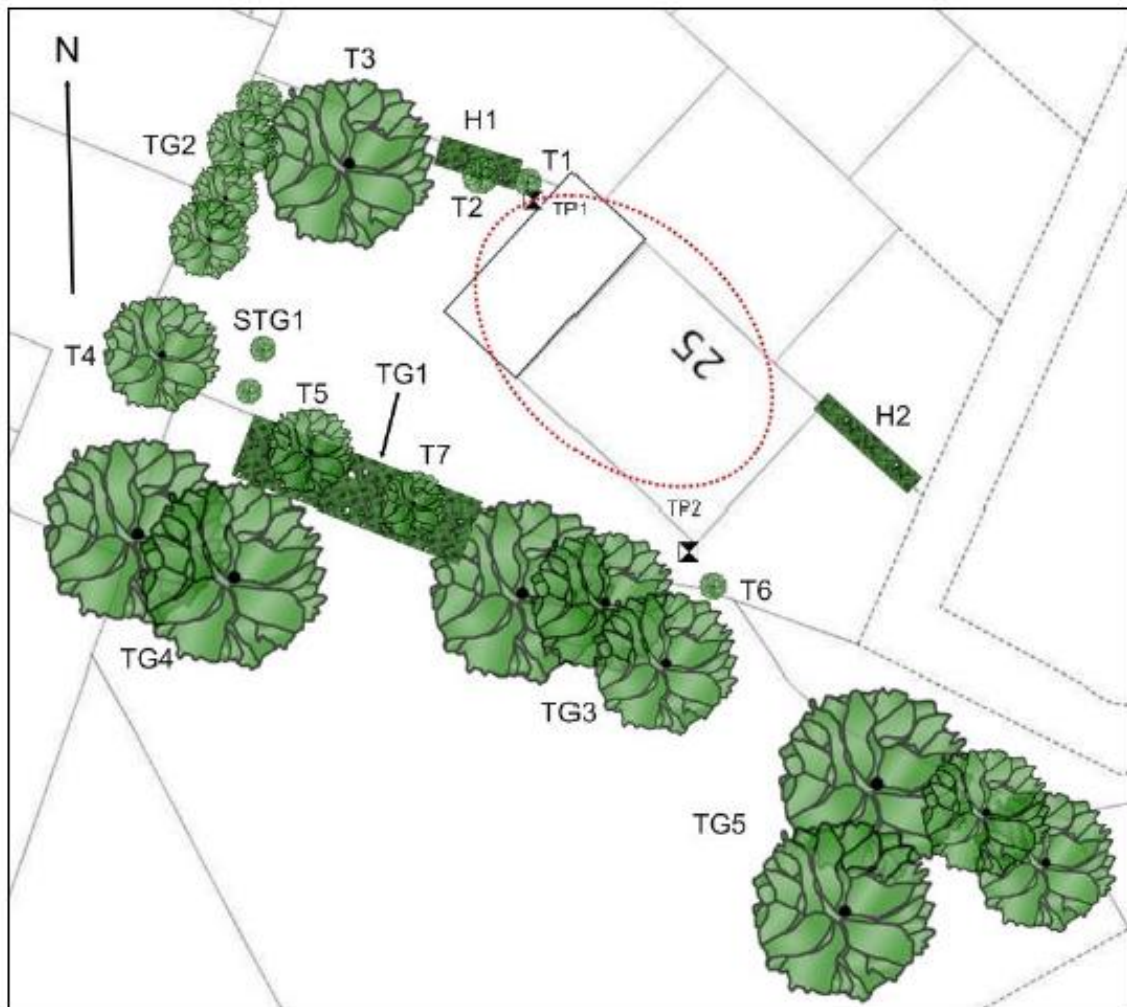
*Figure 2 – Sketch taken from Marishal Thompson Group survey showing location of the principal vegetation in relation to Property*

- 3.3. Site investigations were carried out in October 2013 by Subsnet from which it was concluded that the property had been affected by clay shrinkage subsidence. Marishal Thompson Group have subsequently recommended removal of the Oak trees (reference TG3) at the left hand side of the property which are believed to be the primary influence of the damage to the left hand side of the property.
- 3.4. Tree roots obtained from the boreholes undertaken in October 2013 were subsequently examined by industry experts, EPSL Botanical Identifications and roots obtained between 3.0m and 3.7m below ground level were positively identified as belonging to Quercus spp which are oaks.
