### Information to support application for tree works

14, Nore Farm Avenue, Emsworth, PO10 7NA, subject to a tree preservation order (TPO) no.1981.

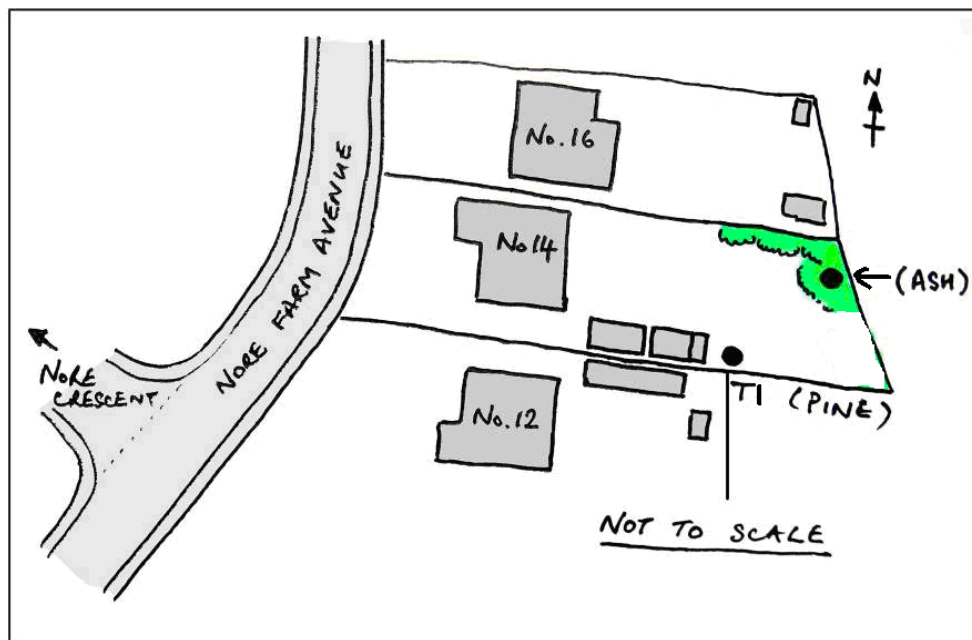
#### 1. Sketch plan showing tree location

Trees shown with ●, the only tree under TPO is T1 = Pinus Radiata (Monterey Pine), solely within the boundary of No.14 Nore Farm Avenue.
