# GEOTECHNICAL

## for Lloyds Banking Group

31 Hollybank Road, W. Sussex, PO10 7UE

Client: Lloyds Banking Group  
Client Contact: David Elliot  
Claim Number: 101431391  
Policy Holder: Mrs C Watson  
Report Date: 03 December 2013  
Our Ref: C9805G4330

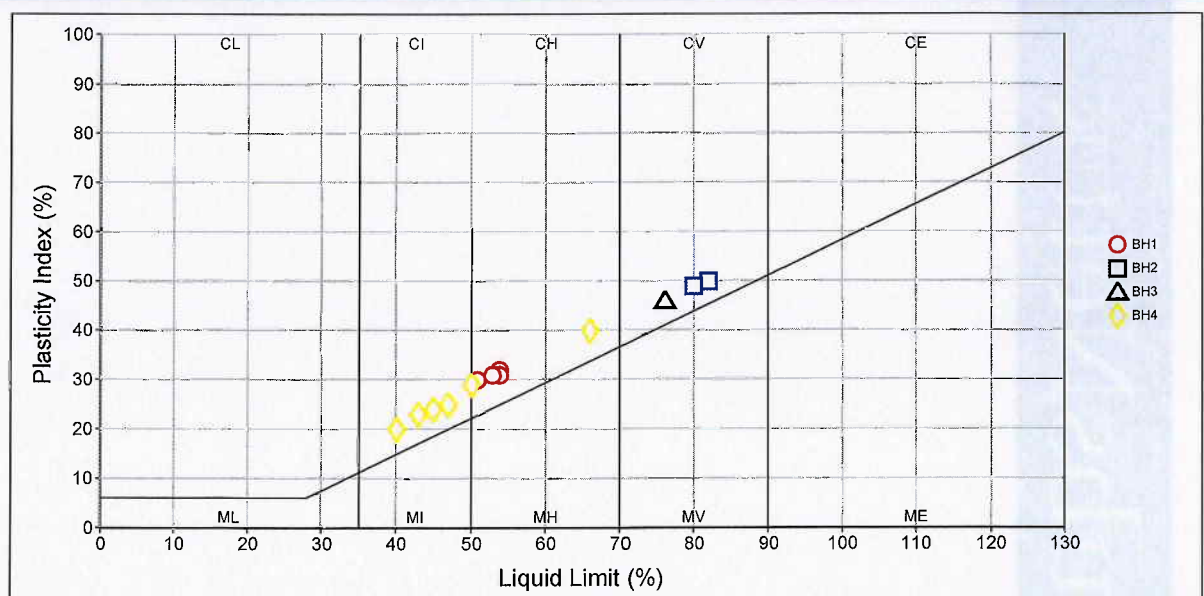
## Plasticity Chart for Casagrande Classification

The following provides a brief interpretation of the test results by comparison of the results to published classifications. The Atterberg Limit test may be used to classify the plasticity of soils; the plasticity classes defined in BS5930:1999 "Code of Practice for Site Investigations" are as follows.
