**SECOND STAGE APPRAISAL**

**ADDENDUM TO FIRST STAGE APPRAISAL 2844**

**86 WEST STREET**

**Job No: 2844**

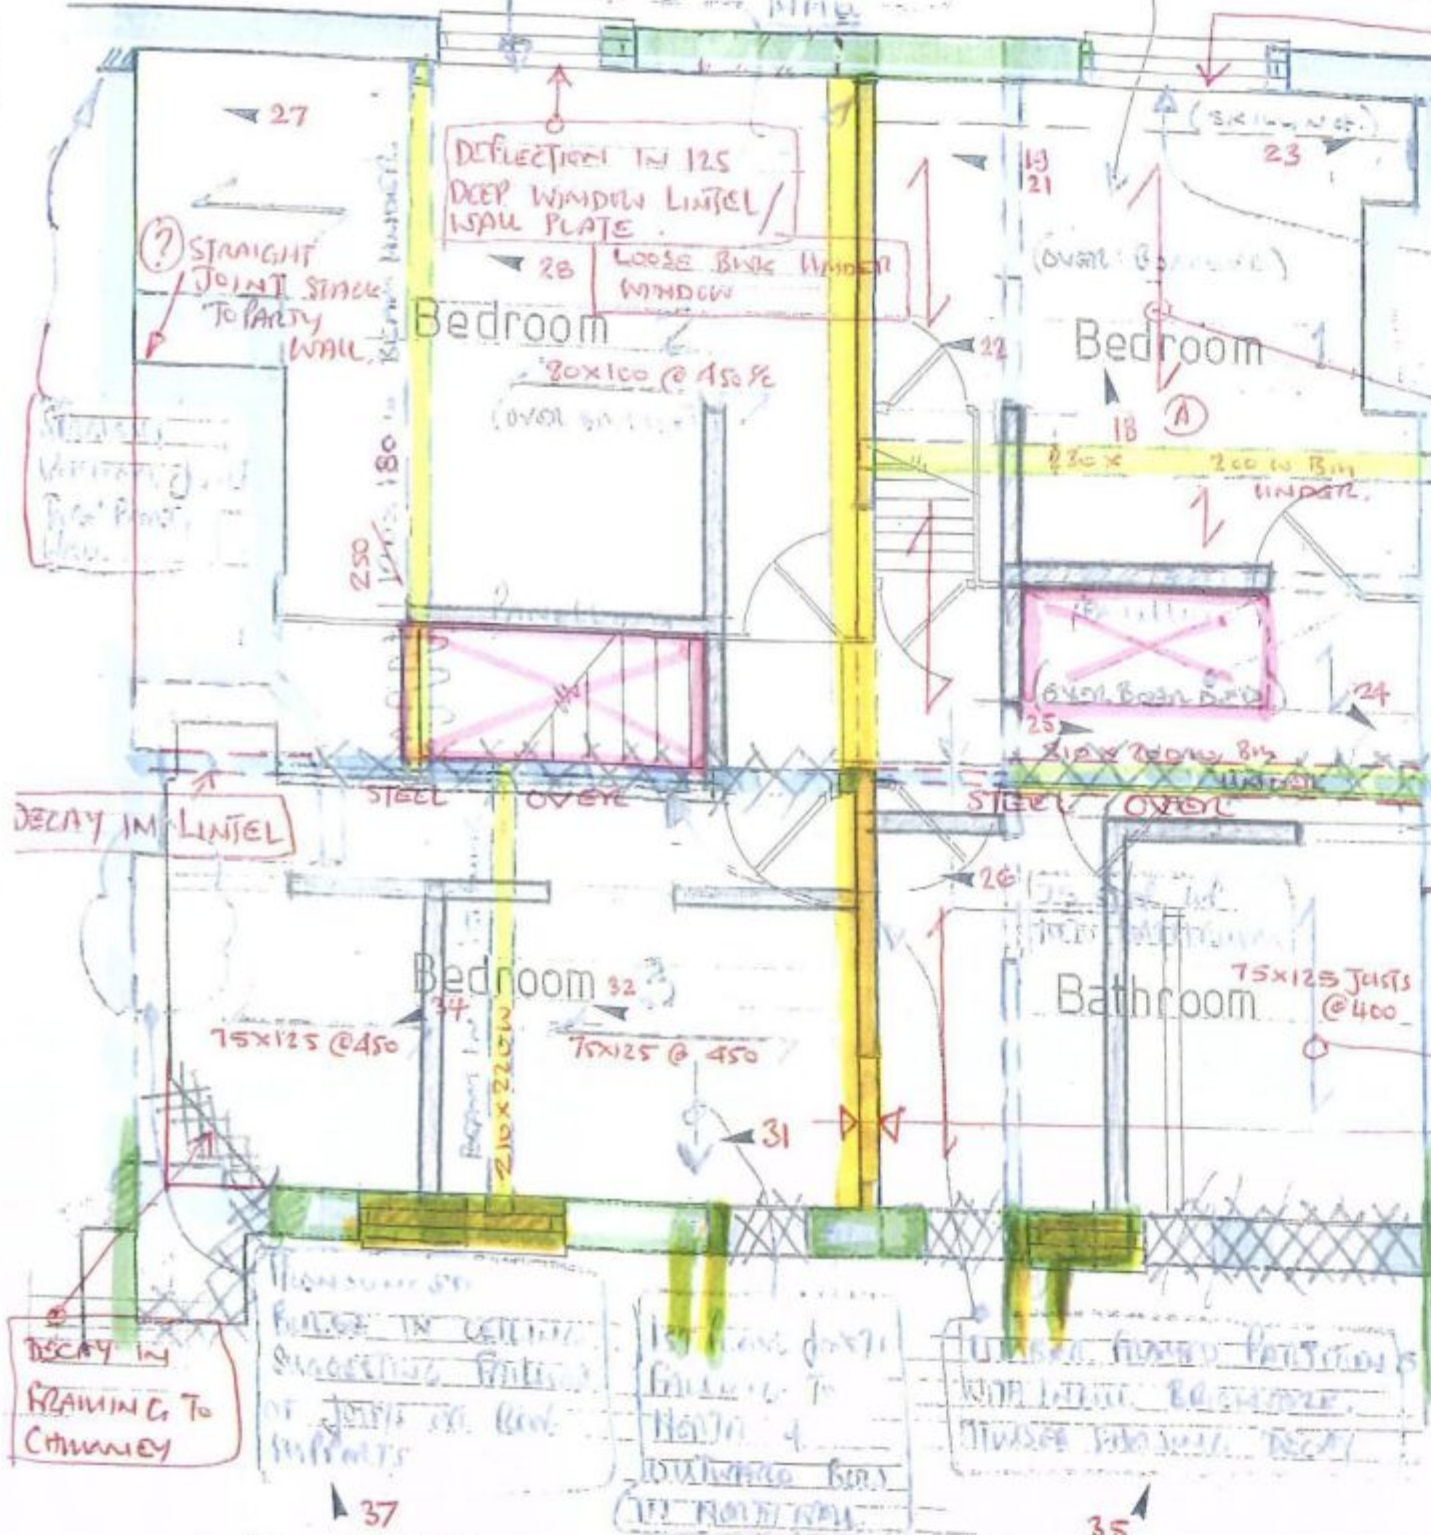
SEVERE DEFLECTION  
IN 1ST FLOOR ON  
CORNER

VERTICAL SEPARATION  
AT REAR WALL / FRONT  
WALL

PROMINENT DEFLECTION OF 125 DEEP WINDOW LINTEL ON CENTRE

1ST FLOOR JOIST SPAN M-S AND HAVE NO BEARING AT FRONT WALL
