# Arboricultural Assessment Report

## Detailed Report on Trees

| | <b>Risk Address:</b> | 18 Crystal Way, Waterlooville, Hants, PO7 8NB |
| <b>Refs:</b> | <b>OCA Ref:</b> | 55556 |

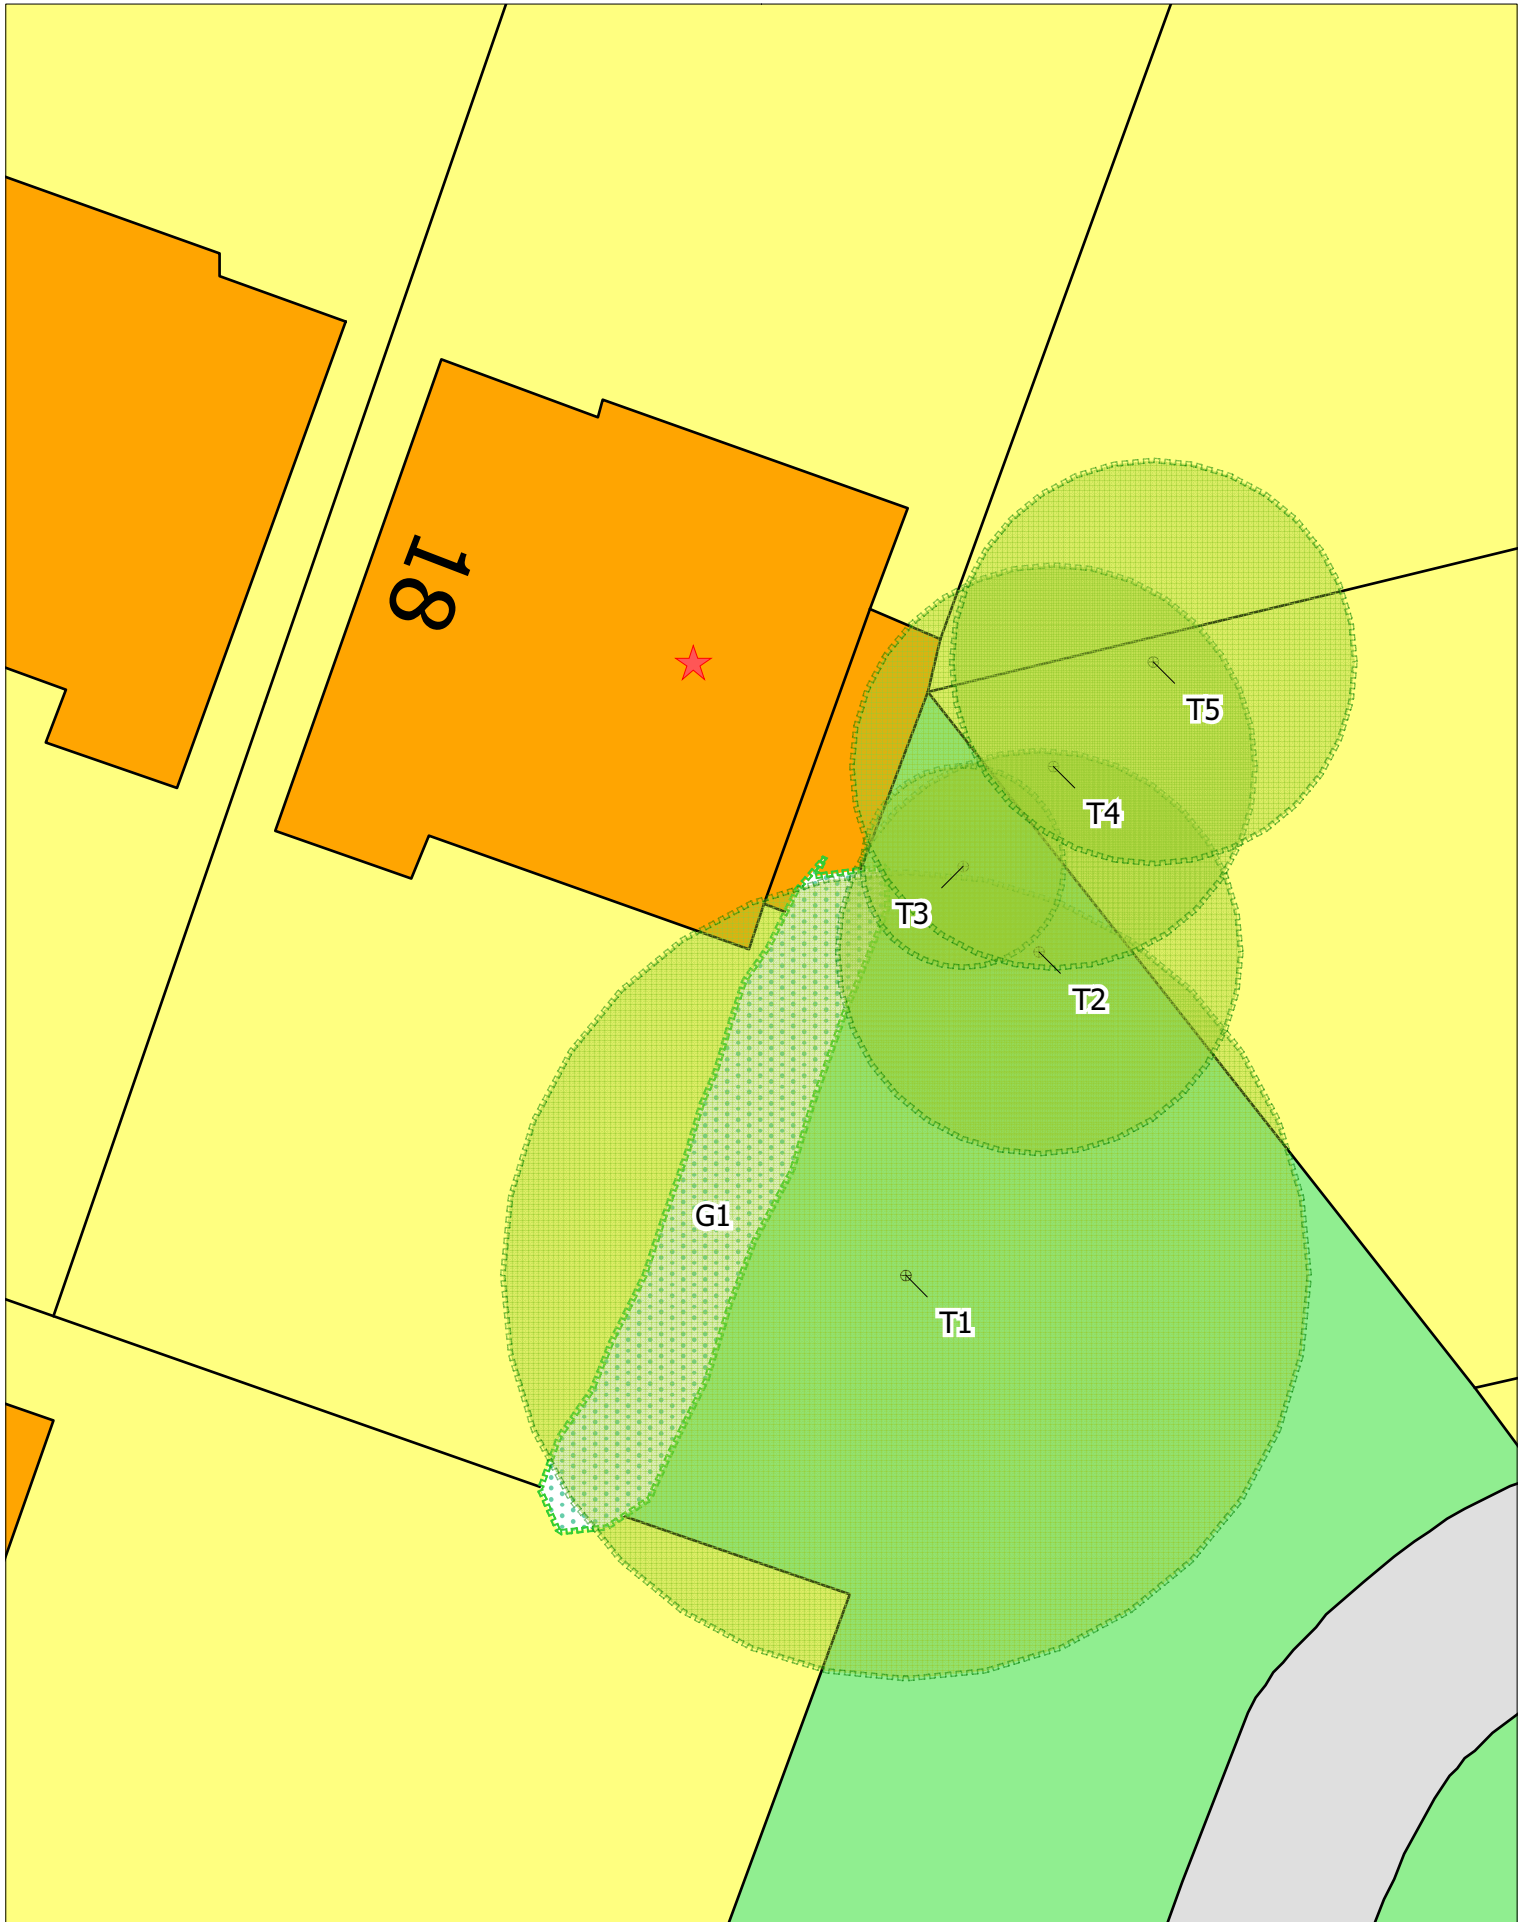
Location: 18 Crystal Way, Waterlooville, PO7 8NB  
Job Ref.: 55556  
Survey Date: 14/01/2014  
Scale: 1:150 @ A4

Therefore it is our opinion that sufficient information has been provided to demonstrate that, on the balance of probabilities, Oak T1, Oak T2, Beech T3, Oak T4, Oak T5 and Lawson Cypress G1 are the material cause of the current subsidence damage

Given their close proximity to the insured property we do not consider that undertaking pruning works to the trees in question will provide either an effective or sustainable means of controlling their water use. Therefore and in order to provide a long-term solution to the current subsidence damage we recommend T1, T2, T3, T4, T5 and G1 be removed.
